# Construction-technical inspection of cemetery church of St. Peter and Paul in Želiv

**Abstract.** This article deals with the construction-technical inspection of Cemetery Church of St. Peter and Paul in Želiv. The church is a cultural heritage and its history dates back almost for 900 years. The construction-technical inspection was performed with the goals to survey construction structures and define their major defects and failures before the commencement of constructional renovation. The survey also included measuring humidity of masonry and wooden parts of the structure.

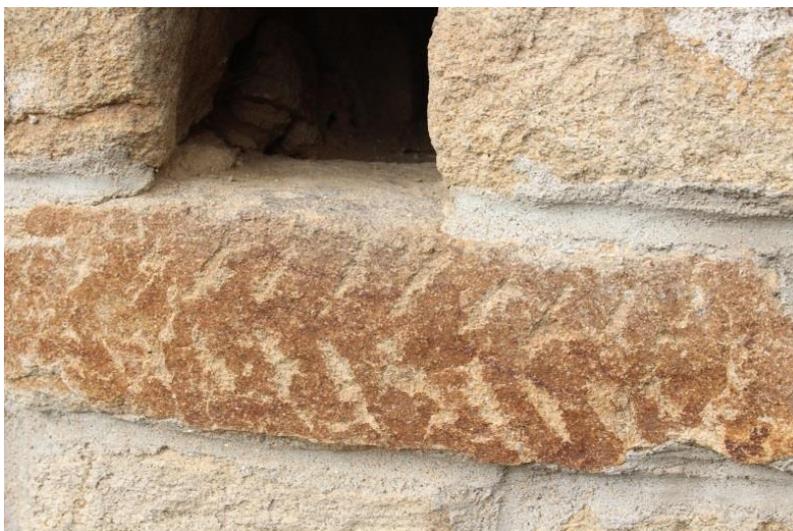
**Figure 5.** A detail of the rocky masonry with a venting hole.

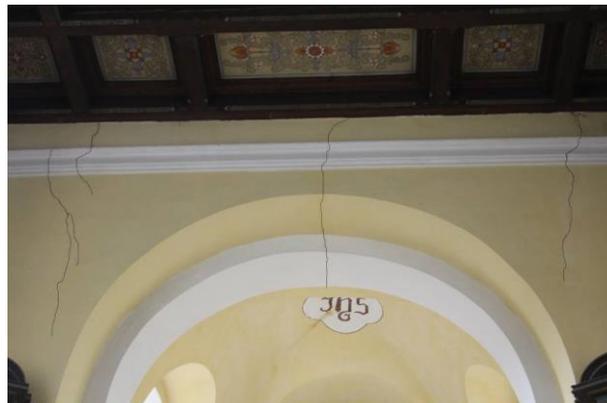
The most significant failures are the ones in the roof cladding. During the inspection leaks in the roofing in the whole area of the roof cladding have been identified, and defects in the details of the gutter, corner and roof valley. Failures which resulted from the leakage of the roof cladding can be seen in constructional structures and materials in the interior and exterior. They especially include the degradation of plasters and cracks in the load-bearing structures, especially vaults (Figure 7).

**Figure 7.** Cracks in the vault of the triumphal arch.
