Experimental Research on the Stability behavior of Composite Curved Stiffened Fuselage Panel under Four-Point-Bending load

C Hao¹, C Y Nan¹, Y Z Bo² and L Lei²

¹Aircraft Strength Research Institute of China, Xi'an 710065, China

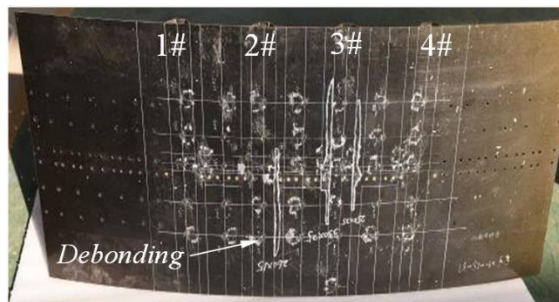
Figure 9. Debonding area of panel 1

After the tests, the ultrasonic non-destructive testing (NDT) has been carried out to detect and evaluate the damage of curved panels. Ultrasound A detection method can directly mark the damage location and area on the specimens, and evaluate the damage status of the structure conveniently and intuitively. Fig. 9 is the NDT results of Panel 1. It can be seen from the figure that small areas of debonding appeared at the bottom of stringer 2 and stringer 3 near the middle area of the frame, respectively. The Panel 1 test stopped earlier and the damage degree of the specimen was slight. The damage of Panel 1 can be used as the initial damage mode. The NDT results of Panel 2 are shown in Fig. 10. The graph shows that stringer 3 and the skin are debonded as a whole, and the surrounding skin is delaminated in a large area, and the edges of stringer 2 and stringer 4 are debonded to the skin. The damage of Panel 2 is much more serious than that of Panel 1. The debonding area extends from the stringer at the bottom of the frame to the edge of the skin and adjacent stringer. The NDT results of Panel 3 are shown in Fig. 11. From the graph, the whole stringer 3 debonded from the skin, the stringer 2 and stringer 4 are mostly debonded from the skin, and the high locking bolts connecting shear-clip and skin between stringer 2 and stringer 4 are all pulled out and destroyed.

The damage initiation and propagation paths can be roughly clarified by comparing and analysing the damage conditions of three curved panels. The main type of damage is the debonding of the stringers and the skin. With the increase of load, the buckling of skin becomes more serious, and the debonding area extends from the bottom of frame to the edge of skin, and from middle of stringer to adjacent stringer. At last, a large area of debonding occurs in the middle of the skin, which leads to the overall instability of the skin, and produces a large peeling stress, leading to tensile fracture of the high lock bolt between the connecting frame and the skin, as shown in Fig. 12.
