Failure Analysis on High Temperature Reheater Tube of T23 Steel in a 660MW Thermal Power Plant Boiler

Jiao Zhong^{1*}, Hao Ke¹, Xi Wang¹, Jing Han¹, Bo Wang², Chao Yu², Hai Huang², Tao Xie², Gang Wu², Xudong Kang²

¹Huadian Electric Power Research Institute Co., Ltd, Hangzhou 310030, China

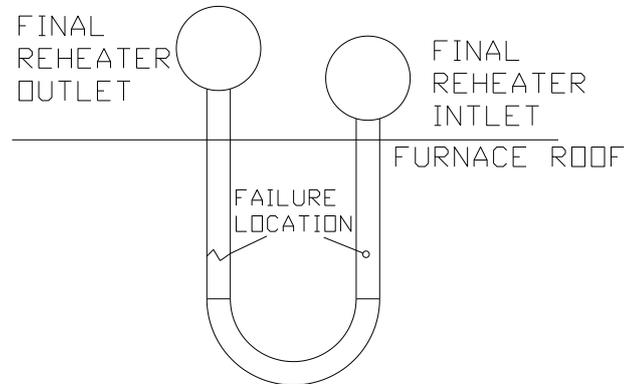
Figure.1 Location of Failures.

Location of failure: the first U-shape elbow from inside to outside of 19th row from left side to the right side of the high temperature reheater tube. The failure location is shown in figure 1.

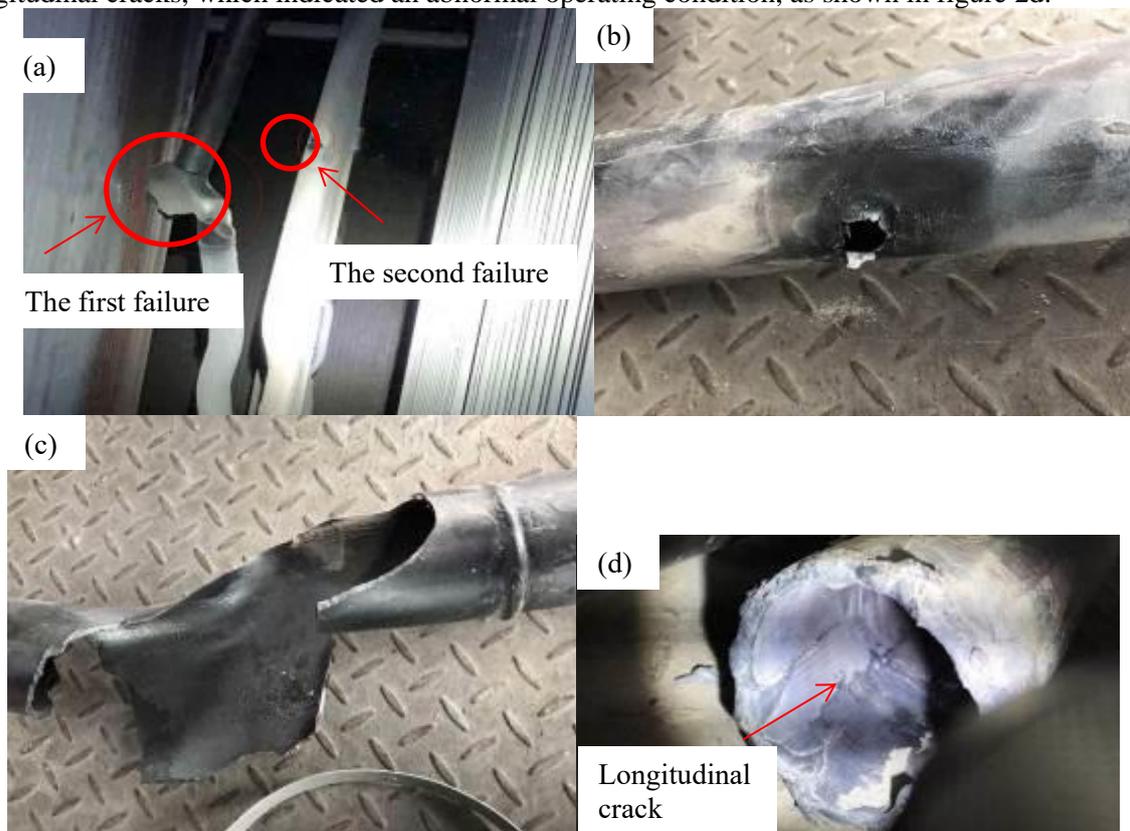
The tube contained two failures, with a tear-shaped one called the first failure (FF) and a blow-out one called the second failure (SF) as shown in figure 2b, c. After the first failure busted, the steam leakage blew the adjacent tube. Therefore, the steam from the first failure led to the second failure that was facing it, which also caused the two failures were on the same tube as shown in figure 2a.

The part (of the tube) at the first failure was incomplete, some of tube flew out during the leakage process, and the first failure edge was not significantly thinned. The oxide scale existed at the

internal/external surface of the burst tubes and the oxide scales of the external surface peeled off. The second failure has obvious traces of steam blowing damage, and the thickness of the tube around the burst was obviously reduced, with a minimum of 0.86 mm.

The part below the first failure was adjacent to the weld for the elbow and the tube. The tube below the weld within one point five meters, with no bulge, was U-bend shape, of which specification was $\Phi 63.5 \times 6$ mm. No oxide scales deposits were observed when the U-bend shape elbow was cutting. There was no obvious peeling of the internal oxide scale where the burst was located. Bulges existed above the first failure within one meter, and the maximum diameter of the tube reached 66.8 mm, which meant a significant swelling. The internal surface of the first failure edge contained numerous longitudinal cracks, which indicated an abnormal operating condition, as shown in figure 2d.

Figure.2 Camera pictures of The failures (a)the position of the two failures in the boiler (b)the first failure (c)the second failure (d)the longitudinal cracks in the internal side of the tube.

It is recommended that T23 steel tubes of the high temperature reheater should be tested such as visual examination and wall thickness measurement, diameter measurement and accumulation oxide scale detection. These steps should be taken to find the defects of the tubes and to make sure that the problem tubes will be replaced by new in time.

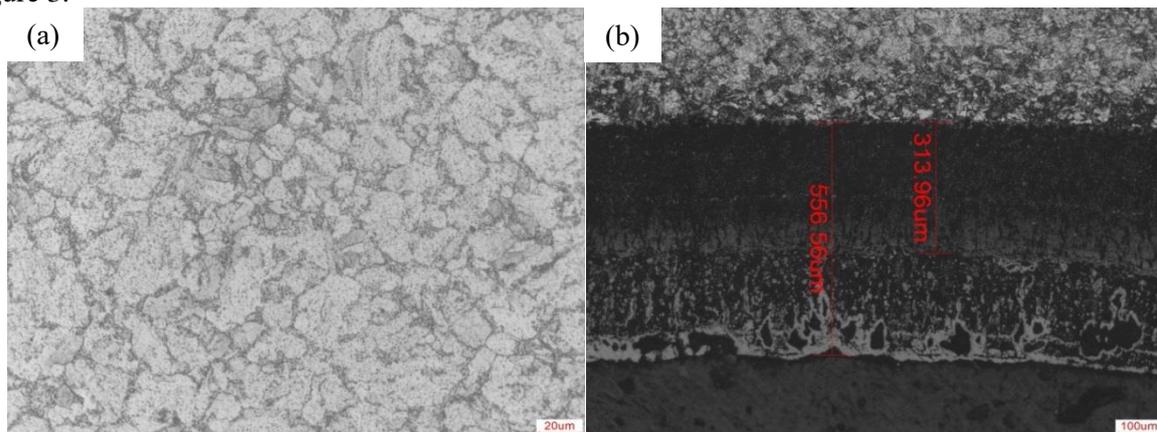
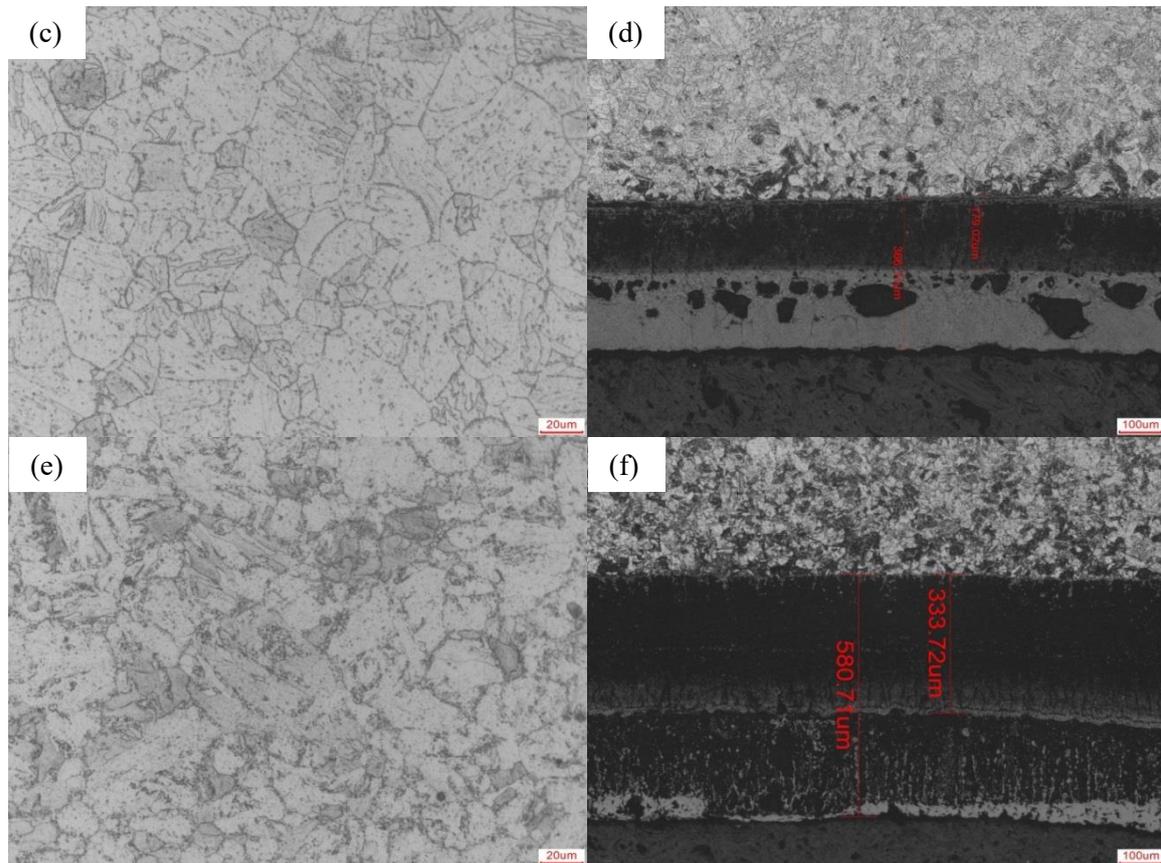
The bainite lath structure of samples was observed. The thickness of internal oxide scale of sample SF was 0.38mm. In the samples FF and FFU, many polygonal ferrites appeared because of the coalescence of bainitic ferrite laths and carbide precipitates aggregated into a chain shape along the grains compared with sample SF. The thickness of oxide scale at the internal surface of sample SF was 0.38mm, and that of the FF and FFU samples were 0.56mm and 0.58mm, respectively, as shown in figure 3.

Figure 3. optical micrographs of the first failure tube.
 (a) (b)sample FF (c) (d)sample SF (e) (f)sample FFU

In this formula $X(t)$, T , t represent the thickness of oxide scales in mils, working temperature (deg.F +460) and operating time in hours, respectively. For Sample FF and FFU, the thickness of the steam-side oxide scale was approximately 550 μm and the operating time was 62750 hours. Its metal temperature could reach approximately 610 °C. That of SF sample was 594°C, which was consistent with its position (leeward side). However this temperature was close to the limit of the T23 material, whose allowable operating temperature was 593°C. What's more, the thermocouple data showed the maximum temperature of the unheated tubes in the penthouse had been over 570 °C. The data indicated the temperature of tubes in the furnace would be much higher than 570°C, which was in agreement with the calculation of the formula. It was shown that the metal temperature of the heating boiler tubes of T23 in the supercritical boiler should be controlled within 570 °C. [2] Therefore, the high temperature reheater tube was overheating [3-4] for a long time. Overheating would lead to reduction of heat-transfer capability internal surface oxide scales and microstructural degradation which was mainly related to the recovery of matrix, disintegration of bainitic microstructure, an increase in the size of carbides and precipitation of M6C carbides. [5] Eventually, the mechanical properties of the material were increased, which in return led to the explosion of the tubes. In the on-site inspection, longitudinal cracks appeared in the inner wall of the tube within 2 meters above the explosion, and the tube showed obvious swelling. The metallographic structure of the windward surface tube was completely aging, and the carbide precipitates in the grain boundary. The tensile strength and yield strength were lower than the standard requirements, indicating that the tube has long-term overheating characteristics.

The cause of high temperature reheater tube failure was a long-term overheating over 570 °C (metal temperature), which led to its yield strength and tensile strength at the room temperature to decrease, resulting in the tube burst with the longitudinal crack rupture.
