Metal fault analysis and preventive measures for grounding accessories of 110kV cable outdoor terminal

Y Xie^{1*}, L Yang², W Li³ and Y L Liu¹

¹ State Grid Hunan Electric Power Corporation Research Institute, Changsha, Hunan, 410007, China

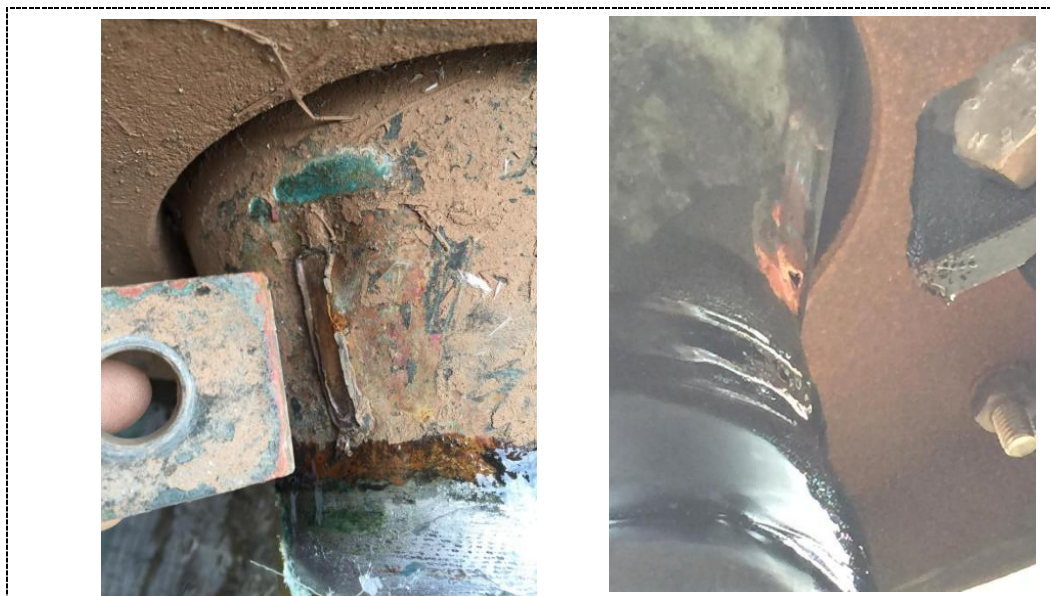
The grounding copper block and the cable tail pipe are generally connected by brazing. The weld is cracked due to stress or its own defects and gradually disengages from the tail pipe. During the gradual cracking of the weld, it is possible that the grounded copper block is completely separated from the tail pipe copper material. For example, the surface of a 110 kV cable terminal A-phase tail pipe leaves a clear trace of welding along the rectangular copper block, as shown in Figure 1(a). The grounding copper joint weld cracking chamber may also break the copper body of the tail pipe to form a hole. For example, and the terminal internal silicone oil leaks from the hole of a 110 kV cable terminal C-phase tail pipe, as shown in Figure 1(b).

Figure 1. (a) Ground copper block and tail pipe copper are completely separated; (b) Cable terminal tail pipe copper weld zone is cracked.

The metallographic test shows that there is a significant weld quality defect in the brazing of the grounded copper block and the tail pipe. At the same time, according to HGJ223-1992 "Technical Regulations for Welding and Brazing of Copper and Copper Alloys", the flux should be brushed on the surface of the welding during brazing [5], and the entire welded end face of the grounded copper block should be covered with flux. From the traces of the weld crack in Figure 1, it can be seen that the grounded copper block is only partially brazed around. More importantly, the brazed weld itself has poor bearing capacity and is generally not brazed at the bearing [6]. Since the grounding copper block is brazed and welded only locally around the grounded copper block, the brazed welded joint has large holes and many pores, so its bearing capacity is poor. It is easy to detach from the tail pipe under the action of the ground wire self-weight, the external wind load installation additional torque and the corrosion stress, so that the contact failure occurs.

(1) It is recommended to fully consider the stress of the weld between the tail pipe of the grounding copper cable end, and select the appropriate welding method and welding material.

(3) The operation and maintenance personnel should regularly inspect the cable terminal, and specifically detect the grounding point of the cable terminal and the grounding wire. When the power failure is overhauled, the non-destructive testing of the grounding wire welding site can be carried out, and the crack is found to be scheduled for power failure maintenance as soon as possible.

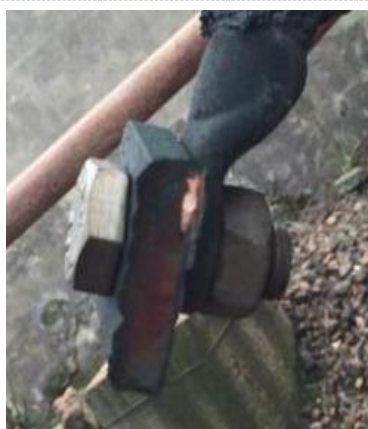
The grounding copper block and the grounding wire are connected by fasteners. Because the installation process control is not in place, only a spring washer is installed on both sides of a 110 kV cable terminal A phase grounding copper block, and no flat pad is installed, as shown in Figure 2.

Figure 2. No fastened connection bolts.

The connecting bolt of the grounding copper block and the grounding wire is an important node in the grounding flow guiding circuit. Flat washers and spring washers are required for bolt mounting. Gaskets and gaskets ensure good bolt contact by increasing the contact surface and preventing loose bolts. Once the bolt is missing, the bolt connection will be loose, and the contact resistance between the grounding copper block and the grounding wire will be too large. There is a safety risk in cable breakdown and high current.

(2) The installation requirements and standards should be strictly installed during the welding to ensure the welding quality. It is necessary to pay attention to the gasket assembly of the connecting bolts and tighten the bolts with a torque wrench. At the same time, the fixing of the grounding wire is improved to avoid additional torque to the grounded copper block weld.

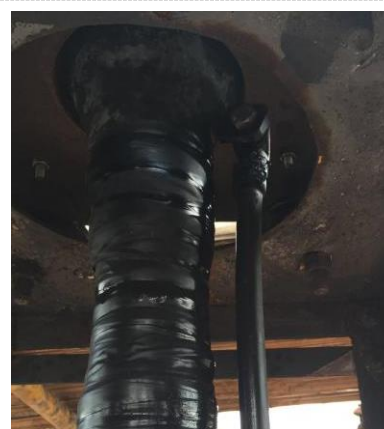
Figure 3. No fixed ground wire connected to the grounding copper block.

The grounding wire connection method of the grounding copper block connection is not specified in the standard regulations and installation documents. Some grounding wires are not fixed by any measures, such as the phase B of a 110 kV cable terminal, as shown in Figure 3.

Although there are no relevant standard procedures and installation specifications to clarify the way the grounding wire is fixed, it is necessary to consider the influence of the grounding wire fixing method on the service condition of the grounding copper bead weld. From the field situation, when the grounding wire is not fixed, the grounding copper block will bear the self-weight of the grounding wire and the load of the environment acting on the grounding wire, and directly promote the cracking of the welded portion of the grounding copper block.

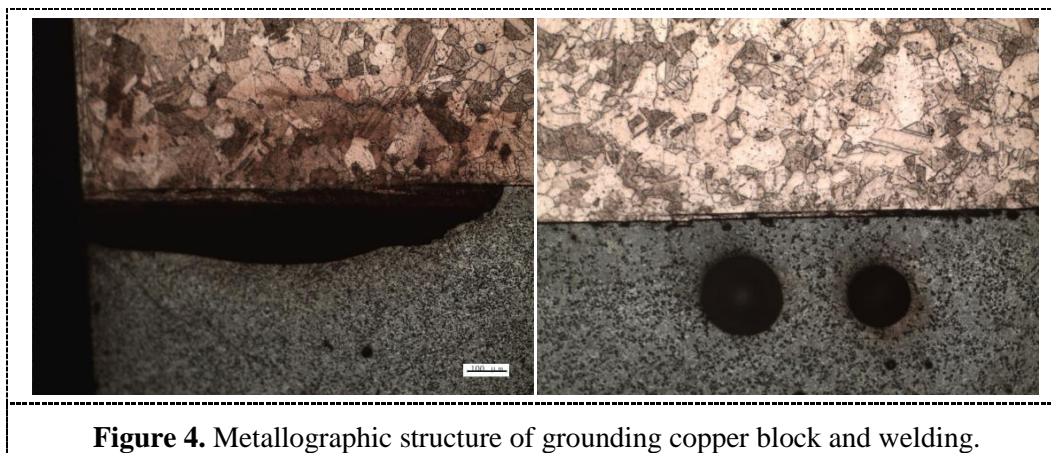
The metallographic test was carried out on the grounding copper block and the weld. The bright color interval is copper matrix and the metallographic structure is normal. The gray interval is the weld structure. Inside the weld, a hole larger than 0.5 mm in size can be seen, and there are also pores of the order of 100 μ m. Since the copper material is not melted and there is no weld transition zone, the interface between the copper base and the weld is clear, which is a typical brazing feature, as shown in Fig. 4.

Figure 4. Metallographic structure of grounding copper block and welding.
