Scuffing analysis of roller-shoe mechanism after an aggressive test

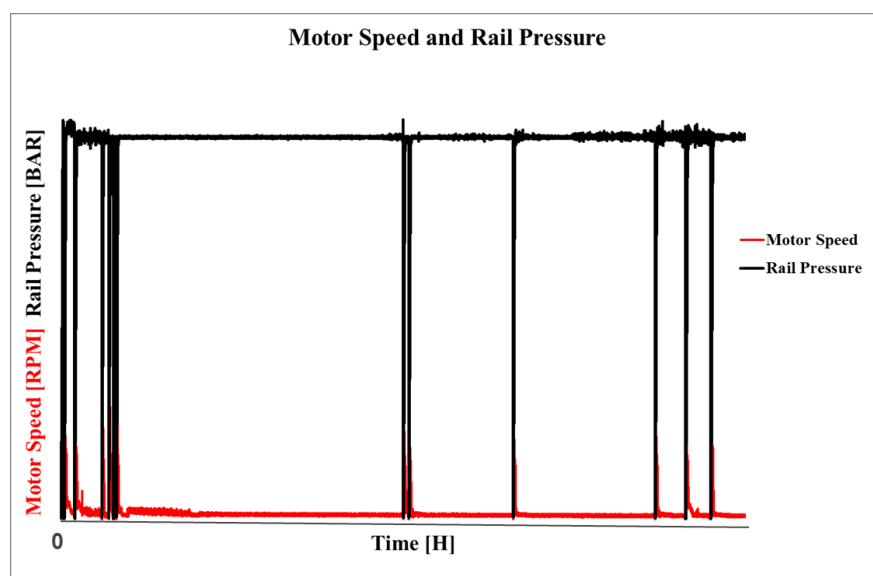
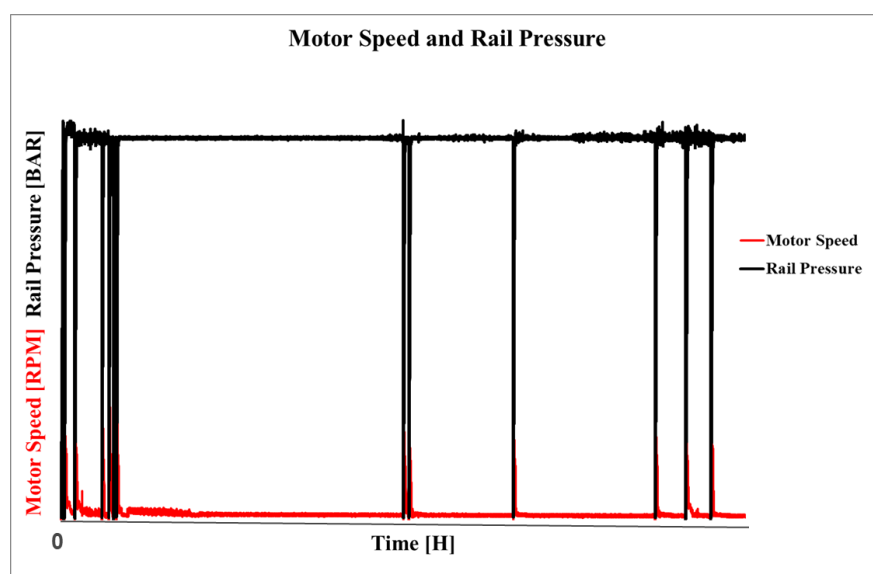
Figure 4. Test No.1 - Motor speed and rail pressure evolution.

Figure 5. Test No.1 - Temperature evolution.

The data analysis (figures 4 and 5) reflect some fluctuations and a few stops, but except these, the rail pressure and motor speed are constant (figure 4). The difference between inlet and back leak (return) temperature (figure 5) is within the limits and the pump has a normal operation.

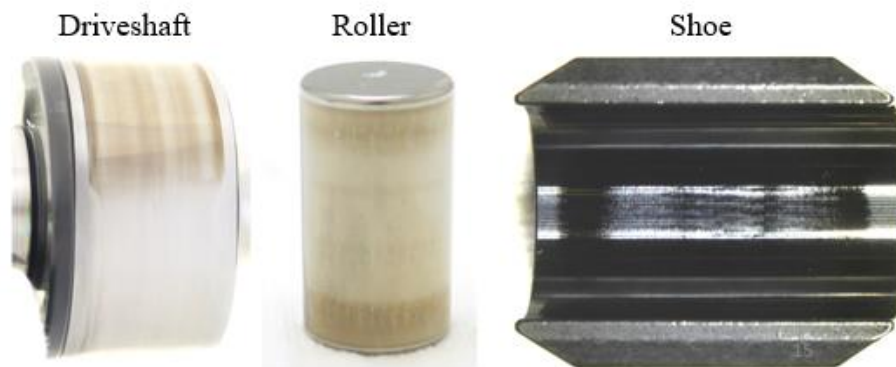
Figure 6. Test no.1 - Visual status of the components of interest.

After the pump is disassembled, it is observed the removal of the superficial layer on the components of interest (figure 6). Also, it is visible the overheating on the shaft due to the test fluid temperature which can reach 120 degrees.

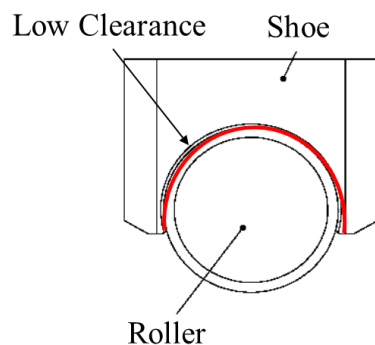
The second test is performed with a special assembled pump. The main defect is the low clearance between the components (figure 7). The roller profile (figure 8) and the dimensions of all components are within the manufacturer's imposed limits.

Figure 7. Roller-shoe assembly.

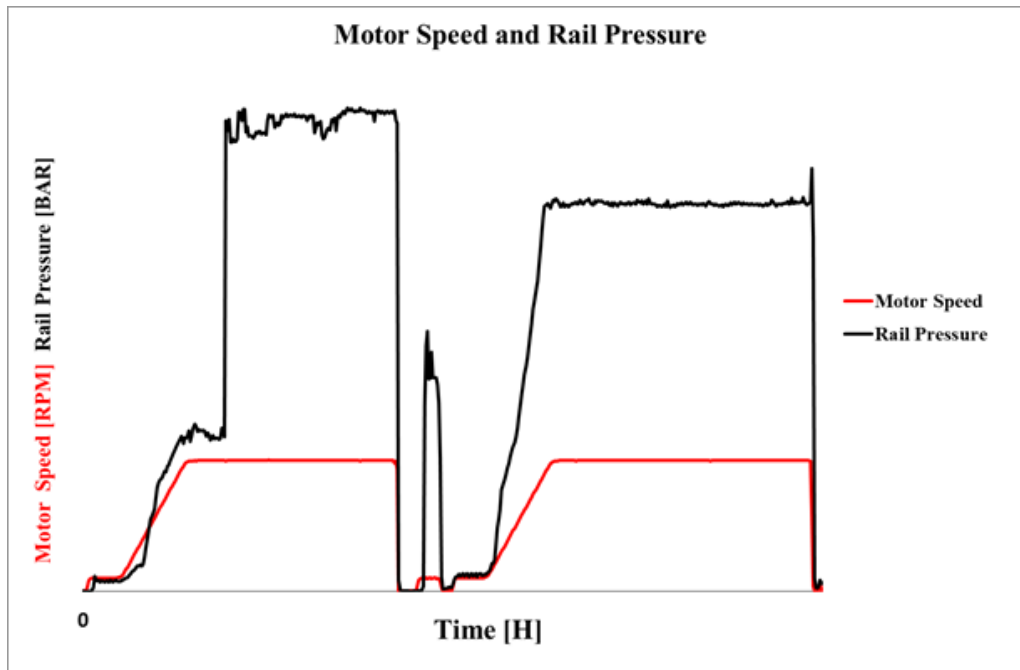
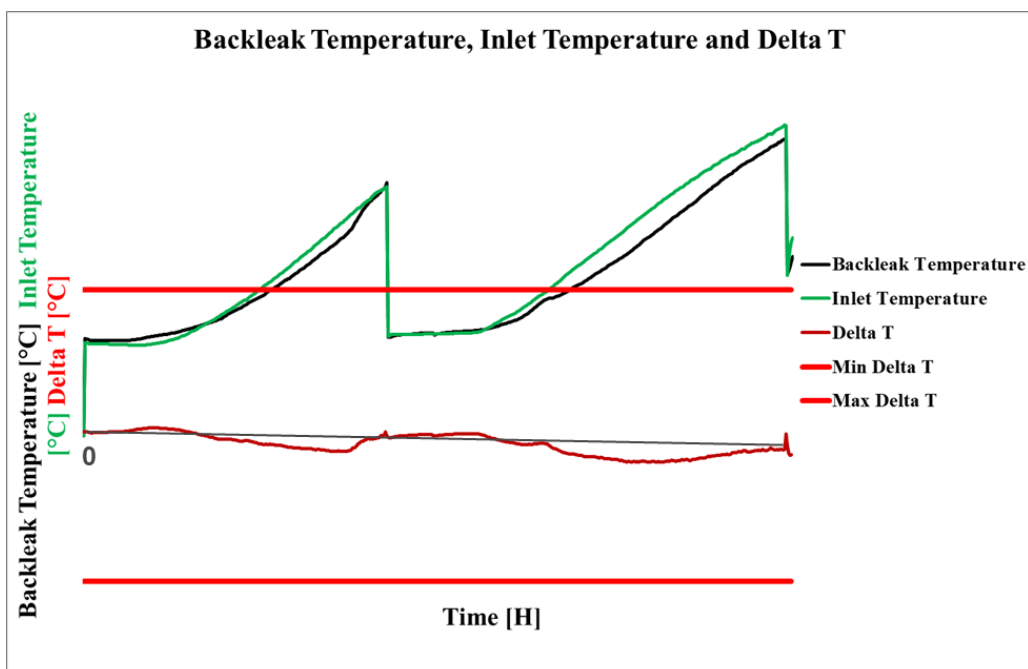
The pump is failed after 10% of the test established time. The test bench was in alarm for two times and the test could not continue. After data analysis it can be observed that the test has two stops and the evolution of testing parameters is abnormal.

The pump cannot deliver the fuel with constant pressure, though the speed seems to be constant (figure 9).

The temperature is quickly absorbed by the material component and cannot reach a high value (figure 10) because the running time is too short.

Figure 9. Test no.2 - Motor speed and rail pressure evolution.

Figure 10. Test no.2 - Temperature evolution.

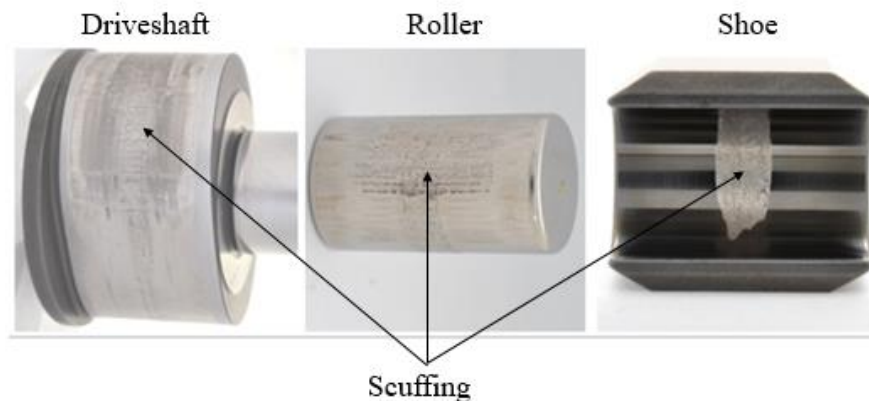
After the pump disassembly, a big wear is observed on driveshaft and roller-shoe mechanism is subjected to scuffing (figure 11).

The roller profile is not relevant after test because the part is affected by scuffing.

Figure 11. Test no.2 - Visual condition of interest components.

In order to reinforce the tests idea that the simulated defect causes the wear, fresh components (new roller, new shoe and new driveshaft) are mounted in the same pump.

They are subjected to the same test and the result is positive, the pump arriving at the end of test with acceptable wear.

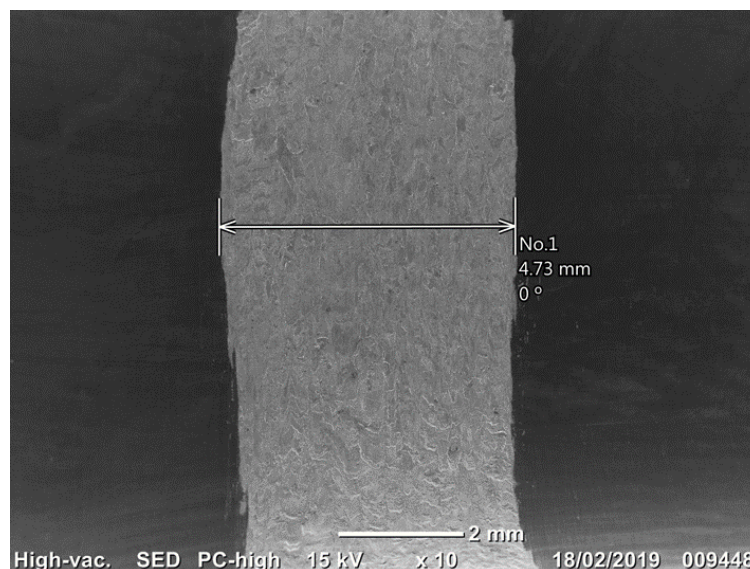
Figure 12. Affected area – SEM view.

The scanning electron microscope (SEM) material analysis (figure 12) do not reveals cracks, scratches or other possible destructive traces resulting form process machining. Chemical analysis is performed on the two surfaces.

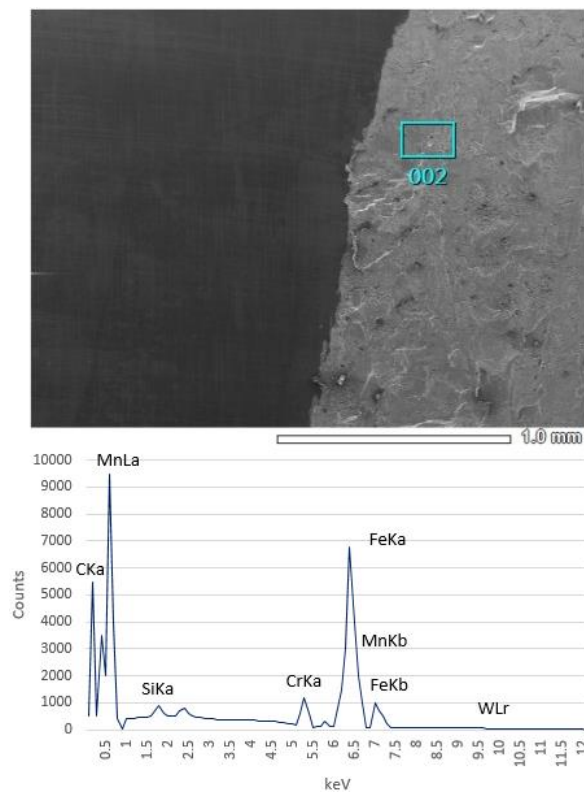
In the affected area (figure 13), it is visible the structure of basic material, with high percent of Fe and C. In non-affected area (figure 14) it is visible the DLC structure. The chemical structure is normal and there was not found contaminants.

Figure 13. Chemical analysis on affected area.

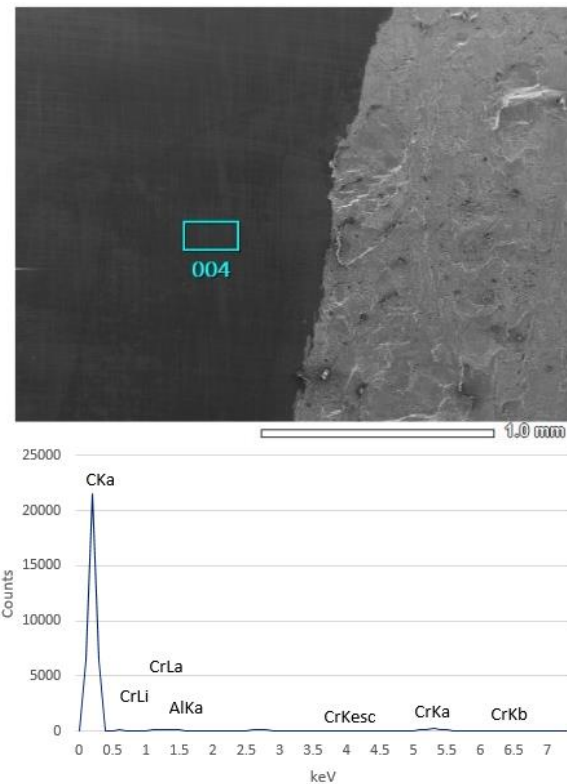
Figure 14. Chemical analysis on non-affected area.

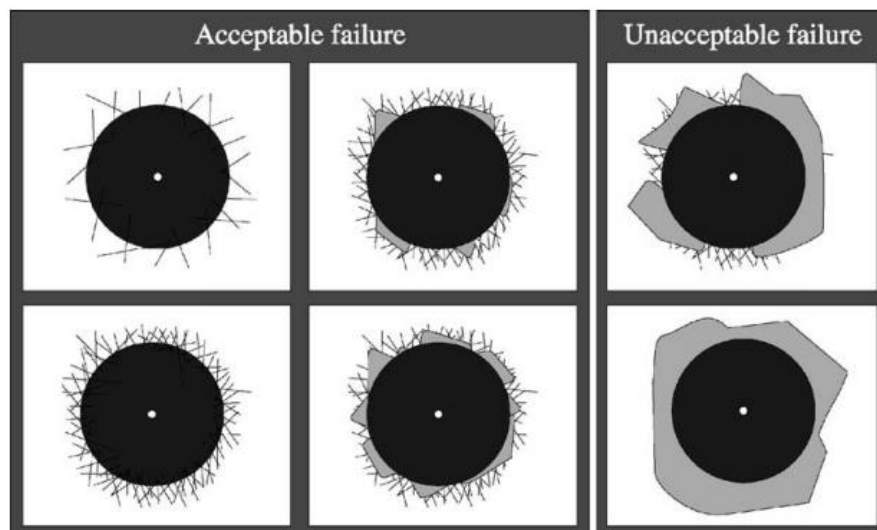
DLC layer is checked and it is observed a poor adhesion on the material. The mark left on the DLC layer in unaffected area is marginally accepted (surface no.4 from figure 15) and this may contribute to scuffing appearance.
