Fracture analysis of GIS outlet bushing's conductive rod

Wenbo Li¹, Lanlan Liu², Bo Liu³, Dengke Li¹, Yunlong Liu¹

¹Hunan Electric Power Research & Test Institute, Changsha, China

Abstract: In this paper, a failure of conductive rod of GIS outlet bushing is analyzed from the connection form, welding quality and microstructure of conductive rod and flange, and it is concluded that the failure of conductive rod is caused by bad welding quality and improper assembly and transportation.

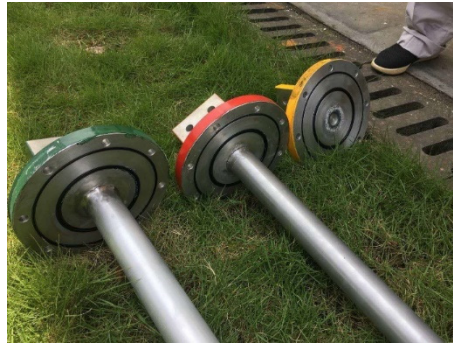
The fracture area of the GIS conductor is the welding joint between the conductive rod and the top flange of the GIS bushing, as shown in Fig. 1. The conductive rod of the A phase conductor is completely fractured from the flange at the top, causing the conductor to fall off during the opening process. Cracks are visible throughout the whole welding joint of B phase conductor, and Cracks appear in the 3/4 circle of the C phase conductor, as shown in Fig. 2 and Fig. 3.

Fig.1 the image of the fracture of the conductive rod

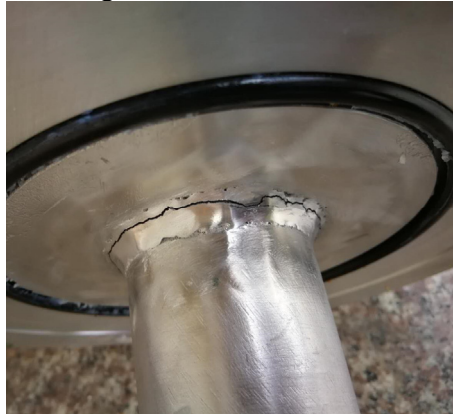
Fig. 2 the crack on the conductive rod of B phase

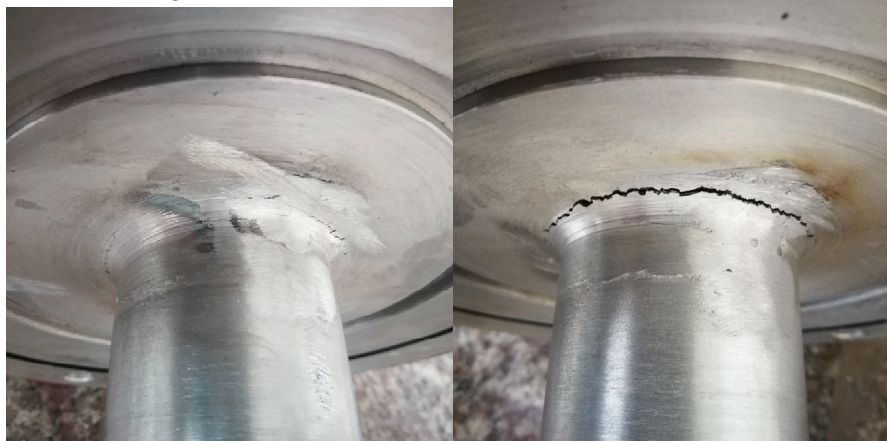
Fig. 3 the crack on the conductive rod of C phase

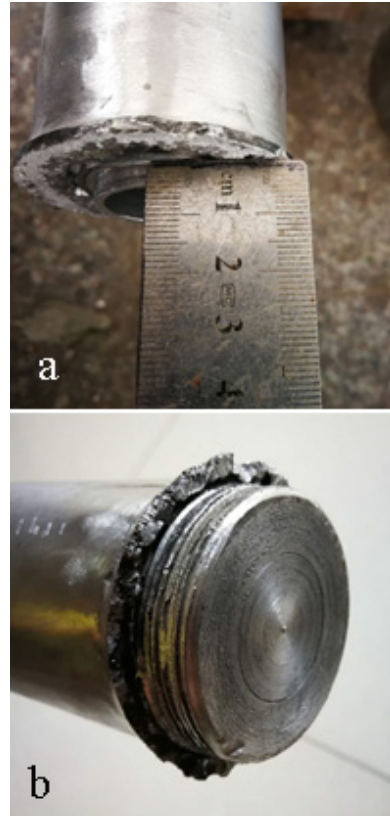
The connecting structure of A-phase conductive rod and flange is checked. The conductive rod and flange are connected by T-type welding joint. The conductive rod is tubular, as shown in Fig. 4. The

The connection between the B phase and flange is different from the other two phases. The end of the B phase conductive rod is shown in Figure 4. The end of phase B conductor has obvious thread, and the length of thread section is about 10 mm, while there is not similar structure at the end of phase A and C conductor.

Fig. 4 the end of the conductive rod of A phase (a) and B phase (b)

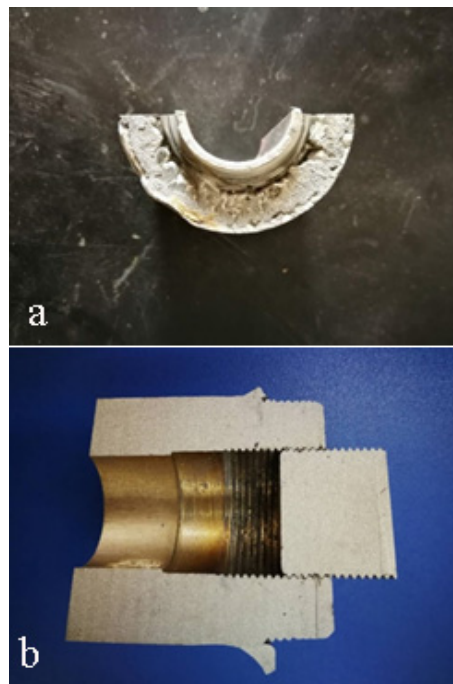
The end of A phase conductor and B phase conductor can be further observed by splitting the conductor, as shown in Figure 5. The connection structure of A phase and B phase flange is also different, see Figure 6. In summary, the B phase conductor and flange are connected by thread, while the A and C phase conductor and flange are connected by welding joint.

Fig. 5 the microstructure of the conductive rod A phase (a) and B phase (b) after splitting

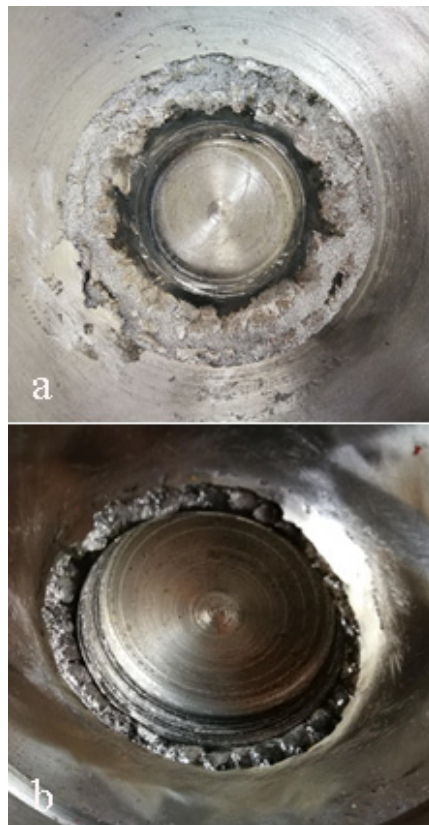
Fig. 6 the flange of A phase (a) and B phase (b)

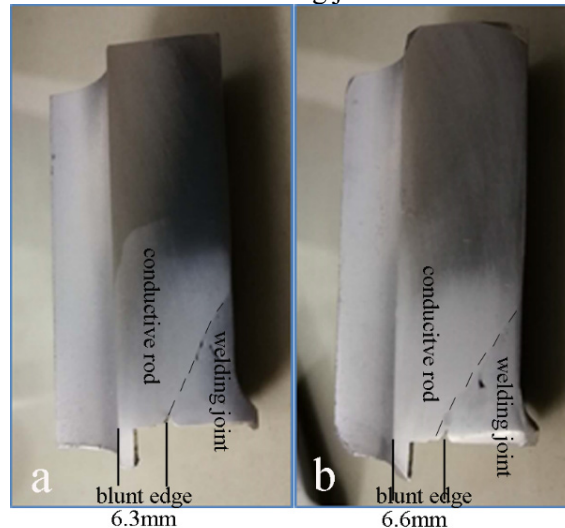
Figure 7 shows the welding joint microstructure of the A phase conductor. The welding joint is T-type joint. The welding depth (the wall thickness of conductive tube) is about 15mm. According to GB/T

985.3-2008 Recommended joint preparation for gas-shield arc welding on aluminium and its alloys [4], the blunt edge should be less than 2mm, and the groove angle should be greater than 50° . However, it is measured that the blunt edge is about 6~7mm, which does not meet the standard requirements. Defects such as non-fusion and pore can be observed in welding joint microstructure, as shown in Figure 8.

Fig. 7 the microstructure of the welding joint of the flange of A phase (a) and C phase (b)

It is suggested that the manufacturer replaces the connection form between the conductor rod and flange of the GIS outlet bushing from T-type welding joint to plug-in connection form, strictly control the welding quality, carry out the welding process evaluation and the non-destructive inspection of the weld when the welding connection is adopted. At the same time, the inspection personnel of the operation and maintenance unit should inquire the relevant information and carry out the spot inspection of the weld quality in the work of equipment acceptance.

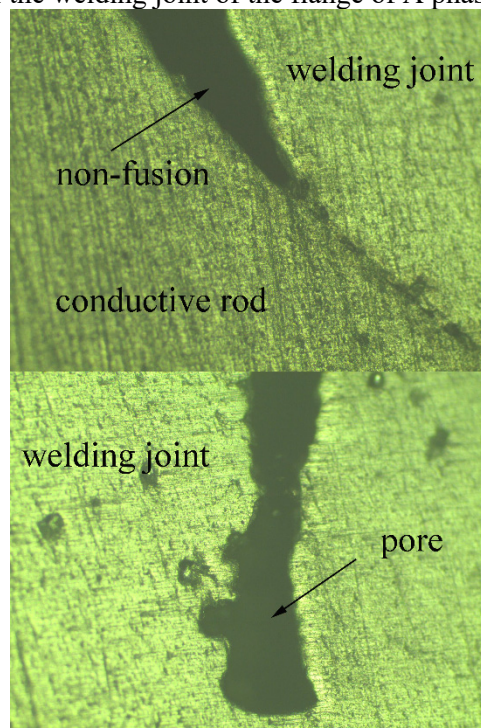
Fig. 8 the non-fusion and pore in the welding joint

flange and the conductive rod bears bending load, because of the poor welding quality of the welding joint, cracks initiates at the welding joint between the flange and the conductive rod under the action of bending loading.
