## Risk Analysis of Rural Housing in yingshang County Anhui Province—For example Brick-Wood Structure

# Risk Analysis of Rural Housing in yingshang County Anhui Province—For example Brick-Wood Structure

**Abstract:** Through the observation and judgment of rural dilapidated houses in yingshang County, by inductive statistics and analysis of data, the criteria for identification of rural dilapidated buildings are used to define rural areas with qualitative and quantitative criteria. The housing is divided into hazard levels, and the structural damage form of the house is pointed out. According to above materials, professional treatment suggestions are given to provide reference and reference for the identification of rural dilapidated buildings in the future.

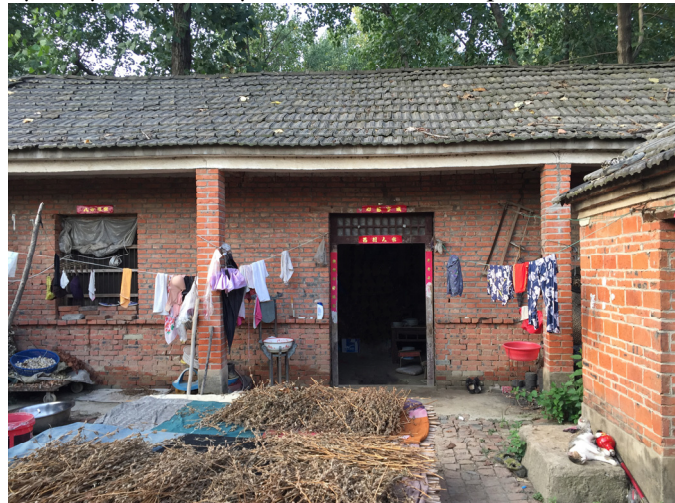
Figure 2. Front view of the house.

- Figure 2 shows the front view of the house. On the outside, there is no obvious large crack.
- Figure 3 shows the obvious crack at the left side of the roof. The width of the crack is 20mm. It starts from the middle of the roof to the wall and spreads all the way to the ground.

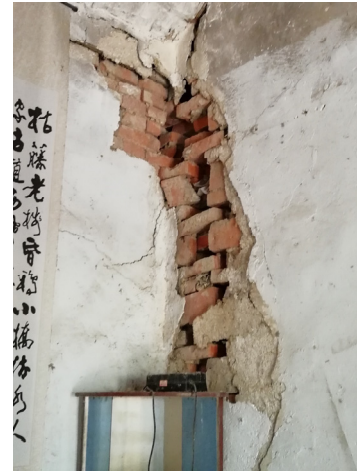
Figure 4. Damage on the top of the right wall

- Figure 4 shows the internal wall, which is connected to the external wall. There are large cracks on the internal wall. Due to the insufficient strength of the condensed material, the masonry has fell and staggered. The staggered width is about 40 mm. There are also other slender cracks, penetrating from the root to the ground.(4) Because of weathering erosion and uncertain weather, the external wall has detached and the material of the wall has also detached. Thus, the masonry has been exposed on the surface and water seepage has occurred. The roof has been for long years out of repair, water seepage has also occurred

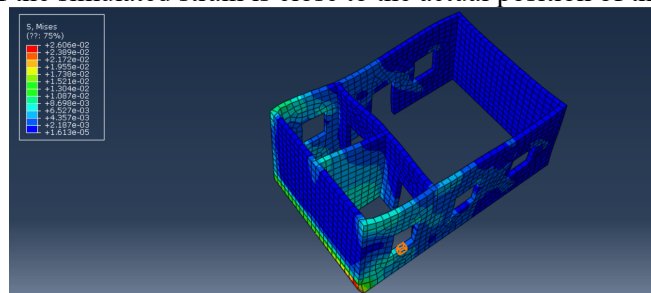
Figure 5. Strain of brick-wood housing

Under earthquake and vertical load, the strain of the model is shown in Figure 5. The wall is close to the foundation, the inner wall is close to the roof and the foundation position, and the strain of upper and lower positions of window is large, indicating it is a weak link in the structure. In the case of insufficient knot material, cracks are likely to occur, leading to large damages, thus a dangerous house. The maximum position of the simulated strain is close to the actual position of the gap.

(2) Under earthquake and vertical load, the weak points are located at the foundation, the upper and lower parts of the window, the corner of the wall and the internal partition wall.

(3) Reinforce the weak link through finite element simulation of the brick-wood structure. More attention should be paid to the weak link of level A, B, and C houses. Level A and B houses should be strengthened, and the level C houses should be reinforced to avoid further damage.
