Stages of Geological Documentation on the Example of Landslides Located on the Slopes of the Dam Reservoir “Swinna Poreba” (Poland)

Anna Szafarczyk ¹

¹ AGH University of Science and Technology, A. Mickiewicz 30, 30-059 Cracow, Poland

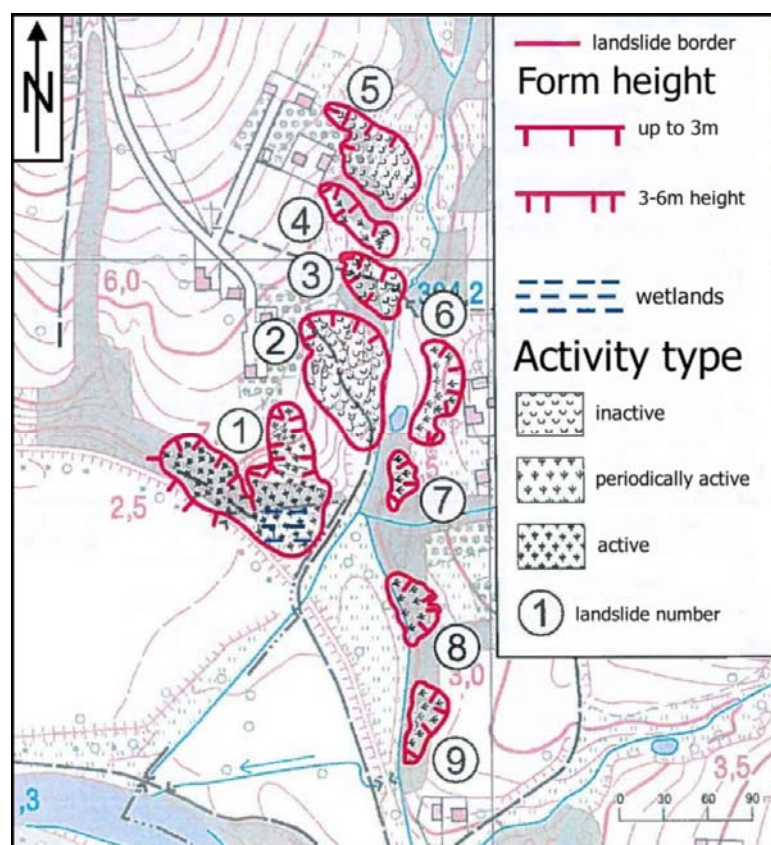
There are 12 small landslides in the analyzed area, within the analyzed section of the valley of the stream, 9 of which have a documentation card along with an opinion, made by the Polish Geological Institute - National Research Institute (Figure 1). Landslides described in the data sheets have been marked with numbers 1-9, where landslides 1-5 are on the left side of the stream, in the hamlet of Ostałowa Zagórska, and landslide 6-9, on the right side of the stream, in the area of the hamlet Ostałowa Dąbrowska.

Figure 1. Topographic map with landslide areas (on the basis of the [4])

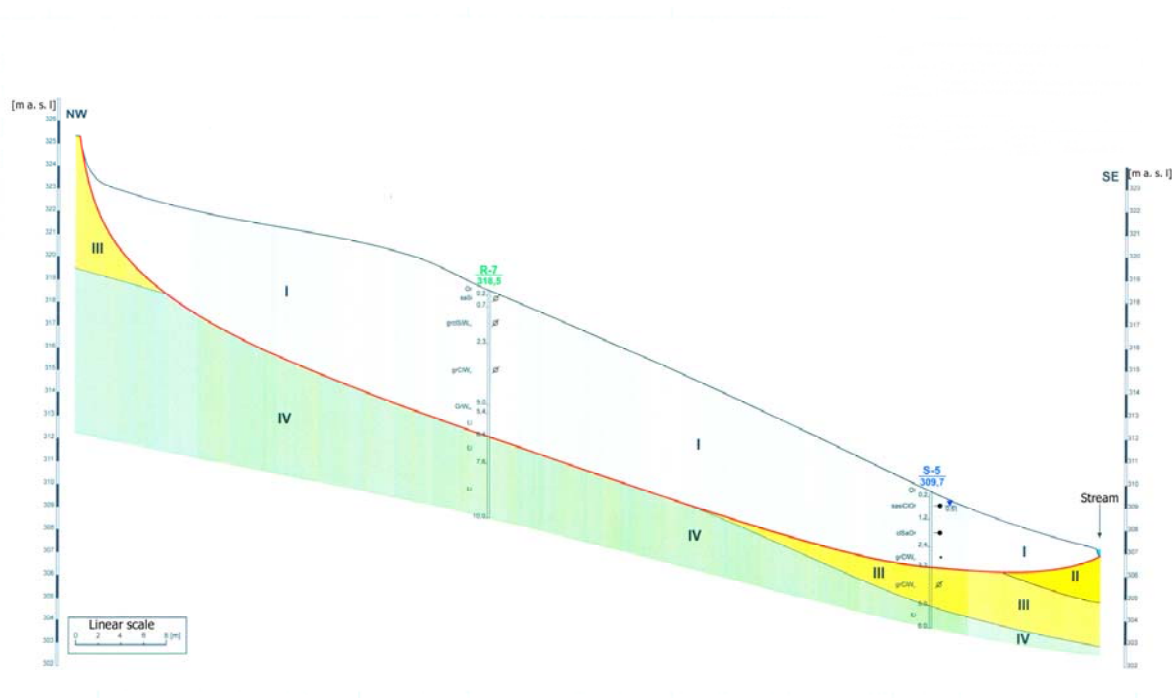
Values of internal friction and soil cohesion were determined in the triaxial shear apparatus. A detailed description of the drilled land in individual wells is provided on the hole document sheets. The spatial layout of geotechnical layers is illustrated by geotechnical sections (an exemplary cross-section is shown in Figure 2), and the aggregate results of laboratory studies of soils and rocks are presented in tabular formulas see Table 1.

Figure 2. An example geotechnical cross-section
