## Flashover characteristics of plastic cloth on $\pm 800$ kV HVDC transmission line

Hui Liu<sup>1,3</sup>, Chao Zhou<sup>1</sup>, Qinghe Shen<sup>1</sup>, Bo Yang<sup>2</sup>, Xiaobin Sun<sup>2</sup>, Zhenning Huang<sup>2</sup>, Rong Liu<sup>1</sup> and Chuanbin Liu<sup>1</sup>

<sup>1</sup> Shandong Electric Power Research Institute, Jinan 250002, China;

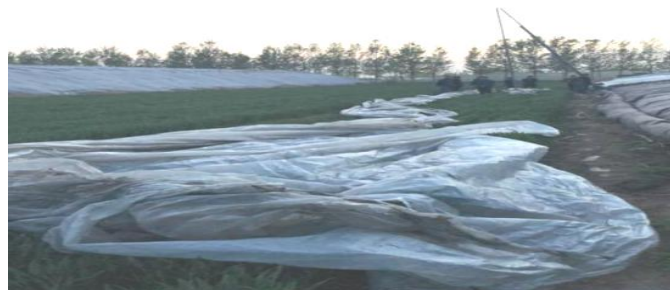
**Figure 1.** Plastic cloth of fault field.

The direct cause of the faults is that the faults are located in the plain area. Vegetable greenhouses in the protection area are dense under the line. Due to the heat collection effect of the greenhouse, a micro-meteorological area is formed, and a strong cyclone is produced in a short time. The plastic cloth of the greenhouse is broken and about 25 meters long plastic cloth is blown to the conductors of pole I and pole II by the wind. Wet broad plastic cloth insulation strength is low, resulting in short circuit.

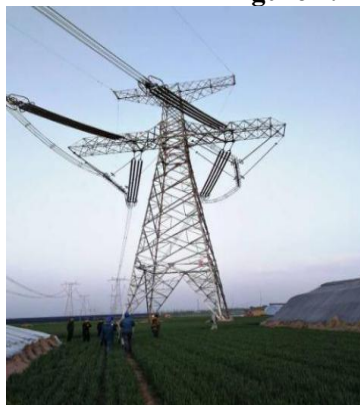
**Figure 2.** Fault pole tower and surrounding environment.

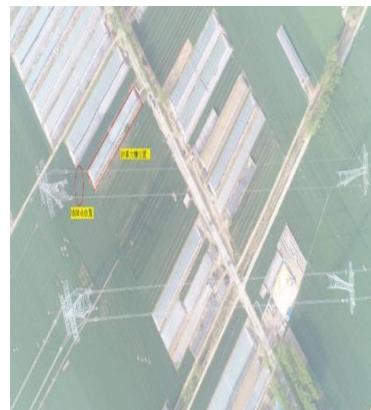
**Figure 3.** Aerial photograph of the fault pole tower.

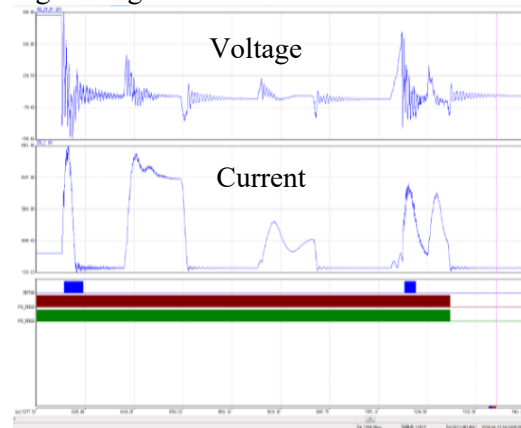
**Figure 5.** Pole I protection fault recorder arm.

The fault recorder diagram of pole I shows that the maximum fault current is 8.27 kA, the fault-to-latch time is about 35 ms, the first full voltage restart is 150 ms after the protection action, the system voltage rises to 421 kV, and the short-circuit current is 7.78 kA. The second full-voltage restart occur after 200 ms, subsequently the system voltage rises to 191 kV and the short-circuit current is 3.13 kA. Third half-voltage restart occur after 200 ms, and the system voltage rises to 639 kV, meantime the short-circuit current is 5.72 kA. Pole II restart process is the same as that of the Pole I.

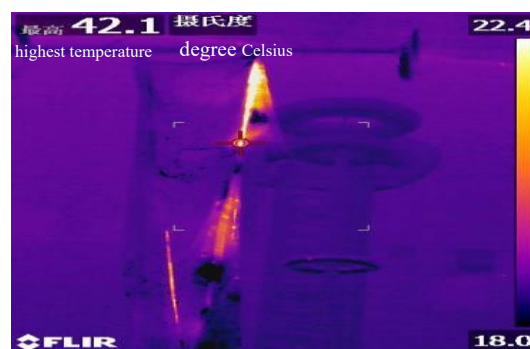
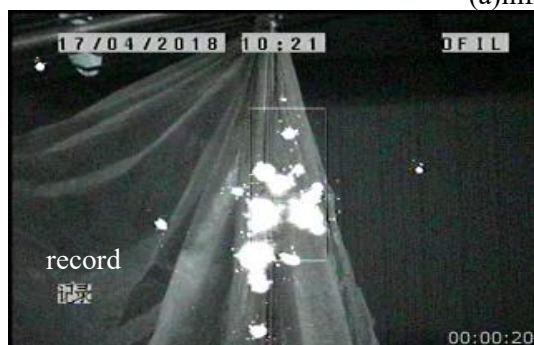
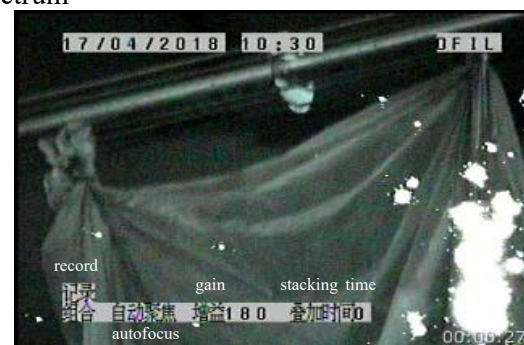
**Figure 7.** Infrared and ultraviolet imaging of plastic cloth of original state.

$\pm 800\text{kV}$  and the maximum temperature rise is  $25.4^{\circ}\text{C}$ . The ultraviolet spectrum shows that the discharge phenomenon of  $-800\text{kV}$  is stronger than that of  $+800\text{kV}$ .

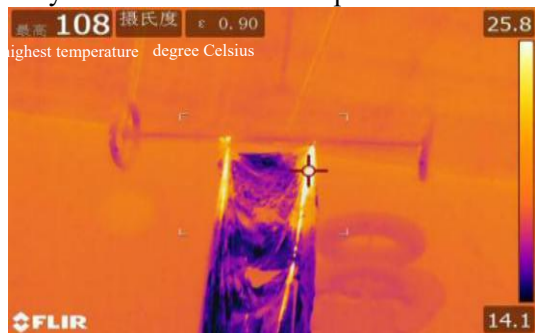
In the second stage, DC resistance test is carried out after spraying  $2.5\text{kg}$  deionized water on plastic sheets in plastic shed. Obvious discharge occurs when the voltage is up to  $-400\text{ kV}$ . When the voltage is up to  $-750\text{ kV}$ , the test current is greater than the current setting value of the test equipment and the protection action is taken. Infrared imaging (Figure.8) shows a maximum temperature rise of  $85^{\circ}\text{C}$ , and ultraviolet imaging (Figure.9) shows a strong discharge. The discharge and heating locations are mainly located in the folds of plastic cloth.

**Figure 8.**Infrared imaging of wet plastic cloth.

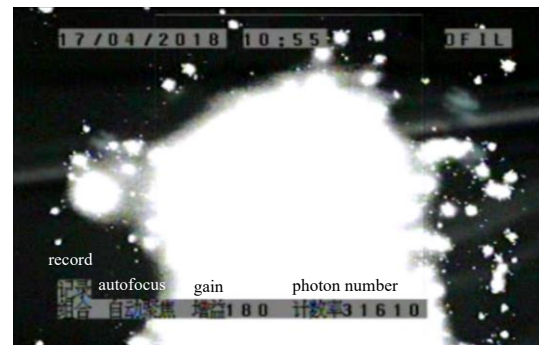
**Figure 9.**Ultraviolet imaging of wet plastic cloth.

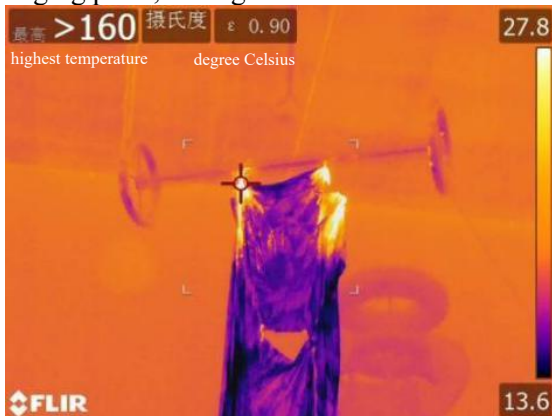
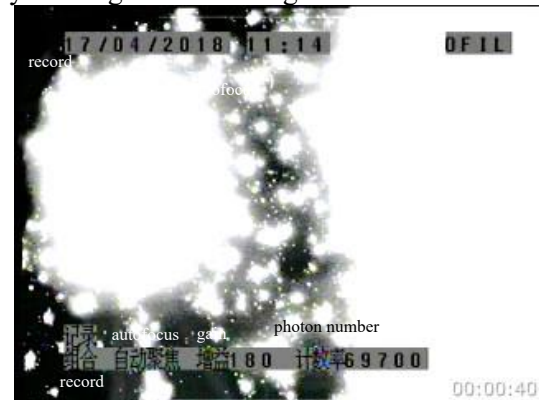
**Figure 10.** Infrared and ultraviolet imaging of plastic cloth in the third stage.

In the third stage, DC tolerance test is carried out after spraying deionized water  $1.5\text{kg}$  in the upper  $3\text{m}$  area of plastic cloth. There is a sharp discharge phenomenon and protection acted when the voltage rises to  $-370\text{kV}$ . As can be seen from Figure.10, the maximum temperature rise is greater than  $160^{\circ}\text{C}$ , the ultraviolet imaging shows intense discharge happens, and the plastic cloth starts to burn from the hanging point, lasting about 3 minutes and then gradually burning off and falling off.

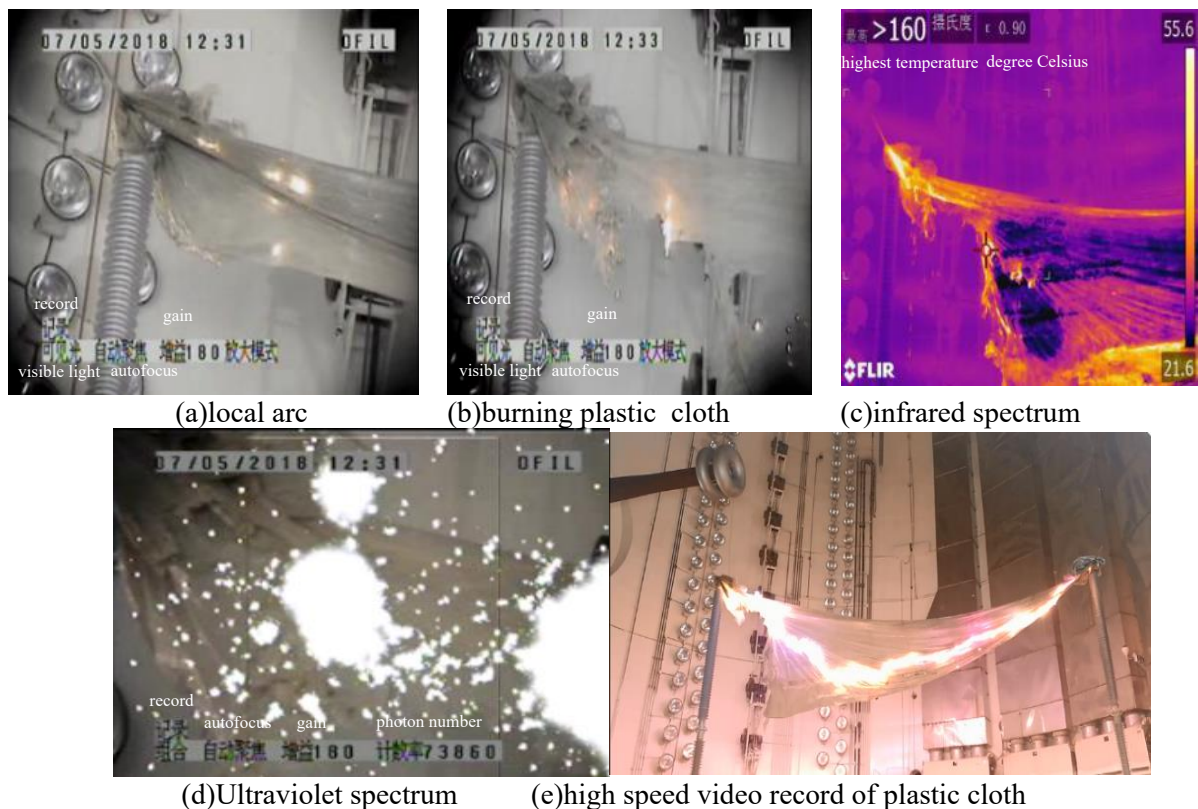
**Figure 12.** DC flashover test of plastic cloth.

During the process, the local arc appears near the high-voltage end of the plastic cloth. The plastics layout obviously heats up and starts small-scale combustion. The infrared spectrum has obvious hot spots. From figure. 12 (c), UV spectrum has violent discharge phenomenon. When approaching the flashover voltage of 640kV, whole arc of the plastic cloth appears from high voltage end to the ground end. After the gap breakdown, the plastic cloth near the high-voltage electrode continues to burn, the combustion is not intense, but doesn't extinguish naturally. The above test results show that the intense discharge at flashover moment is not enough to cause the break of plastic cloth. After the

discharge, the plastic cloth will continue to burn. Finally, the plastic cloth may break, separating from the conductor and even falling to the ground completely. This is consistent with the situation found by the inspectors But the process lasts for about 10 minutes.
