## Cause Analysis of Transverse Cracks and Reinforcement Measures for Midspan of Assembled Box Girder Bridge

Sun Xiaohong<sup>1</sup>

<sup>1</sup> Research Institute of Highway Ministry of Transport, Beijing, 100088, China

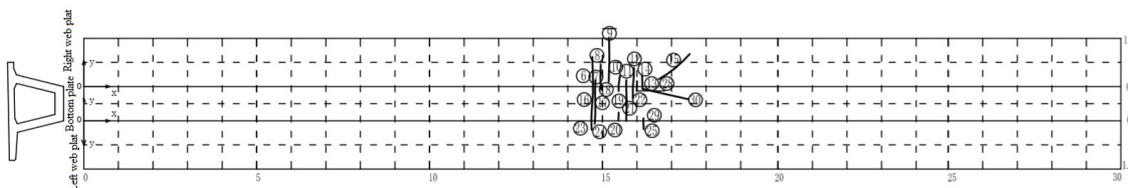
Figure3 Typical fracture schematic diagram

In February 2014, it was first discovered that small box girders had transverse cracks in the floor near the mid-span and vertical cracks in the webs. In June 2015, the number of cracked box girders showed a growing trend. From August to December 2015, the cracked box girders were strengthened with external prestress. In 2016 and 2017, it was found that the unreinforced small box girder continued to crack. The statistics of cracked box girders are shown in Table 1. Typical fracture schematic diagram is shown in Fig. 3.

- (1) For every four pieces of box girder across the transverse, transverse cracks occur in the middle girder or side girder without certain regularity; the new cracks are mostly distributed around the mid-span.
- (2) The cracks are mainly vertical in the abdomen and transverse in the floor, some of which are in the shape of "U" or "L", and the width of the cracks is less than 0.15mm.
- (3) Transverse cracks in the bottom plate of composite box girder and vertical cracks in the web plate are shallow in depth, which crack in the protective layer until the end of the reinforcement surface.
- (4) The cracked beam has slight downwards, and the non-cracked beam has certain upper arch.

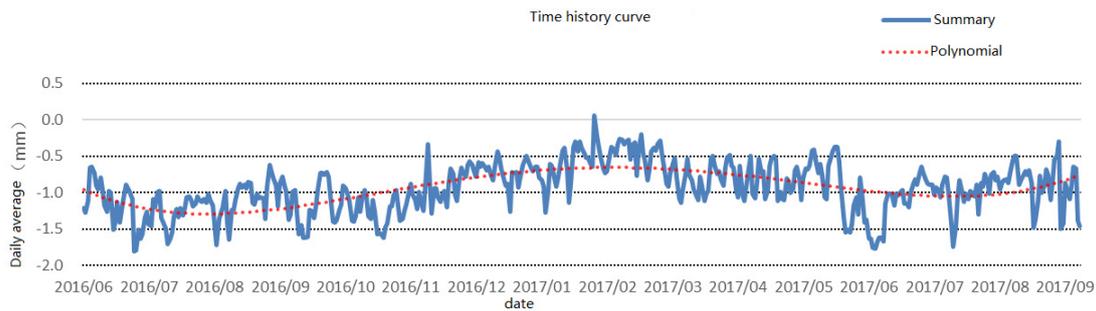
Figure 6 The time curve of daily average deflection of midspan for the bridge span by external prestress

(1) For the bridge span strengthened by external prestress, the early-warning level of the monitoring point under the action of operating load is safe. The deflection data of the same months of consecutive two years are basically the same, and the daily mean change of the deflection measurement point is relatively small, as shown in Fig. 6.

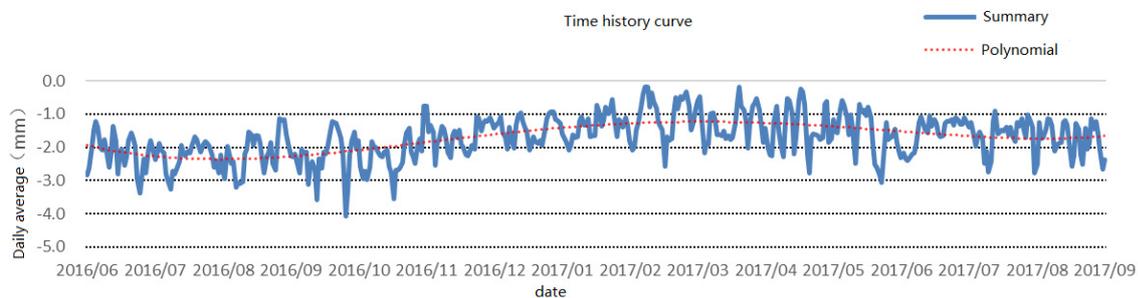
Figure 7 The time curve of daily average deflection of midspan for the bridge without reinforcement

(2) For the bridge span that cracks and are only closed for treatment, the early-warning level of the monitoring point under the action of operating load is highly risky. The deflection data of the same months of consecutive two years across the bridge has an increasing trend, and the beam body downwards. At the same time, new structural cracks are generated in the mid-span region of the bridge, as shown in Fig. 7.
