# Fault Diagnosis and treatment of Abnormal vibration of vertical condenser pump motor towards Ultra-supercritical 660MW turbo-generator set

**Abstract.** The motor driving end vibrates when there is no-load test run after overhaul of condensate pump of power plant unit; Through fault diagnosis and analysis, reasons for vibration were checked and solution found. The main reason is that the condensate pump motor magnetic force center line is not centered. The condensate pump motor is disassembled, then the reason of magnetic force center line is not centered was found and solution. Potential equipment safety hazard was eliminated successfully.

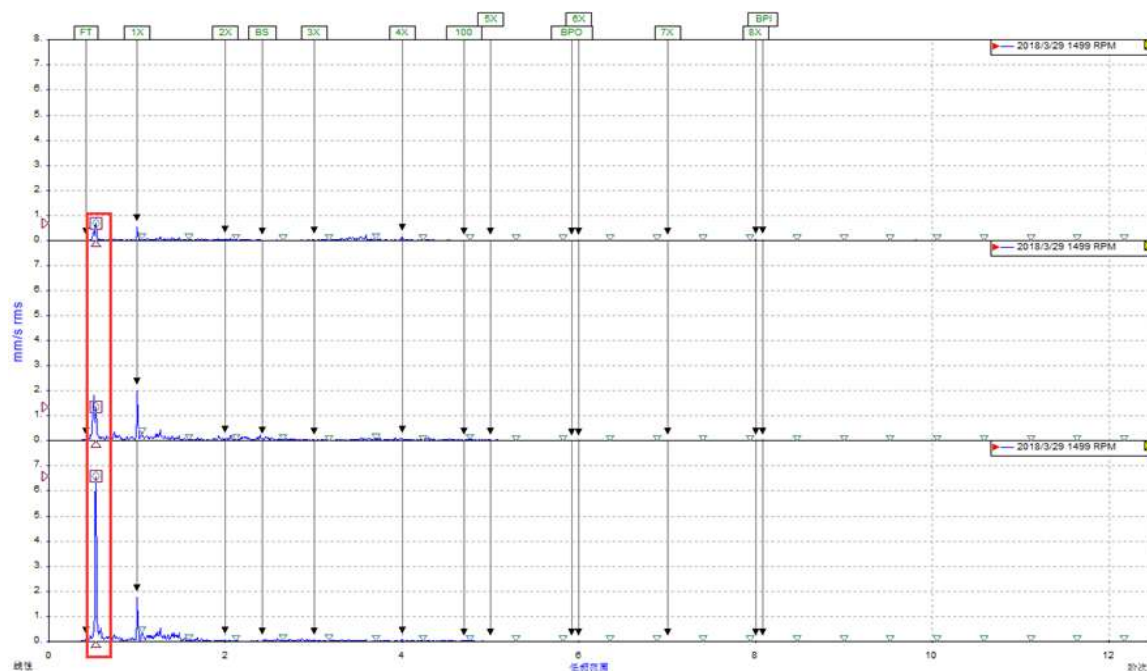
After vibration testing, it can be found that the value of axial vibration of driving end is 0.9 mm/s, radial vibration is 2 mm/s, tangential vibration is 6.78 mm/s, more than alarm value (alarm value of 4.5 mm/s, the critical value of 7.1 mm/s).

**Figure 1** .Spectrum diagram of vibration at the driving end of condensate pump motor running without load.

We can see from Fig.1 that the vibration speed is mainly half frequency, also has a certain frequency component, the may reason is caused by bearing failure or the motor magnetic force center line is not centered, there is a certain eccentric electromagnetic force.

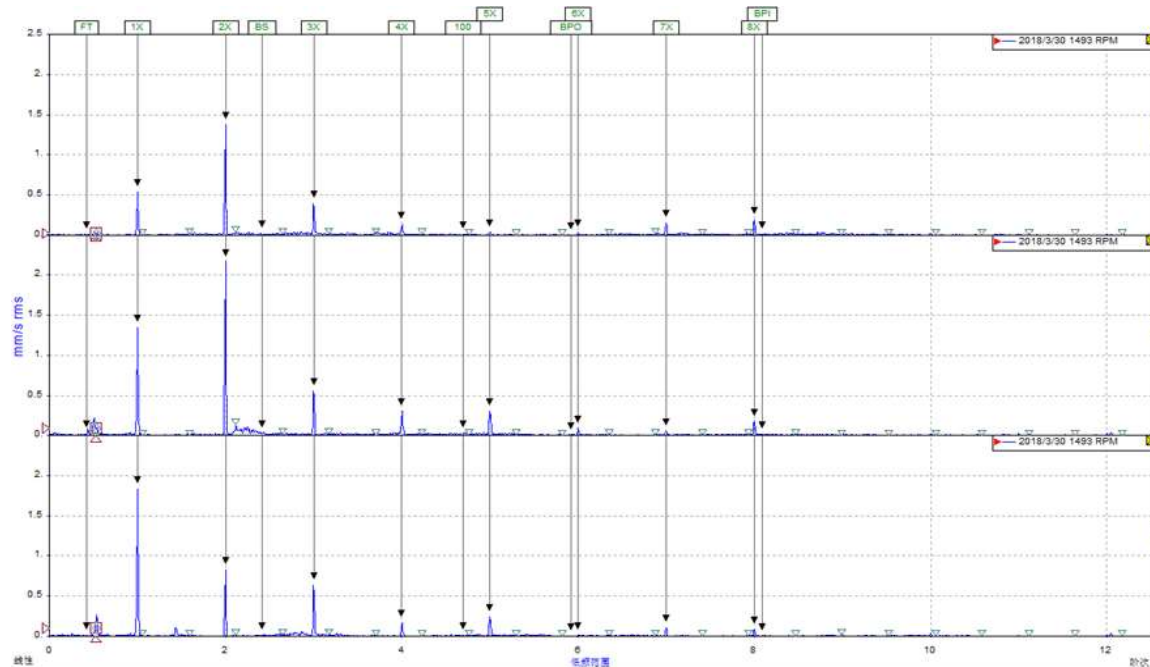
If the center line of the magnetic force of the motor is not centered, the vibration of the condensate pump motor will be large, and the vibration value of the condensate pump motor will decrease after the operation with load. Therefore, the vibration was measured after the condensate pump motor with load. The value of axial vibration of driving end is 1.41 mm/s, radial vibration is 2.18 mm/s, tangential vibration is 1.89 mm/s, and the vibration spectrum is shown in Fig.2.

Compared with no-load test run, there is a decline, which is mainly due to the condensate pump motor movement is limited in a certain range when running with load, under the action of the condensate pump thrust bearing, the motor rotor stability is improved, so that the motor overall vibration value is

reduced. Therefore, it can be judged that the misalignment of the magnetic center line of the motor is the main reason for the vibration of the condensate pump motor.

**Figure 2.** Spectrum diagram of vibration at the driving end of condensate pump motor running with load.

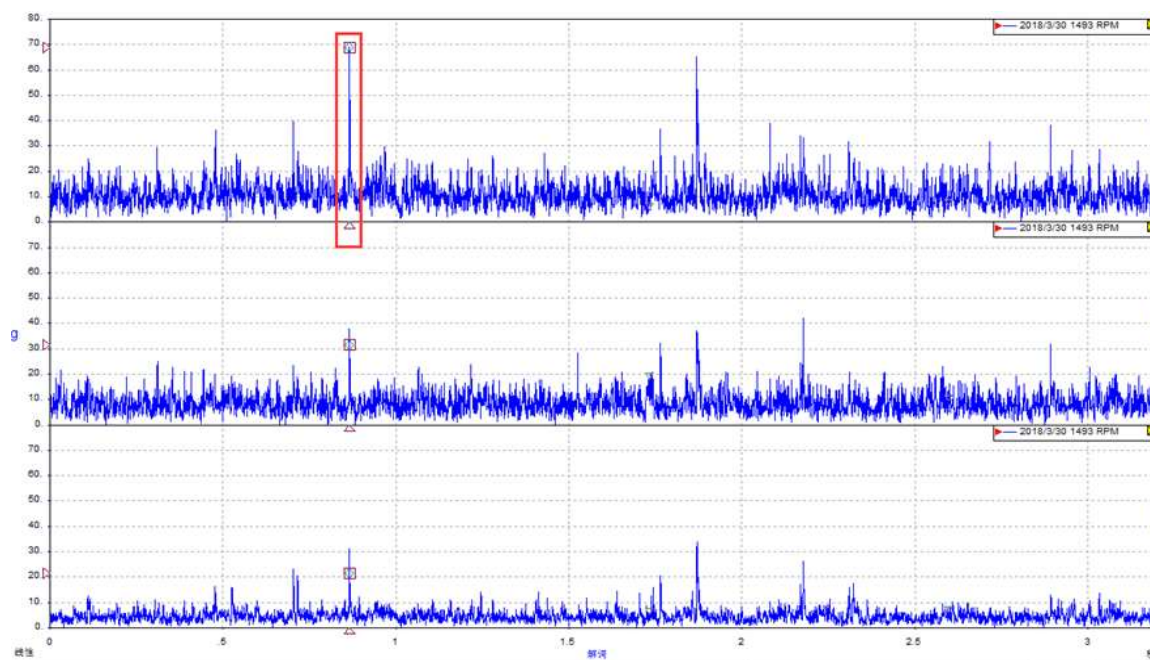
According to the demodulation waveform of the driving end of the condensate pump (as shown in Fig.3), it can be seen that the axial impact value of the pump bearing is large, reaching 68.7g, and a high peak value occurs every one second or so, and the radial and tangential impact value is relatively small.

**Figure 3.** Demodulation waveform of driving end of condensate pump

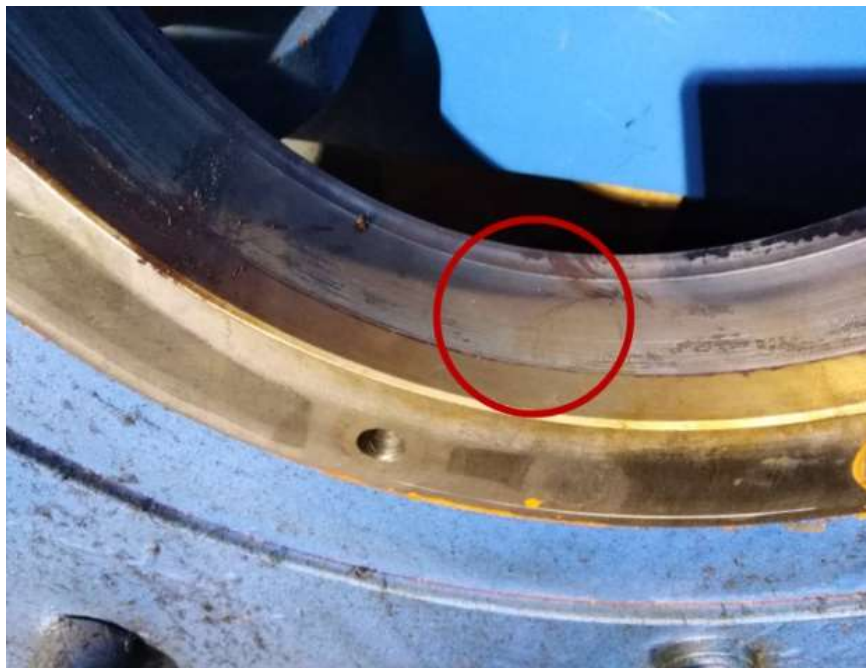
According to the above analysis, we decided to disassemble the condensate pump motor for inspection, it can be found that driving end bearing sleeve has been worn (the maximum wear depth is 0.65mm), as shown in Fig. 4,and color of bearing oil has changed as shown in Fig. 5.

**Figure 4.** Wear of driving end bearing sleeve

After the disassembly of the condensate pump motor, the stator and rotor of the motor were tested and checked, and the cooperation of various parts and related accessories of the condensate pump motor was measured. No abnormal phenomena were found. Condensate pump motor base bedplate levelness has been measured, the result shown that the bedplate levelness is 0.27 mm/m, more than design value of 0.05 mm/m requirement, which cause condensate pump motor stator weight deviation from the vertical direction and the center line of rotor magnetic force is not centered. The vibration of motor increases during no-load test run due to the action of a partial magnetic force. The larger vibration will cause load impact on the driving end bearing, which will lead to wear of shaft sleeve gradually.

Towards above analysis, driving end bearing sleeve has been weared mainly due to the vibration of the driving end of the motor suddenly increases. There are two major reasons of the condensate pump motor magnetic force center line is not centered: first, the center of gravity of the motor stator deviates from the vertical direction; second, motor rotor positioning is not correct.

2) Replace the worn shaft sleeve at the driving end, adjust the interference amount of shaft sleeve and bearing to 0.02mm, and re-check the center.

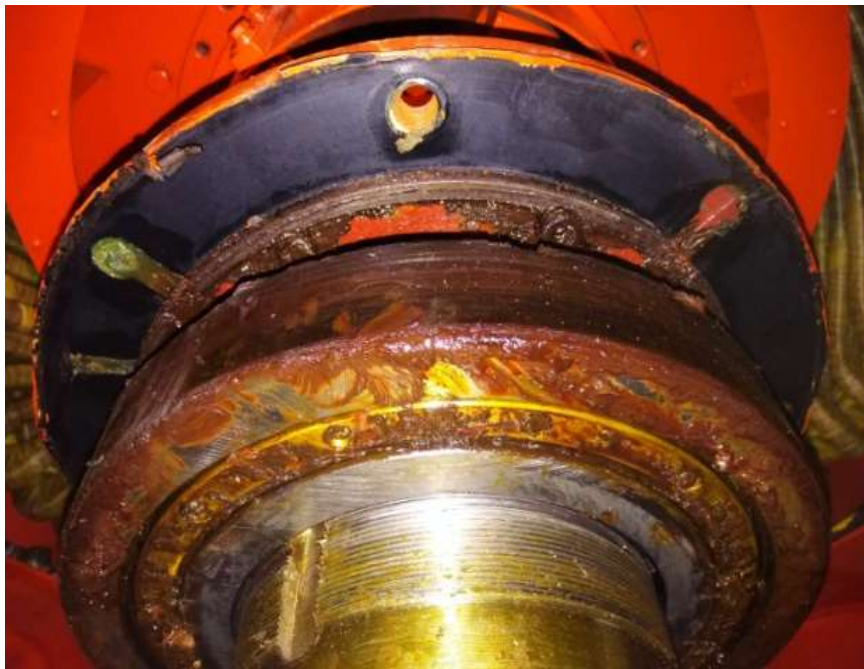
**Figure 5.** Color of bearing oil

The driving end bearing has been checked after the disassembly of the motor. The bearing rotates flexibly, but the deterioration and discoloration of lubricating grease do not affect the normal operation of the motor, and no other abnormal problems were found.

3) Replace the lubrication grease of the driving end and non-driving end bearings of condensate pump motor to ensure the lubrication effect of oil film.
