Detection and Cause Analysis of Structural Defects in Lead Clamp Weld of Transformer

Abstract: In this paper, the causes analysis of the cracking accident at the lead clamp weld-fusion line of transformer in the extra-high voltage substation was conducted.

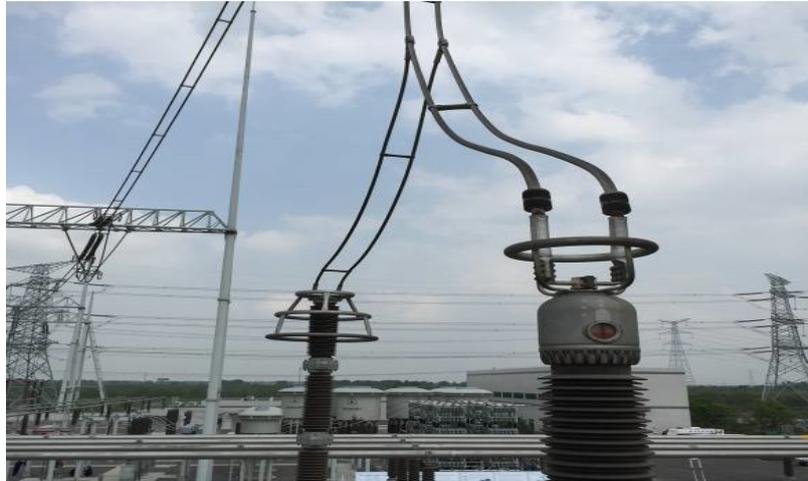
After the cracking of the lead clamp at weld-fusion line on 500kV side of phase A of the #2 main transformer was found, on-site macroscopic inspection for clamps of the same specifications was carried out. It was found that the clamps of phase A of the #1 and #2 main transformers had cracks at the position on the weld. The Figure 1 is the on-site photo. The cracked line clamp aluminum pipe side weld has a full circle of undercut. The cracked clamp weld of the aluminum pipe side had a full circle of undercut, which had a depth of about 2~4mm, as shown in Figure 2 and Figure 3.

Figure 1 Phase A clamp of the #2 transformer

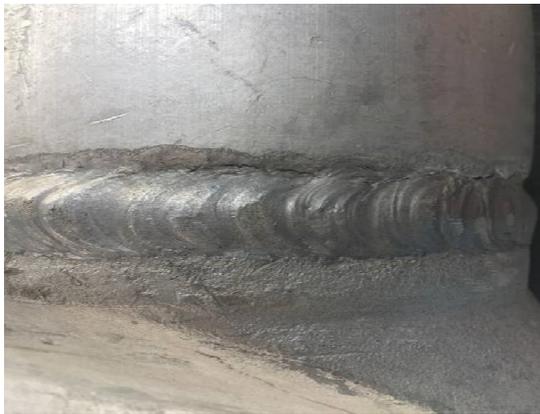
Figure 2 The clamp weld undercut and crack on phase A of #1 transformer

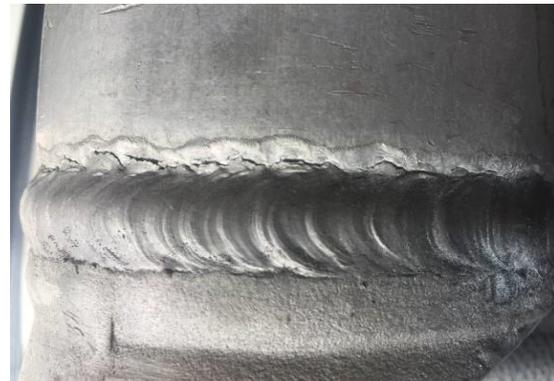
Figure 3 The clamp weld undercut and crack on phase A of #2 transformer

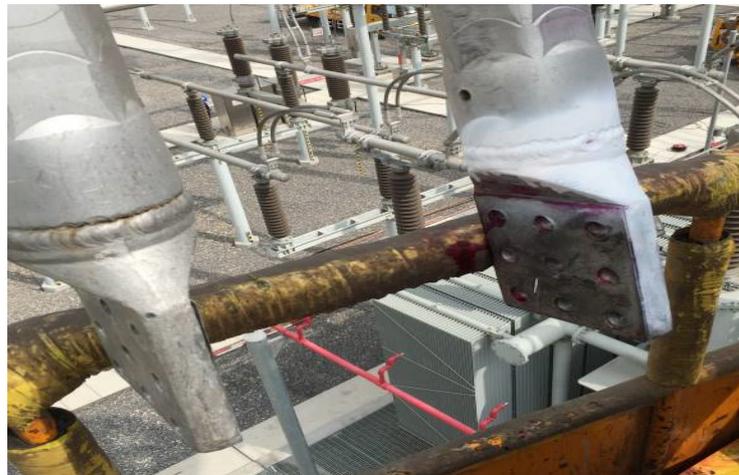
Figure 4 The detection position of the clamp

Penetration testing was performed on all the clamps of #1 and #2 main transformers, a total of 10, and the testing position is shown in Figure 4. There were cracks on the clamp weld-fusion line of the aluminum pipe side and on wiring board side, as shown in Figure 5 and Figure 6. The test results are as follows: the north weld of phase A of #1 main transformer was cracked; There was a crack of 30mm on the west side of the drainage plate in the southern of phase B, no crack in the weld; A crack of 8mm appeared on the west side of the weld in the northern of phase C. A crack of 10mm existed on the west side of the drainage plate in the southern of phase C of the #2 main transformer.

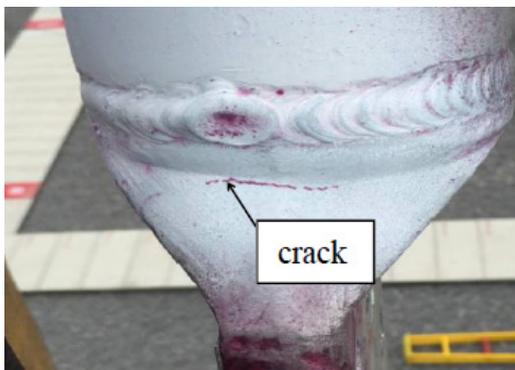
Figure 5 The appearance of the lateral crack of the clamp wiring board

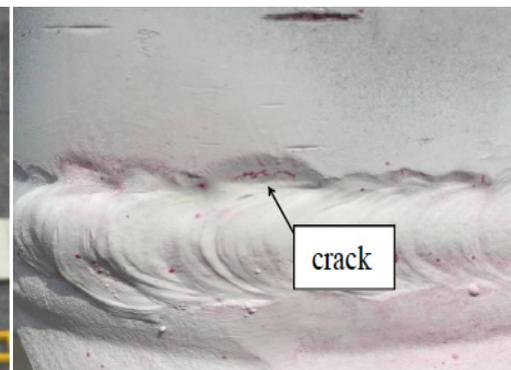
Figure 6 The crack at the fusion line on the aluminum pipe of the weld

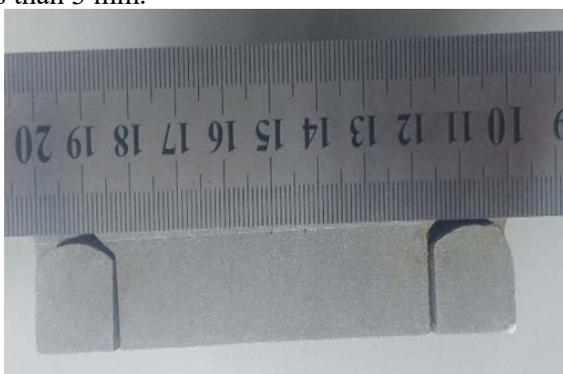
In order to understand the internal structure of the clamp weld, phase A lead clamp of the #2 transformer was dissected to inspect, and it was found that internal structure of the weld had serious incomplete penetration and incomplete fusion, with the appearance shown in Figure 7 and Figure 8. The measurement showed that the effective thickness of thinnest position of the actual welding was less than 3 mm.

Figure 7 The longitudinal section morphology of the weld

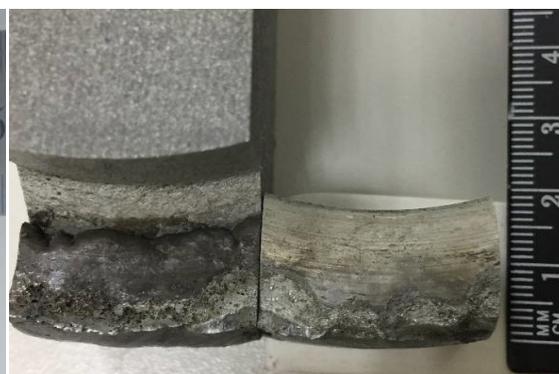
Figure 8 The appearance of welding joint at weld fracture

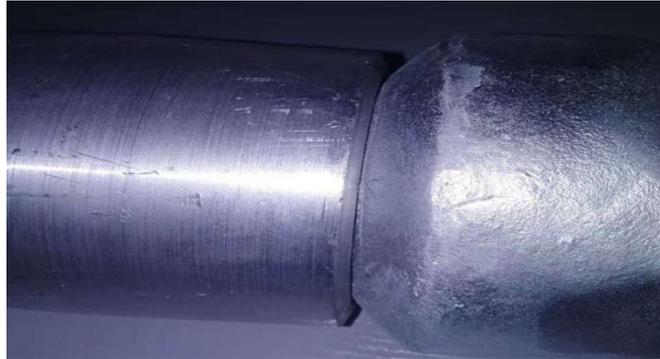
Welding seam adopts no grooving process, pipe side welding surface adopts circular design with wall thickness as radius, and rod side welding surface adopts 45degree inclined plane. When butting, the butt type was formed as shown in Figure 9. The natural voids in the lower half of the fittings could not be welded.

Figure9 Welding butt type

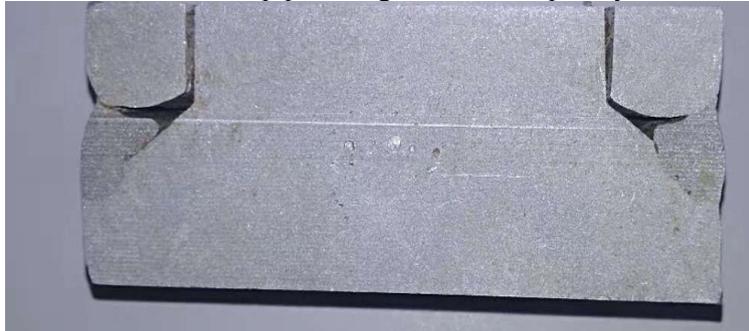
It can be seen from the cross-sectional view of the weld shown in Figure 10 that there was a serious arc bias phenomenon during the welding process. The groove of the rod side was well welded, and a large part of the groove at the side of the pipe fitting was not completely melted.

Figure10 Welding arc deflection
