Assessing the Instability of Dong Nai River in Bien Hoa District Using Bank Erosion Hazard Index (BEHI) and Remote Sensing and GIS

To cite this article: L M Nguyet *et al* 2019 *IOP Conf. Ser.: Earth Environ. Sci.* **272** 022219

L M Nguyet¹, D Q Minh², P T H Lan¹

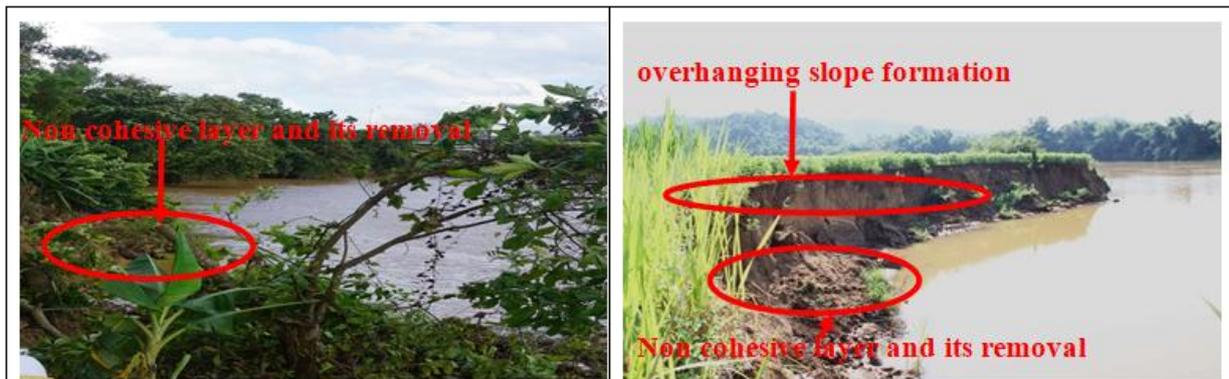
Under cutting or loss of underlying support is the primary cause of bank erosion at Dong Nai River. As a result of hydraulic action, the soil particles of underlying layer is detached and carried far away by stream flow which results in overhanging layer at the top. This overhanging layer with time collapse and execute rapid bank erosion.

Figure 2. Cohesive and non-cohesive layers at Dong Nai River.

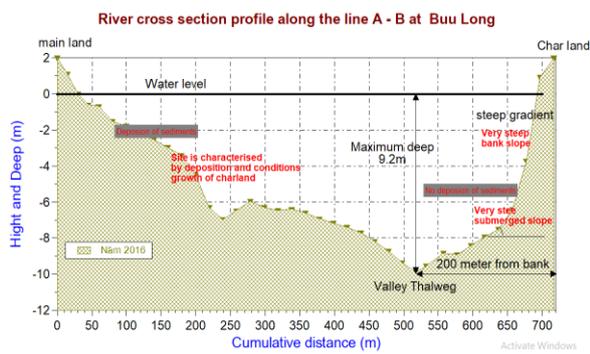
Field survey took place at the location of Hoa An bridge at about 500m to the upstream of Dong Nai River (location MC1). A river cross profile was done along the left bank of Dong Nai River at Buu Long. The near bank river bed profile depicts that the depth is close to the river bank which plays a significant role to increase the velocity of water.

Figure 4. River cross profile between mainland and char land at Buu Long.

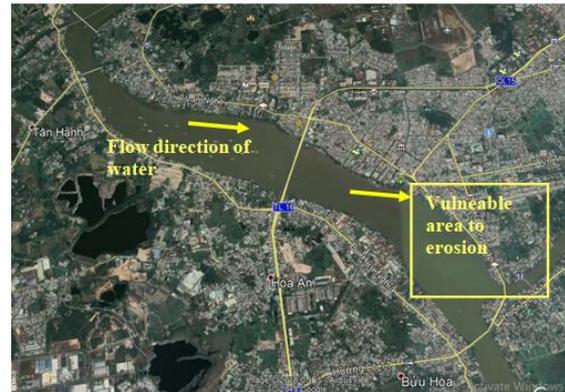
Figure 5: Vulnerable sites of bank erosion at Buu Long - Bien Hoa.
