Repairs and Construction Technique of Neoteric Buildings in China: A Case Study of the Building of College of Engineering in Wuhan University

Yiwen Chen, Qing Zeng, Huiwang Cai and Zhi Liu

Office of Logistics Service, Wuhan University, Wuhan, Hubei Province, P. R. China

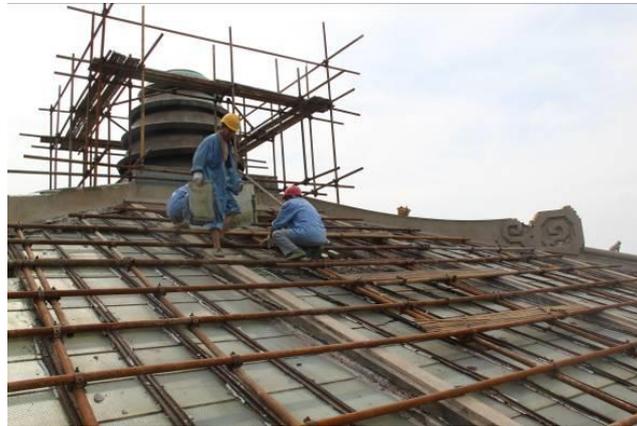
Figure 4. Disassemble glass iron lid strip

Before the glass roof of the building was removed, the roof was photographed and imaged, and then the glass top surface was surveyed and mapped. According to the result of surveying and mapping, the components that couldn't continue to be safely used are processed according to the

original condition. Glass iron lid strip, original wired glass and T-shape iron keel were protectively disassembled from top to bottom (As shown in Fig.4).

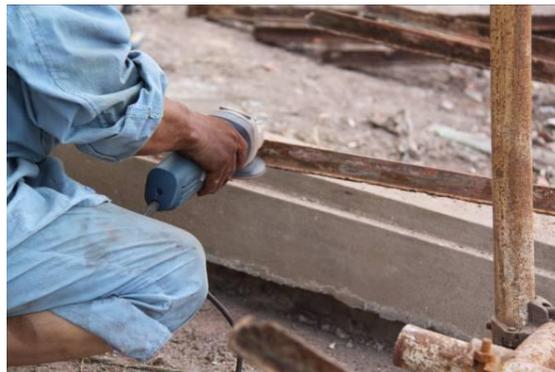
Figure 5. Derusting and polishing of the dismantled iron T-shape keel

Steel components of the roof structure were repaired. All oil paint in original steel roof trusses were removed and rusts were removed by polishing. All steel roof trusses were brushed with antirust paint. Steel roof trusses were embedded twice with fluorocarbon putty and polished, and then coated with fluorocarbon paint. As for the steel structure wrapped in concrete outside, the coating material on the concrete was washed with high-pressure water gun, then the cleaned concrete was embedded with fluorocarbon putty and brushed with fluorocarbon paint.

The entire glass top surface was divided into north, south, east and west areas. The overall construction process was in accordance with dismantling area followed by restoring another area, and then the procedure of another area was conducted in the same way. Derusting and polishing of the dismantled iron T-shape keel were carried out, and two protective agents were brushed. Two protective agents were also applied to the reworked T-shape keel and the copper cover plate (As shown in Fig.5 and Fig.6).

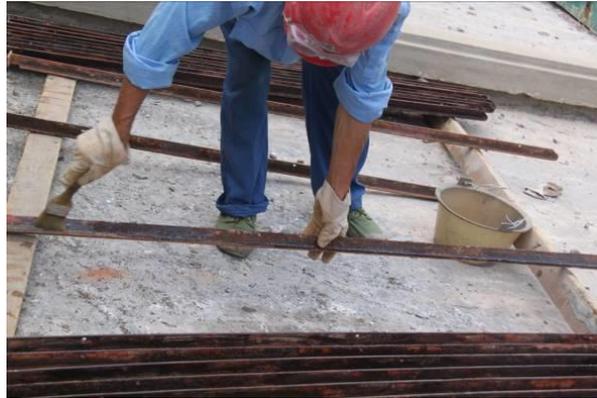
Figure 6. Protective agents were brushed

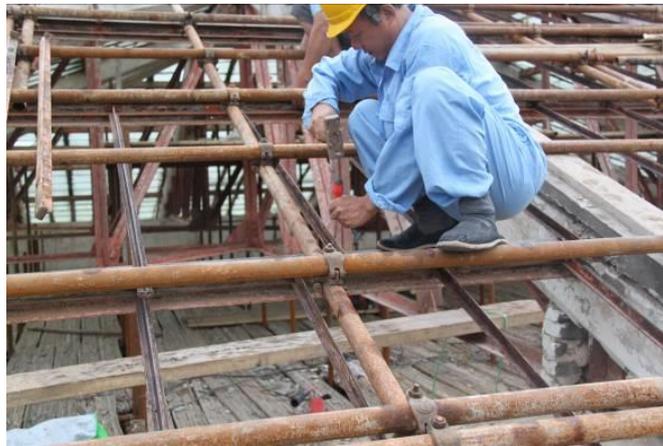
Figure 7. T-shape keels were installed according to original sample

T-shape keels were installed according to original sample from top to bottom (As shown in Fig.7).

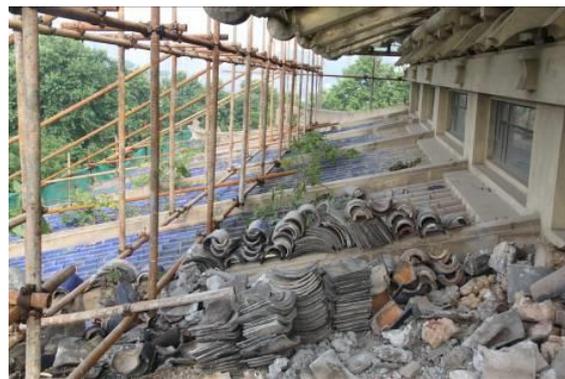
Figure 9. Glazed cylindrical tiles and clay tiles were disassembled

The supplementary tiles were custom processed according to the type, size and number of damage of the various tiles. These customized tiles were made of original size, original material and original color. The glazed cylindrical tiles and clay tiles were disassembled from top to bottom and classified and stacked (As shown in Fig. 9).

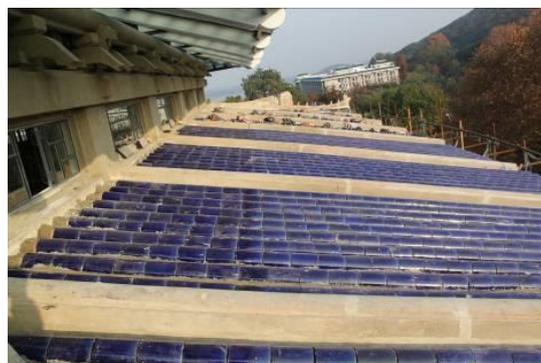
Figure 10. Tiles were paved with cement mortar

The surface of base was cleaned and the tiles were selected and prepared from the supplementary tiles. The ridges were positioned according to the original plane layout. Tiles were paved with cement mortar (As shown in Fig. 10). The way of tile paving was in accordance with original paving of mapping record before disassembly.

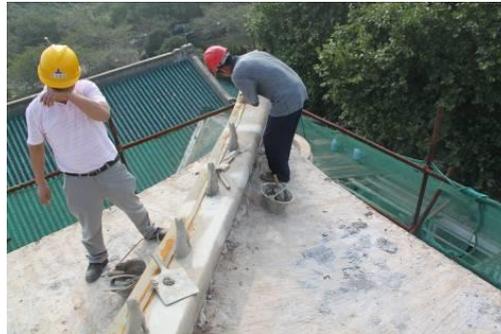
Figure 11. Beasts were repaired

In ancient Chinese Palace architecture, beasts made of pottery or glazed tiles were indispensable parts of roof decoration. All beasts with badly damage were dismantled and they were copied with the same shape and installed by professional clay sculpture technicians on the site (As shown in Fig. 11).

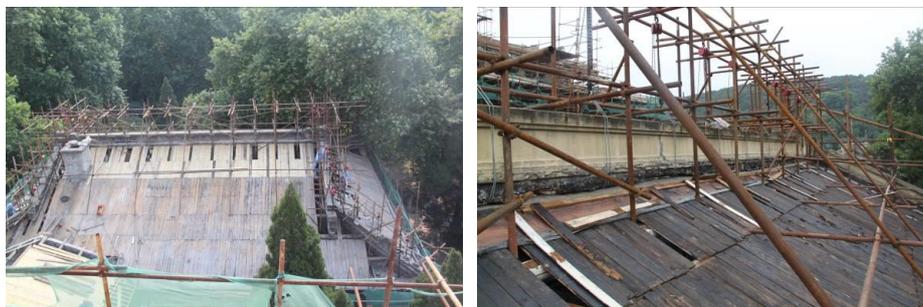
Due to the long history of the buildings and the aging of the roofs, leakage occurred on the main ridge of ancillary building. Waterproof roll could not stick into main bridge at the time of roof paving so that waterproof requirements could not be improved. Therefore, main bridge was uplifted overall for waterproof roll to stick into it and copper sheet covered it for protection (As shown in Fig. 12).

Figure 12. Overall uplifting of main ridge

The steel pipe row frames were set up upwardly from building surface right below and on both side the main bridge and were beyond main bridge through roof.

Along the direction of the main bridge, lifting points were distributed, and then the bottom of lifting points in main bridge were dug through carefully so that the chain of the chain block could cross it, and the angle irons were pad and set on both side lifting point for protecting the lifting point of main bridge.

The main bridge was uplifted with chain block and the speed and height of each lifting point were controlled simultaneously. Then the waterproof roll and the copper sheet were stuck into the bottom of the main bridge after main bridge was uplifted to reserved height.

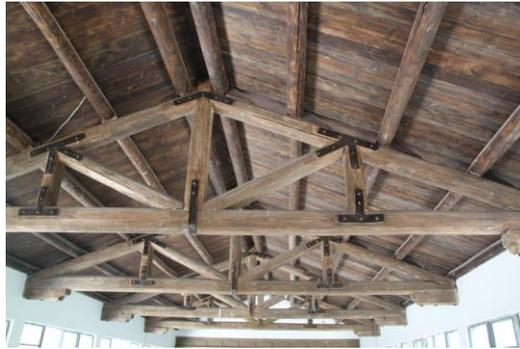
After roof truss and purline were surveyed on site, it was found that stability of overall structure of

wooden roof truss was reliable and partially wooden components were rotten. Thus, rotten sections were removed and replaced with new wooden components. New and old components in the replaced part were connected with steel plates and bolts.

Figure 13. Repair of wooden roof truss of corridor

Screws and nuts, missed in original reinforcing steel members, were added. Original antirust paints on all reinforcing steel members were removed. Protective agent was brushed for rust prevention so as to present original color of steel members and a retro style (as shown in Fig.13).

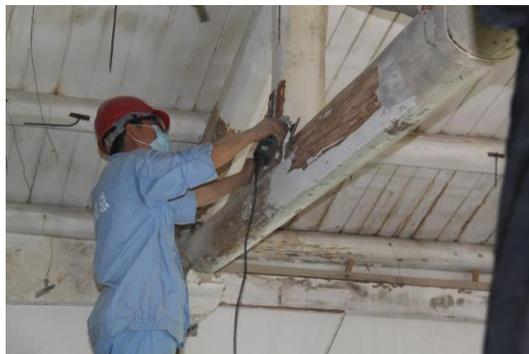
Figure 14. All wooden components were brushed

Original coatings of wooden roof truss were all polished and cleaned so as to remove surface paint. Then antique finishing was conducted for all wooden components. In the end, all wooden components were brushed with two coatings of protective agent so as to present original color of wood (as shown in Fig.14).

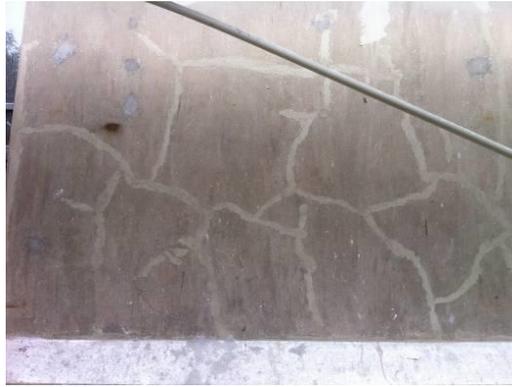
Since external wall had been reconstructed for many times and brushed with multiple coatings, original style and features of the building were lost. In order to present original style and features of the building, the following construction methods were adopted:

Figure 15. Tiny cracks in wall were repaired

- 1) Firstly, water pistol was used to clean original coatings on wall.
- 2) The hollow parts of wall base were chiseled, cleaned and broom-finished, rendered and repaired again.
- 3) Original tiny cracks in wall were repaired with cement mixed with glue (as shown in Fig.15).

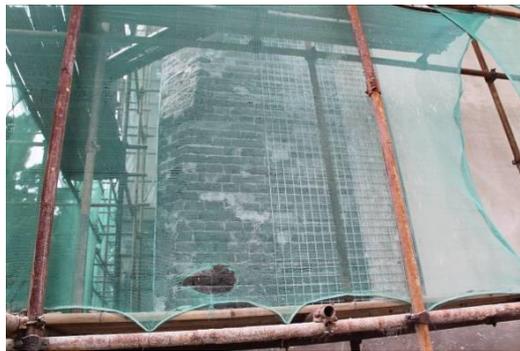
Figure 16. Repaires of cracks at four wall corners

4) For cracks at four wall corners of the Building of College of Engineering, the base where cracks were located was cut and removed with steel wire mesh attached to the surface, and repaired and rendered again (as shown in Fig.16).

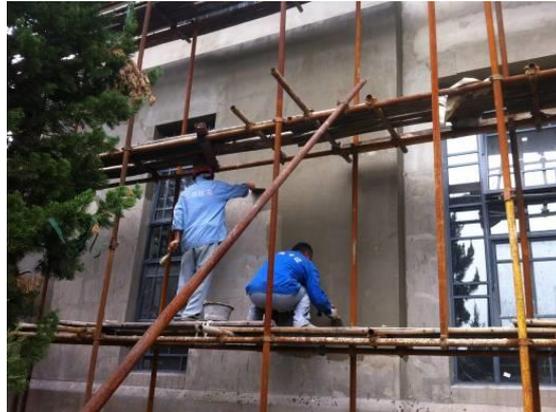
Figure 17. Chromatic aberration processing of wall surface

6) Due to color difference between repaired wall and original wall, the whole wall was colored. Namely, mixture, which consisted of yellow sand, cement and acid and alkali-resisting polymerizer, was used to brush external facade fully and uniformly from top to bottom with brush (as shown in Fig.17).

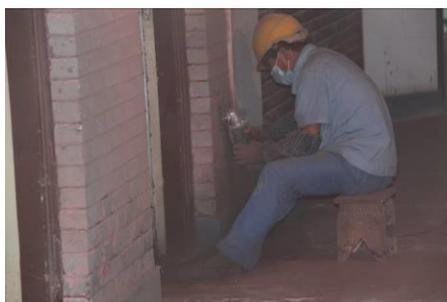
Figure 18. Coatings were removed by polishing

Since dry wall dados have been brushed with coatings for many times in previous years of repair and coatings on the surface were thick. Coatings were removed with paint remover firstly. Effect of removing coatings with paint remover was bad. Thus, in the repairs, coatings were removed by polishing (as shown in Fig.18).

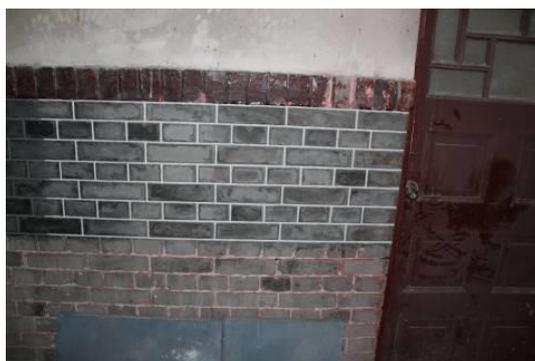
Figure 19. Repaired brick wall surface

After coatings on all walls were removed, original brick wall seams were carved and slotted. Then brick powders were used to repair walls and pointing joints. In accordance with analysis for brick seams in wall with coatings removed, brick seams of original wall were ingot-shaped and thus renovated in accordance with the original approach. In the end, renovated brick wall surfaces were brushed with two coatings of protective agent in order to effectively stop weathering and corrosion and play a role in waterproofing (as shown in Fig.19).
