Analysis and Treatment of Shutdown Due to Bearing Vibration Towards Ultra-supercritical 660MW Turbine

Wanjun Li^{1,*}, Xiaoxia Li², Qingliang Niu¹, Tianqi Huang¹, Deke Zhang¹,
Yang Dong¹

¹ Huadian Electric Power Research Institute Co., LTD., Jinan 250014, China

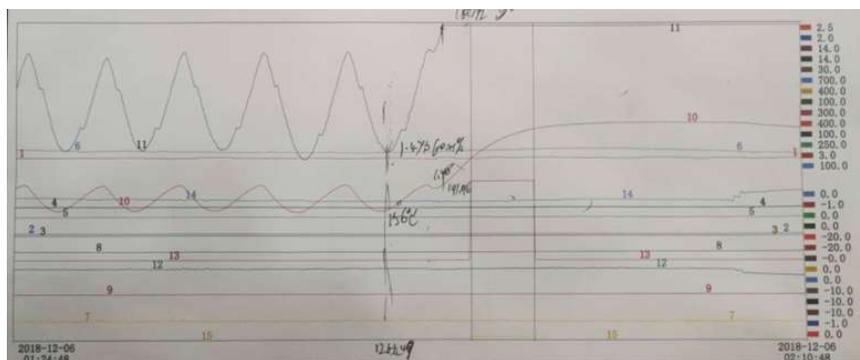
After the unit shutdown, we review the historical trend immediately for analysis, it can be found : On December 6 01:47, low last warm tone opening reduction is 60.41%, shaft seal steam temperature is 156 °C; 01:50, Low closing seal inlet steam temperature rises to 215 °C (shown in figure 1), low pressure shaft seal desuperheating valve open to 99.3% automatically, due to the temperature and the set value deviation (165°C) is greater than 50 °C, remove automatically[3]. At the time of 01:55, the operator throws the automatic switch again, and the switch remains fully open. Until 2:17 on the seventh of December, low closing seal steam temperature fluctuates between 240-270°C (higher than that of the steam turbine equipment manufacturer design value standard 121-177°C). Personnel did not adjust the shaft seal temperature during the operation

Figure 1. Trend chart of low pressure shaft seal steam inlet temperature.

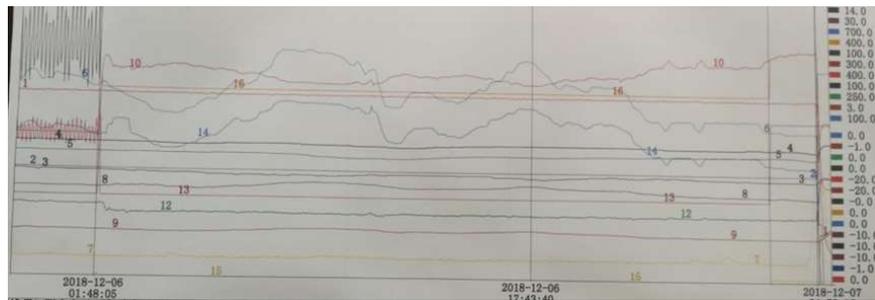
The unit load reduced from 423MW to 330MW, low closing seal steam temperature risen from 267 °C to 286 °C (shown in figure 2). The low pressure shaft seal produces large radial expansion in the long over temperature environment, at the same time, the rotor with low pressure seal also produces great radial deformation due to high temperature steam. Because the heated area of the rotor is large, the radial expansion produced by the low-pressure rotor is obviously greater than that of the low-pressure shaft seal. The result is that the low pressure shaft seal and rotor collide radially. The leaf spring on the back of the low-pressure shaft seal is heated after low pressure shaft seal steam inlet temperature increasing, the stiffness is obviously reduced and even loses its elasticity. When the radial dynamic and static friction between the low-pressure shaft seal and the rotor occurs, the radial movement of the low-pressure shaft seal body cannot reduce the friction between the dynamic and static, resulting in a sudden and sharp increase in vibration (seen from figure 3), until the shaft vibration is greatly protected, and the machine shutdown.

Figure 2. Trend chart of turbine bearing vibration.

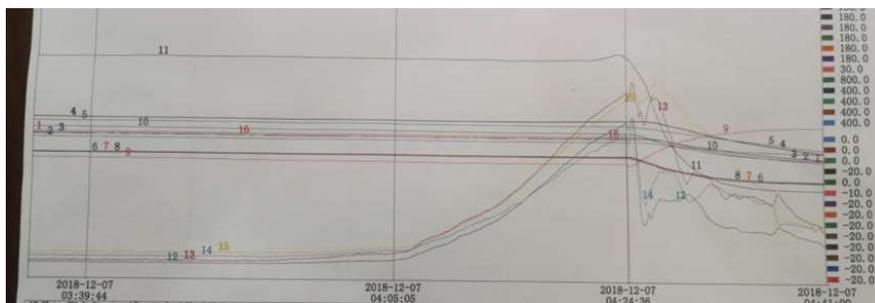
Figure 3. Trend chart of turbine bearing vibration and temperature.

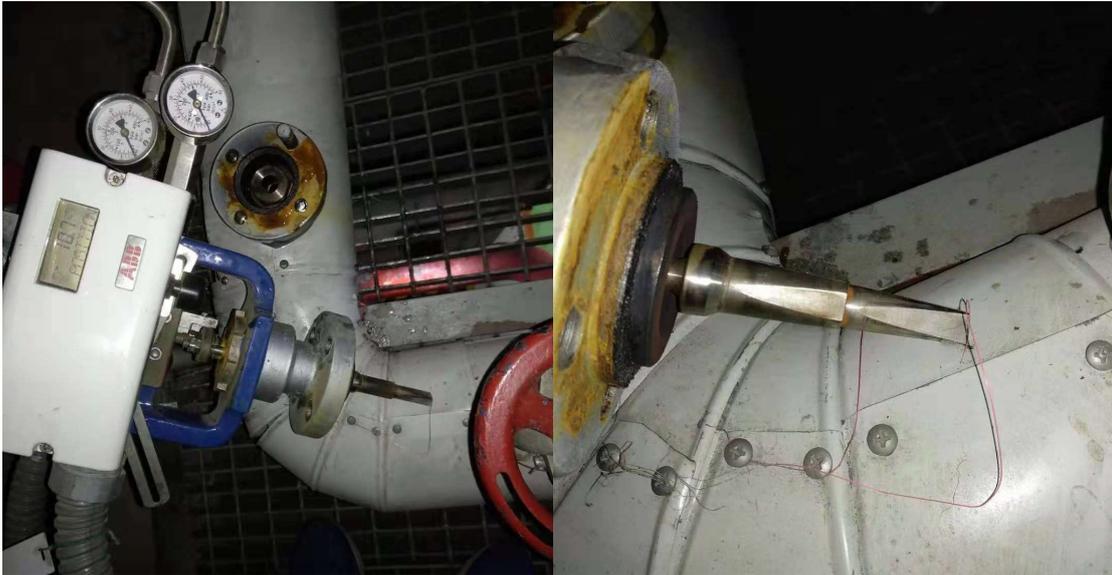
It is impossible to accurately judge whether the low-pressure shaft seal desuperheating water regulating valve is blocked through the test, and then the method of disintegrating the low-pressure shaft seal desuperheating water regulating valve is adopted to check whether there is foreign body blockage. The disintegration inspection is shown in figure 4.

Figure 4. Low pressure shaft seal desuperheated water regulating valve disassembly inspection.

Through the disassembly inspection of the low-pressure shaft seal desensitization regulating valve, it is found that the valve core and the valve seat sealing surface are intact without any abnormality, the valve channel is free from blockage, and there is no foreign matter, so the reason for the blockage of the regulating valve is excluded

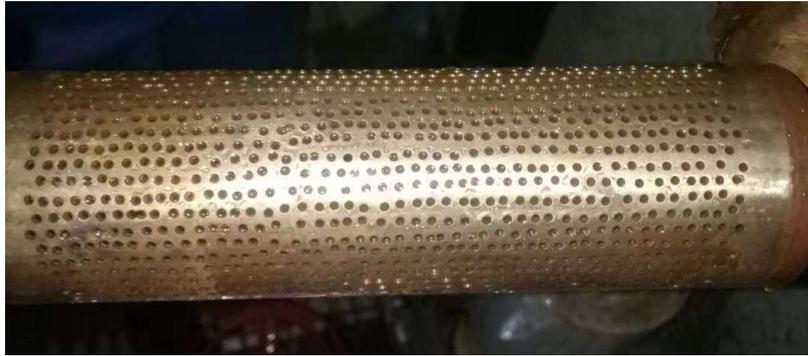
Check the maintenance record of the low-pressure shaft seal desuperheating water filter, and it is found that the filter was not cleaned during the overhaul, and the filter was prone to clogging due to the long running time. In order to further accurately judge the clogging situation of the filter, the filter was disassembled for inspection.

According to the disassembly inspection (seen from figure 5), there is no foreign body on the inner and outer surface of the filter mesh, and there is no abnormal site, so the blockage of the filter mesh is eliminated.

Figure 5. Disassembly diagram of the warm water filter in the low-pressure shaft seal.

3) Optimize the shaft seal desuperheating water pipeline, add the screen isolation door, and realize the online isolation and cleaning of the screen.
