Analysis and treatment of the shutdown reasons of ultra-supercritical 1000MW steam turbine generator set

Abstract. When a power plant ultra-supercritical 1000MW steam turbine generator set is running normally, the electric valve at the outlet of A steam feed pump appears serious leakage. Through on-site inspection and inspection of maintenance records, starting from the structure of the electric valve, the leakage fault of the electric valve at the outlet of A steam feed pump is diagnosed and investigated, and the cause of the fault is accurately analyzed. The leakage problem of the electric valve at the outlet of A steam feed pump has been thoroughly solved by taking effective measures such as changing the packing type, arrangement and improving the installation process.

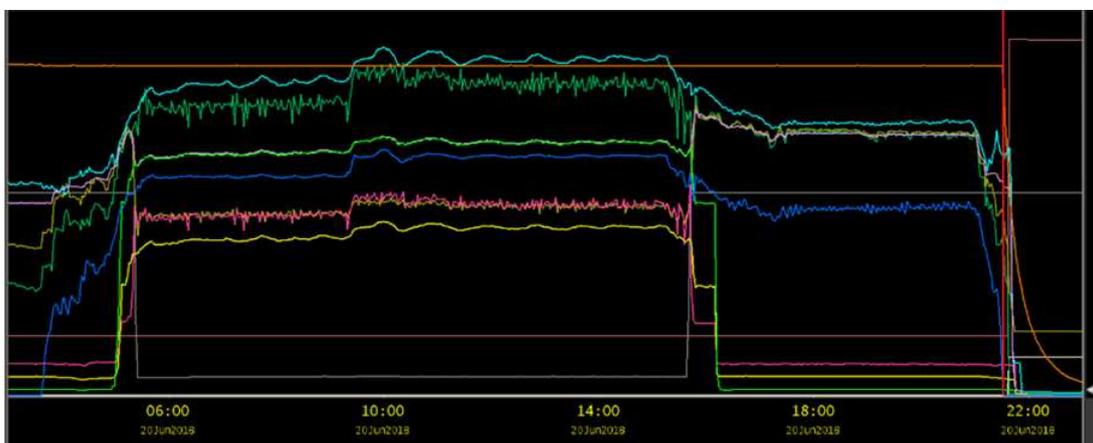
Figure 2. Unit load, feed pump speed trend chart.

At 5:02 on June 20, 2018, the load was 458 MW, the B steam feed pump was running at a speed of 3596r/min, and the feed water pressure at the pump outlet was 15.4Mpa. A steam feed pump started to run. At 5:28, the load was 566MW, the speed of B steam feed pump was 3656r/min, and the feed pressure at the pump outlet was 19.01Mpa, the speed of A steam feed pump was 3631r/min, and the

feed pressure at the pump outlet was 19.02Mpa (seen in figure2).A and B steam feed pumps were running together. Field inspection showed that external leakage of the electric valve at the outlet of A steam feed pump gradually intensifies.

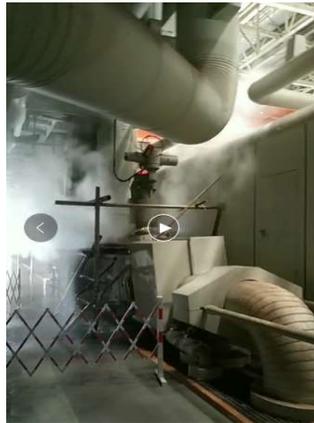
Figure 3. Leakage diagram of the electric valve at the outlet of a steam feed pump.

The shutdown of the unit was caused by severe external leakage of high-temperature and high-pressure feed water through the outlet electric valve of a steam feed pump along the direction of the valve stem (seen in figure3). Feed water of high-temperature and pressure leaked, then vaporized into high - temperature steam rapidly. A steam feed pump outlet electric valve could not be repaired online, thus the unit can only be shut down for the corresponding treatment.

After on-site investigation, diagnosis and analysis, the main reason for the leakage of the electric valve at the outlet of A steam feed pump was the serious leakage at the root of the electric valve.

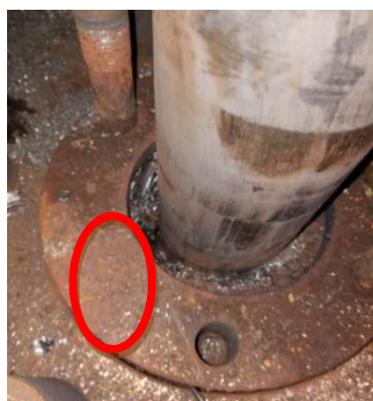
Figure 4. Diagram of the upper packing of the electric valve at the outlet of a steam feed pump.

Disassembled the packing gland of the outlet electric valve, removed the connecting bolts, nuts and gaskets, etc., checked the flexible graphite packing, and found that the outer diameter of the most strengthened flexible graphite packing has local damage along the circumference (seen if figure4).

Based on the above analysis, the main reason for the leakage of the coil root of the electric valve at the outlet of A steam feed pump was the local damage along the circumference of the outer diameter of the reinforced flexible graphite.

Checked the maintenance records and ledger of the unit, it was found that the outlet electric valve of A steam feed pump has been in operation for 6 years since it was put into operation, without any disassembly inspection and graphite packing has not been replaced. The physical and mechanical properties of graphite packing changed, aging and compressible properties became worse. When the valve was in cold state, under the compression of the axial force of packing gland, the axial compression deformation of packing root decreased, resulting in the reduction of radial expansion deformation of packing root, unable to completely fill the gap between the stem and packing packing root, so unable to play a good sealing effect.

When the valve was in hot state, it worked under high temperature and pressure environment, the resilience of graphite packing roots changed worse due to the aging, which makes the thermal expansion of packing roots uneven. As a result, the radial expansion deformation of packing root was not even, and the radial tight contact degree along the stem was not even. The radial force produced by packing packing was not uniform, and then the axial friction on the surface of the stem was not uniform. Some areas were large, and some areas were small, which could not completely balance with the feed water pressure.

High pressure feed water leaked along the stem surface area of small axial friction, flushing of packing surface near stem, resulting in packing volume reduction, aggravate reduced packing sealing effect, made high pressure feed water along the stem surface leakage gradually aggravate[2-3].

5) Replaced the packing, using compound packing type, using braided graphite packing at upper and lower ends, using reinforced flexible graphite packing at the middle layer, joint filler packing the incision should be cut into 45° , the joint filler packing should be 180° staggered.

9) After packing back, tighten the packing gland bolts diagonally to ensure the packing packing was under uniform stress and the packing gland must not tilt. And leaved enough compression margin, so that the entire packing assembly was compressed by 30%, packing gland pressed into the depth of the packing base for its height of $1/4 \sim 1/3$ [4-5].
