Erosion of Pelton buckets and changes in turbine efficiency measured in the HPP Fieschertal

A Abgottspon¹, T Staubli¹, D Felix²

¹ Competence Center for Fluid Mechanics and Hydro Machines (CC FMHM), Hochschule Luzern (HSLU), Technikumstrasse 21, CH-6048 Horw, Switzerland

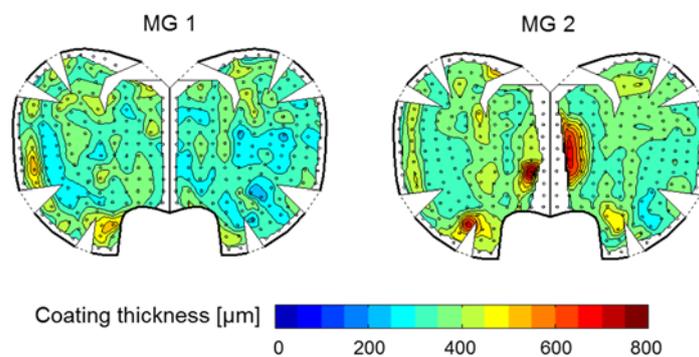
Figure 1 shows a map of the coating thickness in bucket no. 1 of each machine group (MG). The iso-color surfaces were interpolated from the measurements at the black dots. These measurements were taken in April 2013 on runners which have been in operation for at least one season since the last coating in the factory. The coating thickness varied between 200 and 500 μm for MG 1. At MG 2 local damages have been repaired by on-site re-coating, which explains local thicknesses of up to 800 μm . But also without re-coating the thickness may vary considerably, as e.g. in the bucket of MG 1, where the thickness changes by up to 200 μm within a distance of 40 mm close the left contour of the bucket. This emphasizes the importance of a good reproducibility of the measuring points. Measurements in a second bucket of both MGs showed similar patterns as in the first buckets.

From the successive measurements, an area-averaged reduction of the coating thickness was evaluated. This reduction amounted to 10 μm for the sediment season of 2013 with a sediment load of 29 000 tons and to 4 μm for 2014 with a sediment load of 22 000 tons (MG 1). The reproducibility of these coating thickness difference measurements was estimated to be ± 5 μm . Thus the thickness reduction of 2013 is significant while the one of 2014 lies within the band of uncertainty.

It was concluded that in absence of a major sediment transport event as in 2012, the coating in the buckets lasts for several years. In the runner which had to be replaced after the sediment event in 2012, coating thicknesses of only 50 to 100 μm were measured in the bottom region of the bucket and in the neighborhood of areas where the coating was completely removed.

Figure 1. Maps of coating thickness in buckets no. 1 of MG 1 (left) and MG 2 (right).

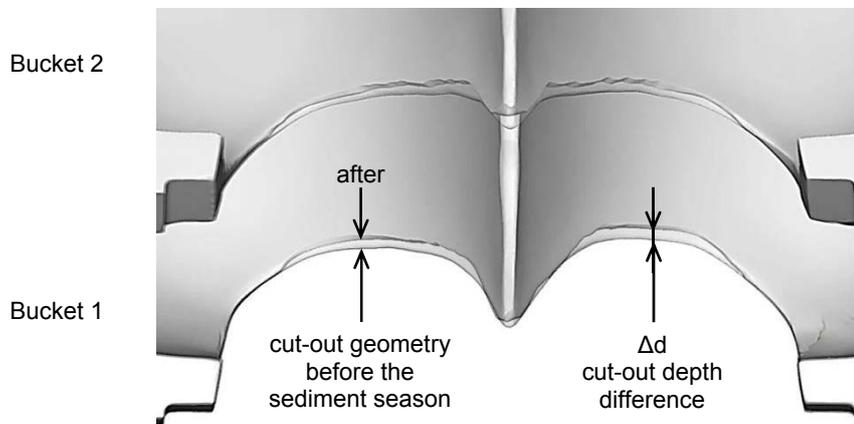
The geometries of selected buckets were measured with a 3D optical scanning camera [18]. Its working principle is based on structured light projection and spatial triangulation. In order to compare the geometries of the successive measurements, a consistent and reproducible geometrical reference had to be used for the positioning of the digital geometric models (3D point clouds) of the buckets. Further information on this procedure and on the data treatment is given in [19]. Figure 2 shows an overlay of the measured geometries of two digitized buckets before and after the sediment season 2012 in topview in the zone of the cut-outs. Erosion occurred mainly in the centre part of the cut-outs and on the tips of the splitters. On the outer sides of the cut-outs the geometry is not altered with time.

The perfect overlay in the zones without erosion indicates a good reproducibility of the geometrical measurements with this method. The reproducibility was estimated to be better than ± 0.2 mm in the zones of the splitters and the cut-outs.

Figure 2. Overlay of the topview geometries of the cut-outs and splitter tips before and after the sediment season 2012 for MG 2.

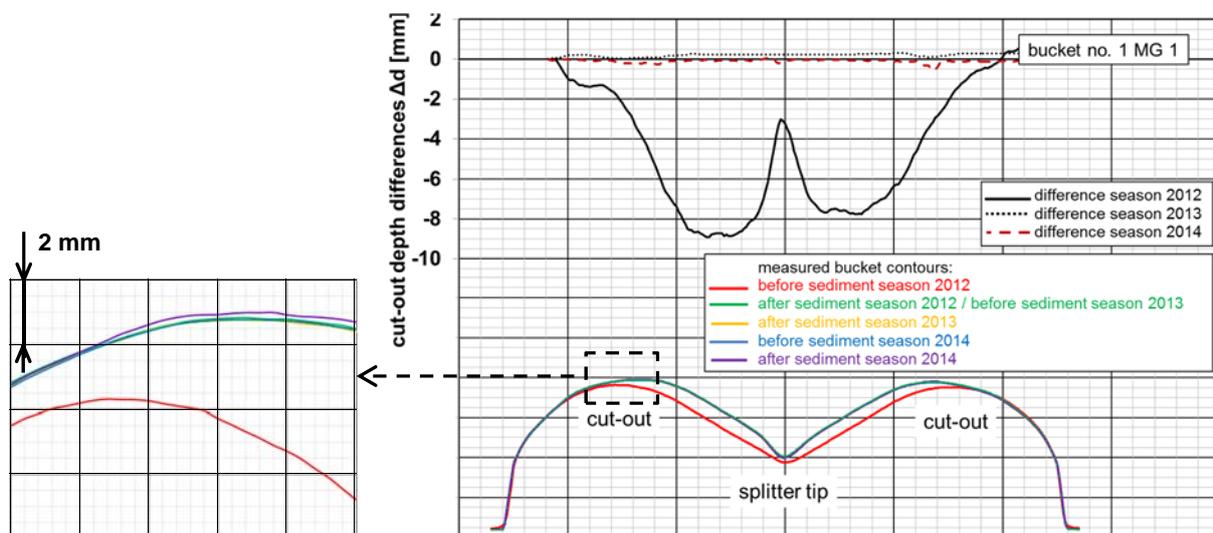
In the lower part of figure 3 the measured contours for the cut-outs of buckets no. 1 of MG 1 are shown also in topview. In addition, the differences in cut-out depths are shown in the upper part of the figure for each sediment season. The results for the bucket no. 2 were similar.

Figure 3. Topview of the cut-outs digitized at various times (with a zoom on the left) and differences (on the top) for each sediment season for bucket no. 1 of MG 1.

During the sediment season 2012 the cut-out depth increased for the bucket shown in figure 3 by up to 9 mm towards the turbine axis. This corresponds to 1.4 % of the inner bucket width ($B=650$ mm). Contrarily, no or very small hydro-abrasive erosion occurred in the other seasons (no detectable difference of the green, yellow, blue and purple lines). These findings are confirmed in figure 4 where for the same bucket the measured longitudinal profiles of the splitter are depicted. The resulting differences of the splitter heights for each sediment season are quantified. During the sediment season 2012 the splitter height was reduced by up to 6 mm in the middle part of the splitter. This corresponds to 0.9 % of the inner bucket width. The overlay of the lines in the zoomed details of figures 3 and 4 demonstrates the high resolution and the high degree of details of the measurement method used.

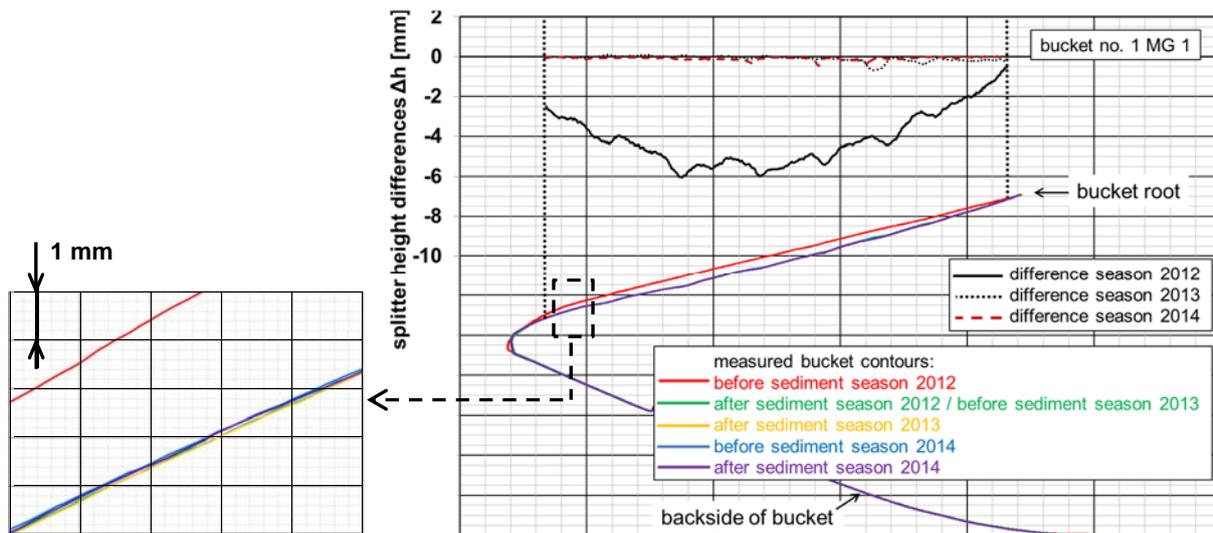
Figure 4. Side view of the splitters digitized at various times (with a zoom on the left) and differences (on the top) for each sediment season for bucket no. 1 of MG 1

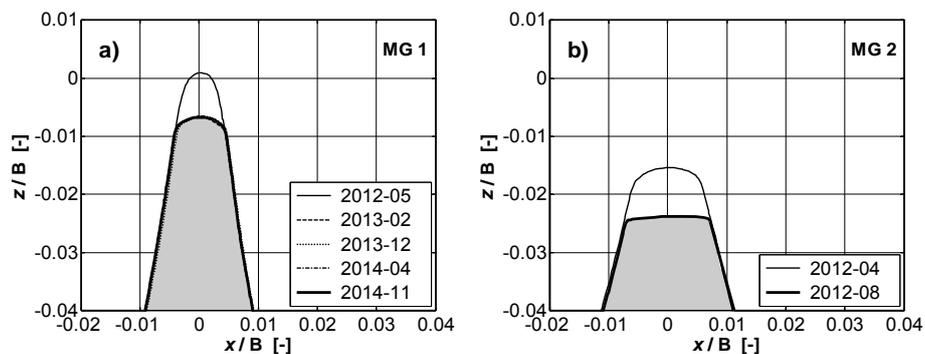
Figure 5 shows the measured cross sections through the splitters of the buckets no. 1 of each MG. The sections are located at half of the splitter length. Always the same runner was installed in MG 1 in the years from 2012 to 2014. Due to heavy hydro-abrasive erosion in the year 2012 and the maintenance works afterwards, the splitter at MG 1 was widened and rounded. During the following two years it remained practically unchanged. At MG 2 the splitter was already relatively wide at the beginning of the sediment season 2012. The splitter was further widened in part of the year 2012. After the major sediment transport event the runner was taken out of operation in August 2012. Although the reductions of the splitter heights at MG 1 and 2 were similar, more material was eroded at MG 2 because of the wider splitter.

Figure 5. Splitter cross sections of buckets no. 1 at various stages of erosion and maintenance works: a) MG 1 and b) MG 2; coordinates are normalized by the inner bucket width B .

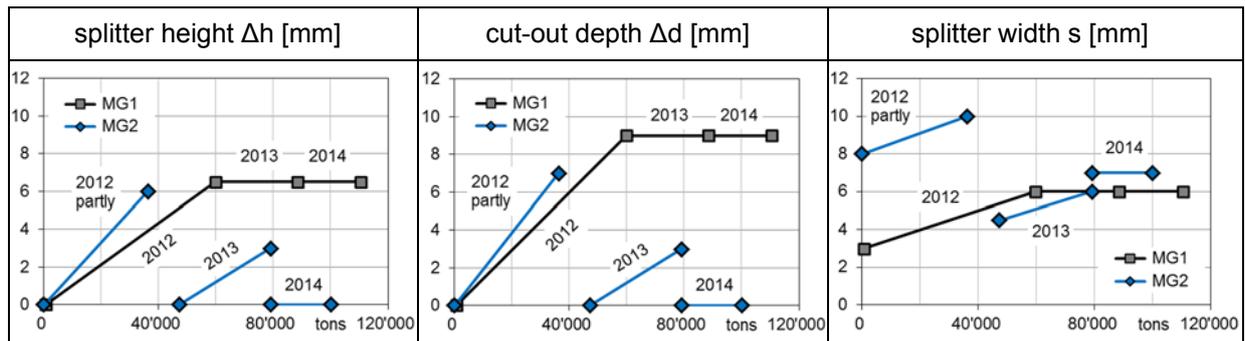
Figure 6 shows the variation of height and width of the splitter as well as the increase of the cut-out depth for both MGs as a function of their cumulated sediment loads. Displayed are the averaged values for bucket no. 1 and no. 2. As mentioned before, always the same runner was installed in MG 1 since 2012. In MG 2 three different runners were installed during the same period for which reason the lines are interrupted. A first runner exchange was necessary after the major sediment transport event of 2012. The second runner replacement became necessary due to a crack at the bucket root, unrelatedly to hydro-abrasive erosion.

In the course of the sediment season 2012 the coating in the zones of the splitters and the cut-outs of both MGs was completely removed by hydro-abrasive erosion. The successive erosion led to

considerable loss of base material. At MG 1, the splitter was widened by about 3 mm and its height was reduced by 6.5 mm after a sediment load of 60 000 tons. In contrast, only very local removal of the coating was observed during the sediment seasons of 2013 and 2014 and no changes in splitter and cut-out geometries were measured. At MG 2, the initial splitter width was more than twice that of MG 1. This led to serious secondary damages and the runner had to be replaced after the major sediment transport event, in spite of a 30 % lower sediment load compared to MG 1, where no runner exchange was required. This demonstrates that the status of a runner before exposure to high sediment loads is essential for the arising amount of erosion.

Figure 6. Histories of splitter and cut-out geometries as a function of the cumulated sediment load per MG in the HPP Fieschertal.

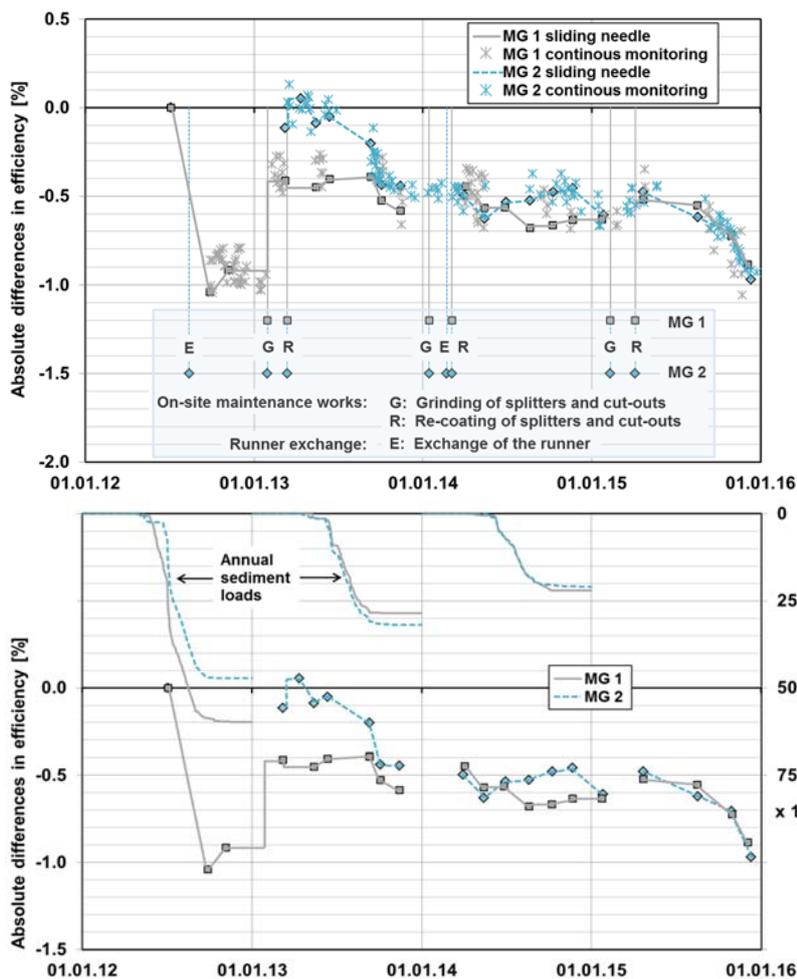
Figure 7. Efficiency history obtained from the sliding needle procedure compared with the continuous efficiency monitoring and remarks on maintenance works and runner exchanges.

For continuous monitoring, data are recorded at 1 Hz, as for the sliding needle measurements. For each set of sampled data efficiency is evaluated. The scatter of these efficiencies is relatively high and a daily averaged difference to a reference curve from a sliding needle measurement is evaluated in steady state conditions. The history of such data is displayed in figure 7 and the larger scatter compared to the sliding needle data is obvious. This scatter was reduced by sophisticated data processing, elimination of outliers and filtering. Further it was necessary to introduce plausibility tests to check the individual measuring quantities, especially the pressure measurements. Pressure data were compared to calculated pressures, evaluated from head water level measurements considering the head losses in the penstock. Figure 7 shows the index efficiency history for both MGs for a period of four

years from 2012 to 2015. The points which are connected by lines show the history evaluated from the sliding needle procedure. The crosses indicate the results from the continuous efficiency monitoring. The maintenance works carried out are marked as well.

In the second part of the sediment season 2012 an efficiency loss of 1 % was measured after 1902 operating hours at MG 1. The main cause for this efficiency loss is the major sediment transport event of July 2012. In the winter 2012 / 2013 the splitters and cut-outs were grinded and rounded. This led to a measured increase in efficiency of 0.56 %. In the year 2014 the measured efficiency reduction of MG 1 was only 0.14% after 3048 operating hours. Two further grinding and re-coating actions after the sediment seasons 2013 and 2014 did not lead to significant increases in efficiency. Efficiency benefits of on-site maintenance works depend on the erosion status of the runner.

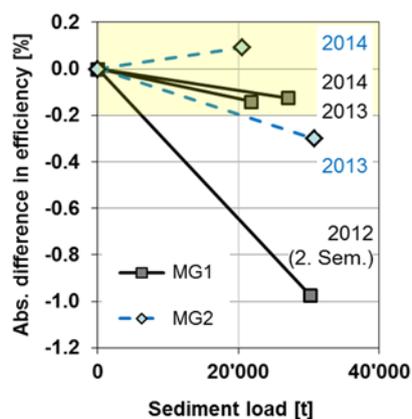
For each sediment season and each runner the efficiency changes are displayed in figure 9. The shown efficiency differences are taken from the efficiency data of figure 8. The estimated reproducibility is ± 0.2 %. In this range the results should not be over-interpreted; especially the small increase of efficiency is questionable.

No efficiency difference is available for MG 2 in the year 2012, since the runner had to be replaced unexpectedly after the major sediment transport event. For MG 1 one observes for similar cumulated sediment loads of about 30 000 tons efficiency differences of -1.0 and -0.1 % in a part of the year 2012 and in the year 2014, respectively. This corresponds to a factor of ten, from what can be concluded that the sediment load alone is not suited for explanation and prediction of efficiency losses.

Figure 9. Comparison of the measured efficiency differences with the sediment loads per MG and year at HPP Fieschertal.
