# Earthquake damage of self-built reinforced concrete frame structures in Ms 8.1 Nepal Earthquake

**Abstract.** An earthquake measured Ms 8.1 occurred near the Nepal Pokhara on April 25, 2015(Beijing time). As a member of China to Nepal disaster assessment team, the author conducted thorough investigation about the earthquake damage of all kinds of engineering structure in Nepal. Self-built reinforced concrete frame structure which is widely accepted by the people at all levels in Nepal and is one of the building structure forms which are widely built suffered damage by varying degrees in the strong earthquake and aftershocks. Based on the seismic damage investigation date of the earthquake and its aftershocks, the characteristics of aseismic construction are summed up, the damage characteristics and the reasons of its destruction are analyzed. The main problems in the design and construction of the structure are pointed out. The advices on the existing problem of self-built reinforced concrete frame structures are given.

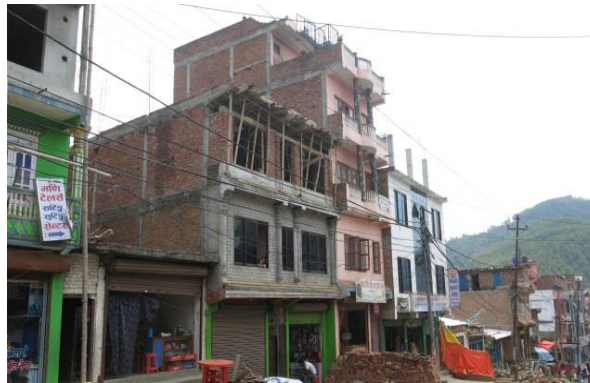
Self-built reinforced concrete frame structure are mainly 3-5 layers (Fig. 1).The top of general structure are ready to be followed by half layer of reinforced concrete columns and exposed steel cage(Fig. 2).Storey height is 3.0m.Layout is symmetric regularly.Column space is from 3m to 3.9m.

**Fig.1** Overall picture of self-built reinforced concrete frame structure

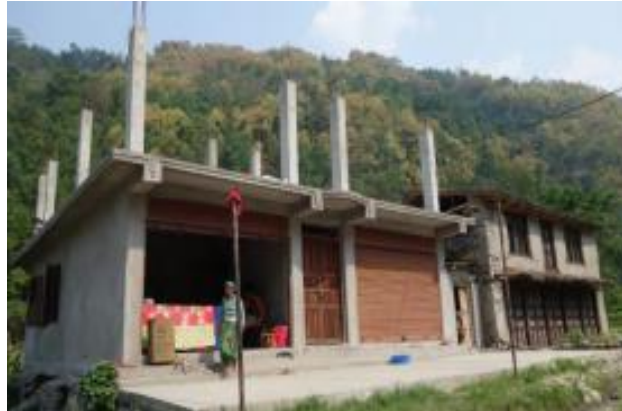
**Fig.2** Reserved reinforced concrete column and steel cage on the top floor

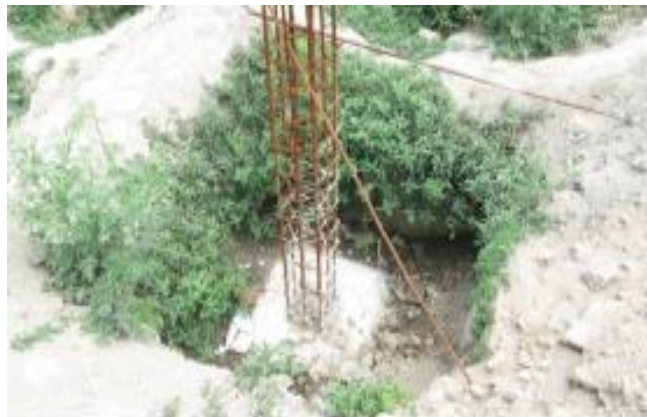
The structure use independent column foundation; the size of frame column section is 230mm×230 mm ;longitudinal bar is 6A12 and stirrup is A6@120,without reinforcement of stirrup encryption in frame columns (Figure 3); the size of frame beam section is 300mm×230 mm; the majority of beam section's size is greater than the column section's size,violating the specification requires for a "strong column, weak beam"and component section with minimum size concept design principles of all countries in the world ; floor and roof panels use cast-in-place reinforced concrete floor slab, of which the thickness is 100mm; infilled walls use solid brick (220mm×100mm×50 mm) and mud masonry; the outer wall thickness is 220mm, the inner wall thickness is 100mm;there is no construction rachel measures between the wall and the frame column(Figure 4).

**Fig. 3** Reinforcement of frame column

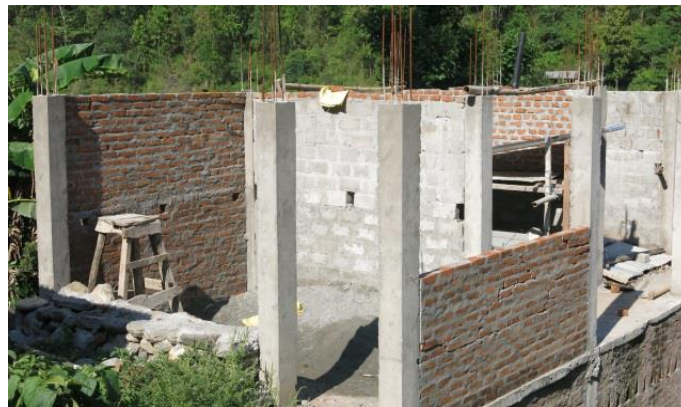
**Fig.4** Structural Rachel measures between infilled walls and frame columns are not set

bottom of the beam during construction. Cement mortar masonry should be used in the infilled wall. And at the same time, enough construction rachel measures should be ensured between the infilled wall and the main structure.

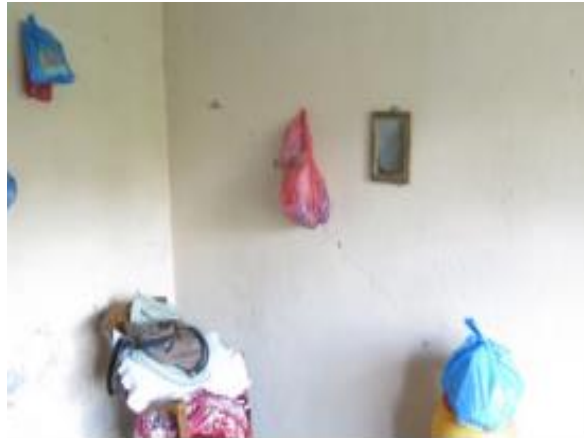
In VI zone, there were no obvious damage in infilled walls. In VII zone, the bottom infilled walls run through the inclined cracks or cross cracks (Figure 5). In VIII degree, the bottom infilled walls run through the transparently inclined cracks or cross cracks (Figure 6). In IX degree, the bottom infilled walls collapsed partially, and were damaged heavily (Figure 7). Using mud masonry in the infilled wall lead to the low level of walls' shear strength. Under the action of reciprocating horizontal earthquake, a large number of shear cracks or cross cracks happened in the infilled walls; at the same time, the infilled walls had external flash, or even collapsed in high intensity area because there were no reinforcement structure filled between the walls and the frame columns.

**Fig.5** Destruction of infilled walls in the region of VII degrees

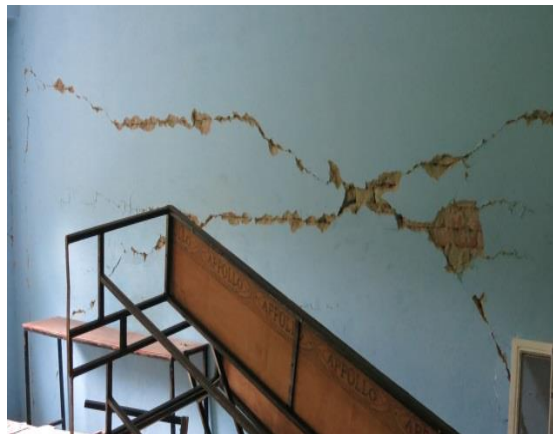
**Fig.6** Destruction of infilled walls in the region of VIII degrees

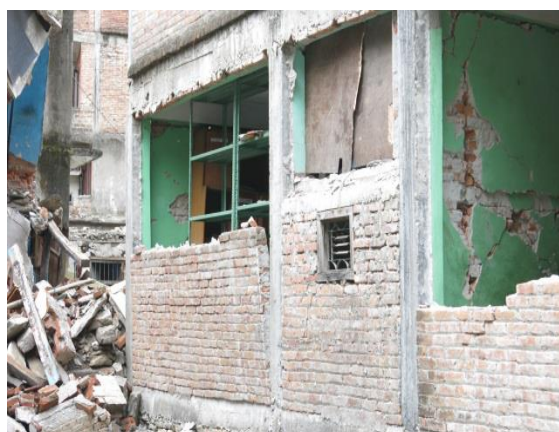
**Fig.7** Destruction of infilled walls in the region of IX degrees

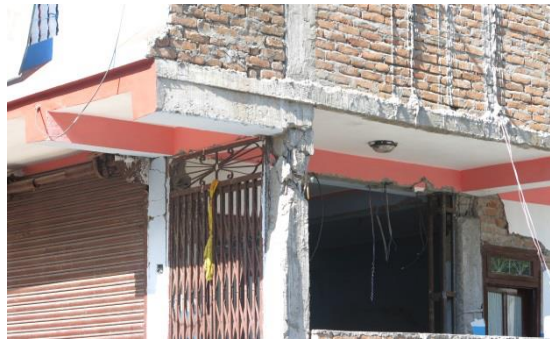
In VIII degree area, shear failure occurred at the top of a small quantity of frame bottom columns (Figure 8); In IX degree area, shear failure occurred at the top of some frame bottom columns, shear failure occurred at the middle of a small quantity of frame bottom columns (Figure 9). In self-built

reinforced concrete frame structure, the size of beam section is generally greater than that of the column section and the reinforcement of reinforced beams are often stronger than the column, resulting in the formation of "strong beam weak column" mode in the structure<sup>[1-3]</sup>. At the same time, the lack of joint hoop reinforcement near the beam and column node area<sup>[4-6]</sup> lead to less reinforcement brittle damage on the top of column more easily. At the same time, there is an inherent weak link in the top of the column because most of the frame columns were poured directly to the bottom of the beam during construction. It increased the destruction of the top of the column under the horizontal earthquake reciprocating action, eventually leading to shear failure occurred on the top of the column.

**Fig.8** Destruction of the top of the underlying columns in the region of VIII degrees

(5) In view of the existing problems of self-built reinforced concrete frame structure, it is proposed to strengthen the supervision and review of the new reinforced concrete frame structure by the government departments of Nepal. The cross-sectional area of the frame column should be strictly ensured in the structural design, and enough stirrups encryption area should be set up in the beam - column joint area at the same time. We should ensure that the self-built frame structure is a "strong column and weak beam" ductile structure, and the frame column should not be poured directly to the

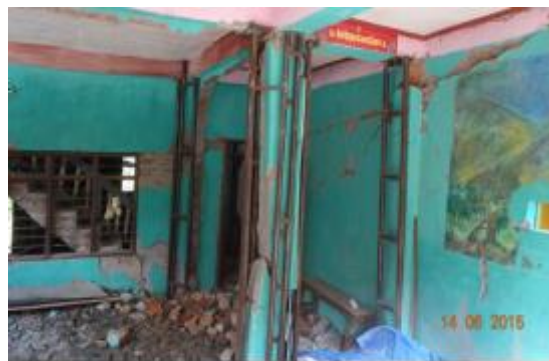
**Fig.9** Destruction in the middle of the bottom frame columns

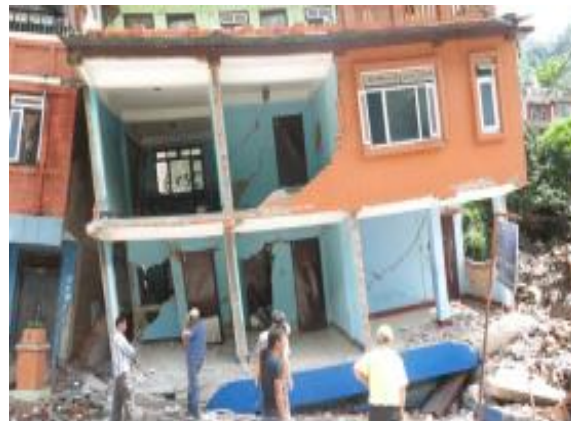
In IX degree, the disappearance of bottom layer occurred on parts of self-built reinforced concrete frame structure. The research found that most of the bottom columns suffered severe shear failure in the main shock. In the following 3 larger aftershocks, the damage on the top of columns continued to increase until the underlying structure disappeared (Figure 10).

**Fig.10** Collapse of the self-built reinforced concrete frame structure

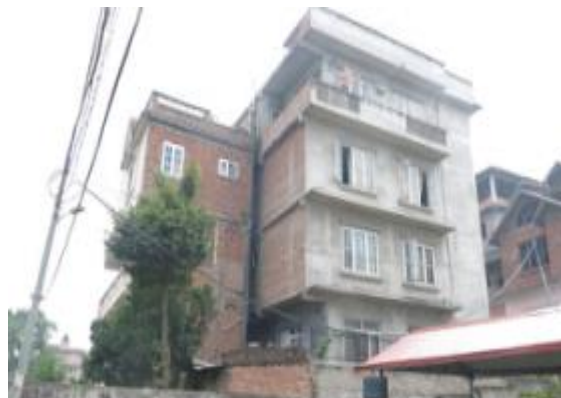
Due to the limited land resources, the density of buildings in Nepal's towns is extremely high and the spacing between adjacent buildings is extremely small. And the design and construction of self-built reinforced concrete frame structure has not been effectively supervised by the government. The above two reasons lead to obvious differences of dynamic performance of adjacent structures, adjacent buildings collide and the structure is damaged in the earthquake. (Figure 11)

**Fig.11** Collision damage to adjacent structures

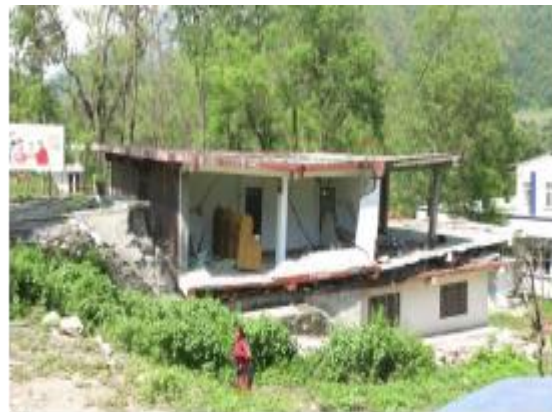
Parts of the self-built reinforced concrete structure were built along the road. Structure were close to the road subgrade or connected by rigid connection with the road subgrade. Because the dynamic performance of the structure and subgrade is different, the two collide with each other in the earthquake, resulting in serious structural damage and even collapse. (Figure 12).

**Fig.12** Collision damage between self-built reinforced concrete frame structure and highway roadbed
