Investigation on cause of the elevator turbine wear

J Zhang¹, W P Ouyang² and J A Xue²

¹ Fengxian District Special Equipment Inspection Institute of Shanghai Supervision, Shanghai, No. 89 Jianghai South Road, China

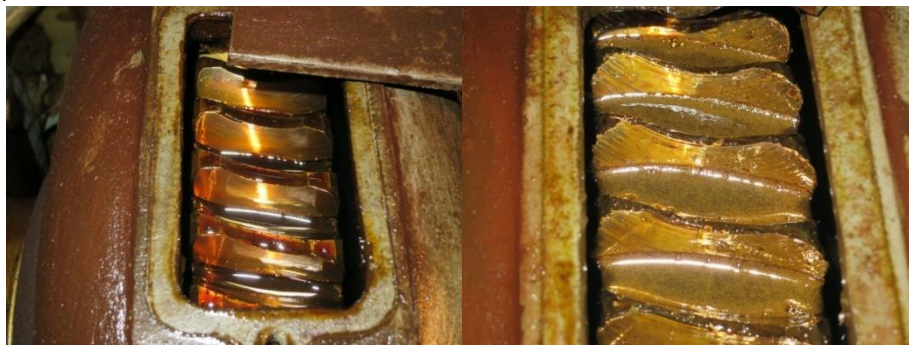
Figure 2. Worm wheel surface of two gear tractors

As shown in Figure 2, two worm wheels A and B come from two completely identical tractors, which have the same brand model and working environment. However, its contour and surface are still smooth, and there are no any signs of wear and pitting, and gear oil is also viscous. But B not only has a serious uneven surface, but also compared with the original thickness size has resulted in serious wear thinning. Even in the addendum, there have been defects, and worm shape is no longer smooth. At the same time, the gear oil produces foam and becomes muddy. So the problem of worm wheel B is very serious.

- The reason may be due to the tractor seal aging, gear oil leakage, resulting in the gearbox oil level drops, the two conjugate tooth profiles surface without oil film protection under high strength condition, and then the temperature rises rapidly. So this series of processes cause severe wear on the surface of the worm wheel.

- The gear oil may be mixed with hard impurities, such as sand, metal chips, etc. When the worm and gear is running, these impurities are formed by cutting and scraping the two conjugate tooth surface, which wear the tooth surfaces. If iron scraps produced by wear could not be cleaned up in time, the gear oil and impurities in the gearbox are not changed. The impurities will be accumulated more and more. So this series of processes cause severe wear on the surface of the worm wheel.

- In order to reduce cost, the gear oil added by the maintenance unit does not match the worm gear, or the new gear oil is not replaced for a long time. For this case, the viscosity of the original gear oil has dropped down, and it may have been deteriorated after mixing air and moisture, so the worm and gear could not be effectively lubricated and cooled. This process causes severe wear on the surface of the worm wheel.

- When the elevator is regularly maintained, especially when replacing gear oil, pay attention to ascertain whether there is pitting or abrasion on the surface of the worm wheel. Open the oil tank covers, and check the whole worm surface carefully through maintenance operation;
- According to the elevator's usual environment, use condition, use frequency, maintenance unit needs to replace the suitable gear oil regularly. In addition, by checking the existence of impurities or ablation in the old oil, we can judge the operation and wear of the gearbox;

- During the regular maintenance, maintenance staffs can touch the tractor shell to determine whether there are phenomena of oil temperature rising, trembling vibration, decreasing efficiency and noise increasing when the gearbox is running, so as to judge whether the worm gear meshing is normal;
- When the wear is serious, we can judge whether the tractor runs normally by riding the car to feel its running stability;
- Elevator inspectors should give attention to the wear of worm gear, the quality of gear oil and oil level. If necessary, we can also measure the circumferential backlash of the worm wheel;

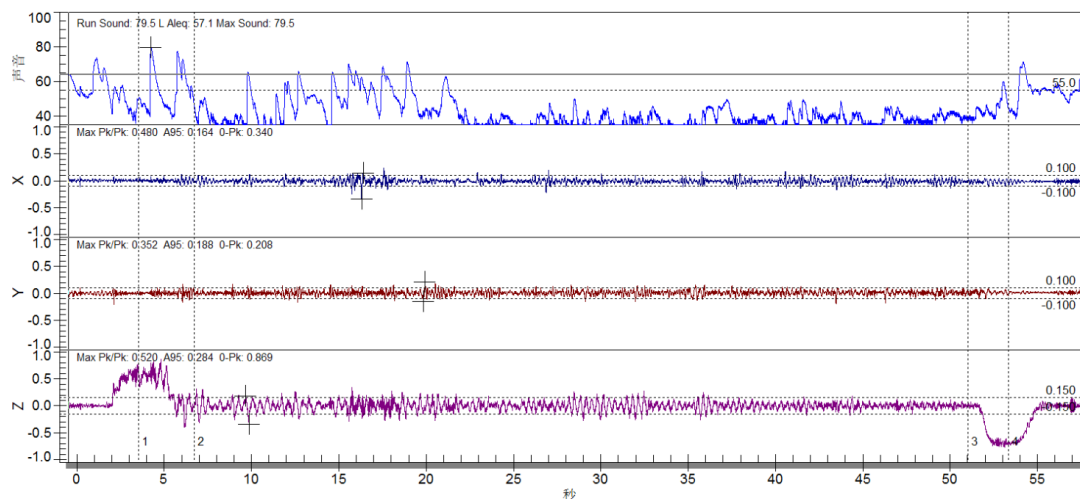
Figure 3. Noise and vibration waveform

The two charts as shown in Figure 3 and Table 1 are the vibration data measured during the operation of the elevator. It could be seen that the car of the elevator not only exceeds the standard in horizontal and vertical directions, but also has a great noise when the elevator is running based on the Figure 3 and Table 1. It has a great relationship with the wear of the worm wheel. Worm transmission will have sliding friction. The serious wear will result in reduction of contact precision and reverse hysteresis error. If the worm will be still run, the worm tooth surface will be aggravated, the vibration of the car will increase, and the comfort of the car will be reduced. In addition, if the elevator runs in reverse, the tooth thickness will decrease and the worm pair's backlash will increase, which will increase the reverse hysteresis error of the elevator. The whole process will lead to a sudden drop or rise when the elevator starts. If the elevator is utilized under heavy load, it may cause gear teeth to break and the transmission system to fail. The arrester acts on the output side of the motor and it is placed on the same side of the worm. If the car stalls down or rises, it will trigger the speed limit switch and cut off the power supply of the motor and arrester. However, even if the arrester is operated, there is no way to stop the stalled car. If the speed limiter can't operate effectively, then the elevator will become very dangerous and cause grave consequences.

Analysis	Measured	Limit	% Limit
Max horizontal Vib .ISO (m/s^2)	0.208	0.200	104.07
Max Vertical Vib .ISO (m/s^3)	0.448	0.300	149.43
Max Jerk (m/s^3)	1.2	2.5	47.8
Max Velocity (m/s)	1.74	1.60	108.9
Max Acceleration (m/s^2)	0.773	1.500	51.501
Max Sound Level dB(A)	79.5	55.0	+24.5 dB
