A study on a instability slope in Taiwan subjected to rainfalls

D H Hsiao^{1*}, C S Hsieh¹, L C Yeh¹, D Y Lin¹ and V T-A Phan²

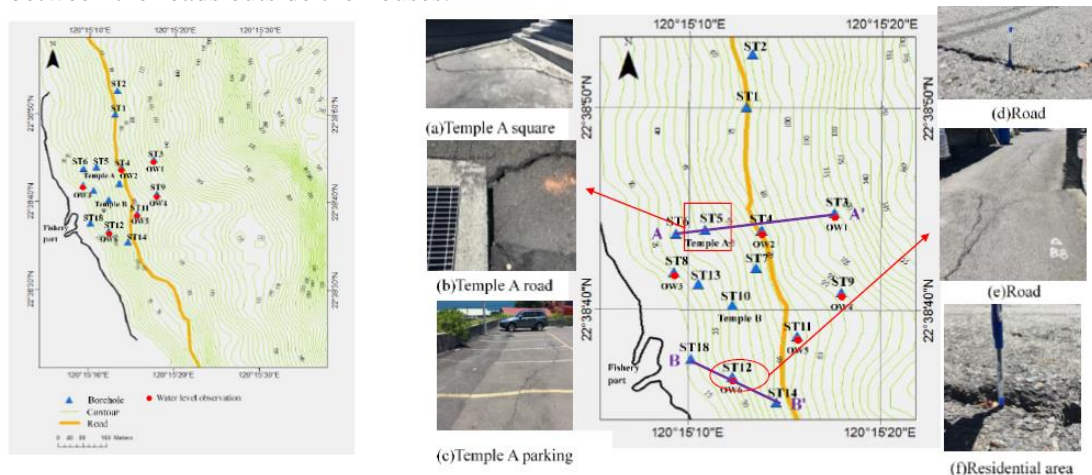
Figure 3. Topographic map (left) and field investigation (right) in site survey

Figure 3 shows the topographic map of Chaishan in Kaohsiung. The overall topography shows an east-west slope with a slope of about 20-35%. However the west side of the road seems slightly steep, possibly 40-50%, there are two temples in this area, Temple A (Shan Hai Temple) is a center for local people's beliefs, and many houses gather around these two temples. Figure 3 also shows the relevant on-site buried monitoring instruments, including drilling holes, inclinometers, piezometer, GPS stations, automatic rainfall equipment and the others, but only the inclinometers and piezometer positions are shown in the figure. A total of 21 monitoring systems, including 15 inclinometers, 6 piezometers, 15 GPS measuring stations and one automatic rainfall gauge, were set up in the zone between 2005 and 2012. At the beginning there were 18 drilling holes drilled in June 9th, after that onwards to begin monitoring. Figure 3 shows also a field investigation in site survey in the area, showing the elevation of the two sections and the Chaishan Road. The monitoring results over the long-term period (2005-2012) show that the stratigraphic slip in the area is mostly concentrated on the west side of Chaishan Road, and the displacement during the rainfall shows a significant increase. The on-site survey shows that there are obvious displacement for roads and houses in this area with obvious clearly cracks. It can be seen from the figure that there are obvious cracks and differences in height between the roads outside the houses.

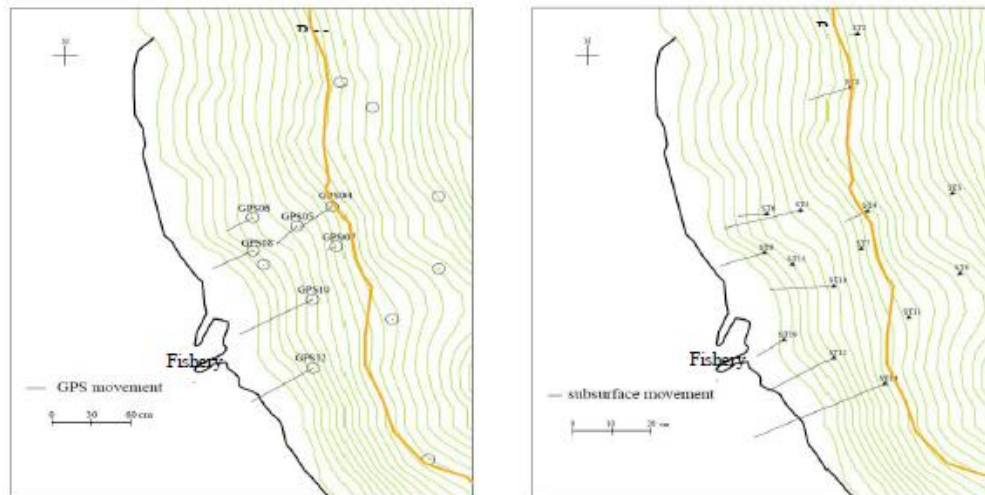
Figure 4. GPS and inclinometer displacement diagram

Figure 4 shows the GPS and inclinometer surface displacement map between 2005 and 2012, although there are differences between the two plans but the overall road to the west side having a larger amount of displacement, as the GPS measurement is larger because there is no inclinometer

embedding resistance. The annual displacement to the Taiwan Strait in Chaishan ranges from 7 to 8 cm. In the monitoring results, great displacement was found around Temple A. Based on the monitoring data, the inclinometer number near Chaishan Fishing Port was identified as ST18, in which the thick mudstone layer is underlain, there seems to be a little bulging due to the swelling behavior of mudstone. In comparison with elevation contour diagram in figure 5, we may see clearly the actual conditions on the scene from the figure.

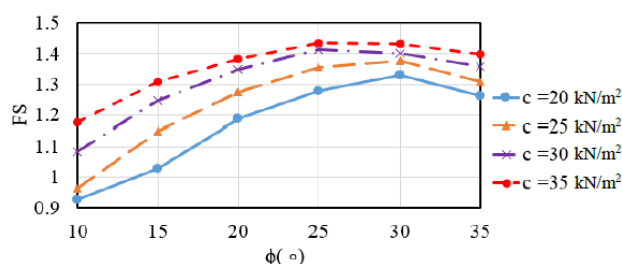
Figure 10. Changes of the safety factor owing to c and

According to the cross section A-A', it is found that the section is thicker and forms like a bowl-shaped structure in the rear of Temple A, and is connected with silty layers and silty clay layers. The sliding surface of the area can be mainly located at the interface between the collapsible soil and the silty clay layer. Therefore, using the SLOPE/W analysis, the c values of the collapsed soil layer A-A' are defined as 20-35 kN/m² and then ϕ angles are 10°-45°, the variation of the safety factor is calculated. Figure 10 shows the safety factor for slope with different values of c and ϕ for the clayey soil. The table shows that when $c = 20$ kN/m² and $\phi = 10^\circ$, the FS = 0.93 and the ϕ angle continuously increases FS = 1.32 at $\phi = 30^\circ$. Although the soil cohesion increases but the angle ϕ remains constant, the slope is still unable to resist. It can be clearly seen from the figure that when c and ϕ increase, the safety factor of the slope tends to increase. However, when $c = 30$ kN/m² and $\phi = 30^\circ$, there is a decrease of FS = 1.4 of the slope after calculation due to the phenomenon that the safety factor is decreased due to the transformation of the failure surface of the slope, which can be seen from the figure 11, the failure surface of the slope changes from arc-shaped dotted line to solid line. The reason for the decline is that the failure surface is transferred from the soil layer to the silty clay layer, as shown in figure, however, ϕ angle of the silty clay layer is smaller, so the worse after sectioning.

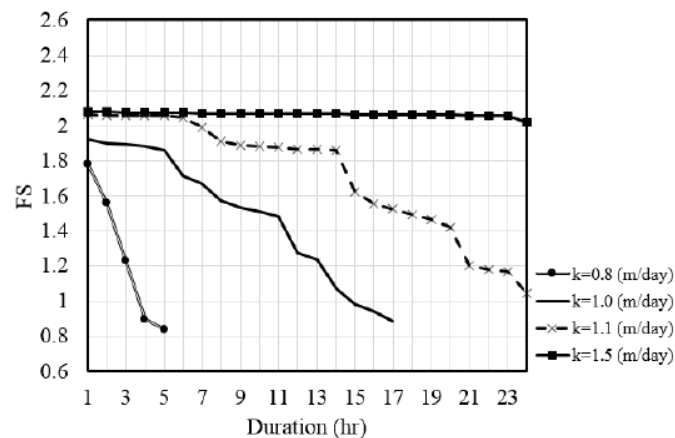
Figure 12. Different values of k impact on the safety factor for B-B 'cross-section

better water permeability in this area, by replacing the collapsed soil layer with limestone. The permeability coefficient of the soil layer is discussed to affect the change of the slope safety factor when the rainfall comes. The permeability coefficient is first set from 0.8m/day to 1.5m/day. Figure 12 shows that the coefficient of permeability of collapsible soil layer is $k = 0.8\text{m/day}$, the $FS = 1.78$, however, when the rainfall persists and the rainfall continues for 4 hours, FS of the section will decrease to 0.89 and then breaks down. It can be clearly seen from the figure that on the contrary when the k value of the collapsed soil layer is larger, the rainfall has little effect on the safety factor of the slope because the surface soil rainwater can be quickly removed and the dangerous hazard to the slope is relatively low.

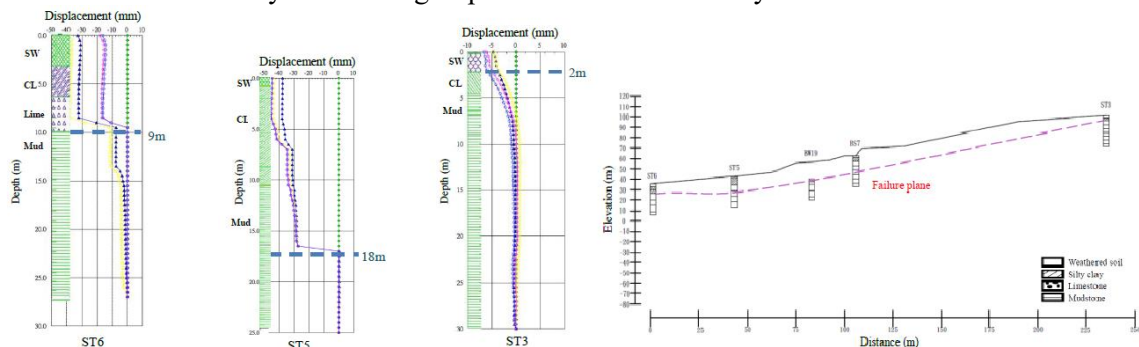
Figure 13. the inclined tube displacement and sliding surface position in A-A 'cross-sectional

Firstly, this study sorted out the monitoring data of each inclinometer over the years and extracted some data to provide the range of failure surface to explore the influence on the safety factor. Figure 13 is a displacement map using the inclinometer ST6, ST5 and ST3 for the section A-A'. Monitoring data show the location of the destruction of the surface, roughly draw a group of slope slip surface, and then use SLOPE/ W analysis of each group of sections of the safety factor.

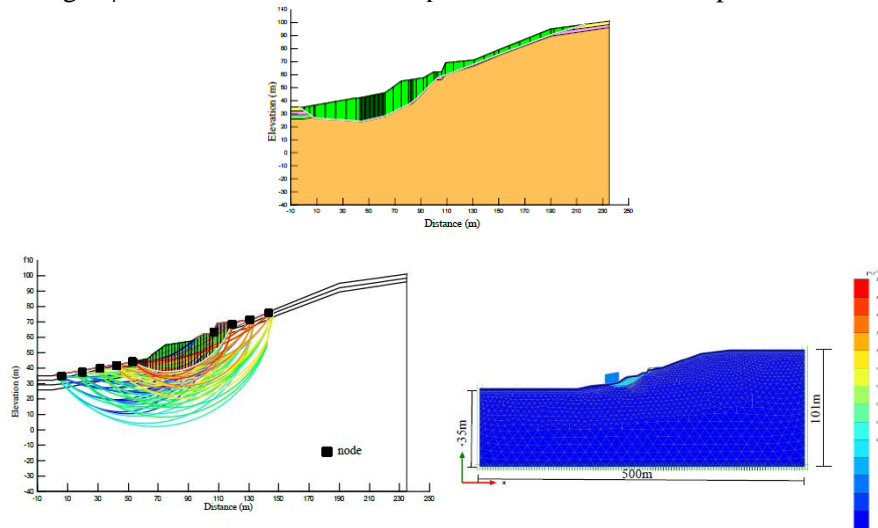
Figure 14. (a) completely designates, (b) designated A-A' section out of the entrance damage, and (c) PLAXIS for the failure plane A-A'

The results of the analysis are shown in figure 14, in which figure 14(a) shows the safety factor for the fully specified failure surface of section A-A', where the green border is the slope sliding surface area. However, the factor of safety will overestimate the overall stability of the slope due to the fact that the slope may first be destroyed elsewhere. Therefore, in figure 14(b), the setting of the entry and exit of the failure surface, to find out the safety factor of the slope in the critical state. In the figure, the green arc-shaped checkered area is the area of failure surface of the section. Both of the above two methods belong to the boundary of the failure surface, Therefore, in figure 14(c), PLAXIS software is used to evaluate the overall slope reduction factor, and the safety factors of the three conditions are

summarized in Table 4. The results show that using different methods to calculate the safety factor of slope varies greatly, among which, the failure surface $FS = 1.94$ is completely specified. Since this failure surface is a sliding surface drawn according to the failure section of each inclinometer, when SLOPE/W is calculating the safety factor sliding will only be made using this sliding surface, so the result may be significantly higher than the other two. $FS = 1.07$ shows the process of calculating the damage surface. The software calculates the node on the entrance and exit repeatedly and calculates the critical damage of the slope, however PLAXIS considers the overall displacement of section A-A' and reduces the angle ϕ until the failure of the slope, which results in a slope FS of 1.06.

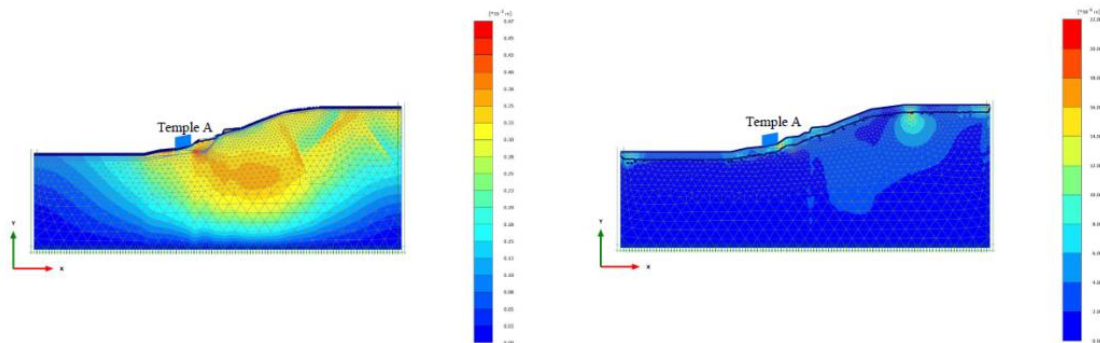
Figure 15. The displacement chart of the slope when groundwater level -2m and -10m

mudstone in the section discussed is about 10 meters below the surface. Therefore, the groundwater is also located at a depth of 10 meters below the earth's surface. The result of figure 14 shows that the main displacement area is around Temple A. The simulation results show that the groundwater is located 2 meters below the surface. This may be due to the fact that the influence area reaches to 15-meter-thick silty clay layer, probably because its own drainage is not easy and existence of poor permeability of mudstone underlain below, resulting in rainwater infiltration in this area. As for 10 meters below the ground surface of figure 15, we can observe that the displacement of this area is small. The overall finding is that displacement at -2m is much larger than those at -10m.

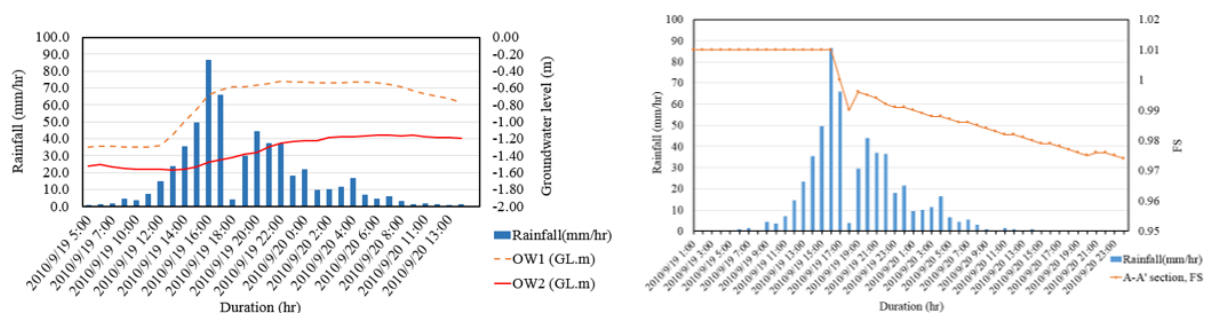
Figure 16. Variation of groundwater level during Vanaipi typhoon

In order to investigate the relationship between the main causes of slope-slip and the rainfall in Chaishan, this study uses the rainfall readings measured during the Fanabi typhoon in 2010. Through the analysis of the stability of slope A-A' in Chaishan by PLAXIS and SLOPE/W software, and plot the relationship between time duration and the rainfall during the typhoon period in figure 16 and the groundwater level variation by the piezometer OW1 and OW2 adjacent to the A-A' section. The figure shows OW1 groundwater level gauge change trend is obvious, because the region geological collapse of the soil layer is relatively thin, and then take about 1.5-3m thick silty clay, so the rain can't be quickly excluded, and in this formation of temporary habitat groundwater; OW2 underground water level meter in the rear of the Temple A, the collapse of soil in this area about 19m thick, so the upward trend of groundwater level is less obvious. Further use of SLOPE/W analysis, where the A-A' section safety factor changes during typhoon, the results are shown in figure 17. In this figure, it is seen that the safety factor gradually decreases along the A-A' section during the typhoon Fanapi than during the typhoon. However, at 4:00 pm on September 19, local time, Than the highest rainfall intensity in the typhoon, the rainfall intensity as high as 86.5 mm/hr, it is clear from the figure that the section of the safety factor at this moment also significantly decreased phenomenon. Yang et al. [3] mentioned that the increase of cumulative rainfall led to a decrease of the safety factor, which may be related to that the p'-q' graph is close to K_f -line.
