Study on Breakage Cause of Copper Pipe

Bin Li¹, Song Guo¹, Wei Li¹, De-man Zhang¹, Bo Wang¹

¹Wuhan Second Ship Design and Research Institute, Wuhan, China

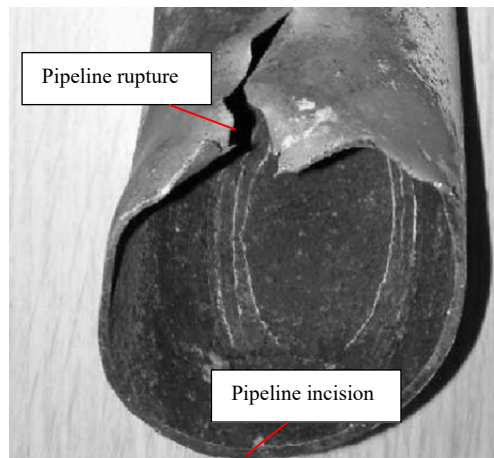
Fig 1 Diagrammatic of leakage pipeline

One of the ships had just sailed when a serious corrosion occurred in the pipeline of its seawater system, resulting in leakage of the pipeline. The leakage pipeline is shown in Fig 1, and the pipeline structure is shown in Fig 2.

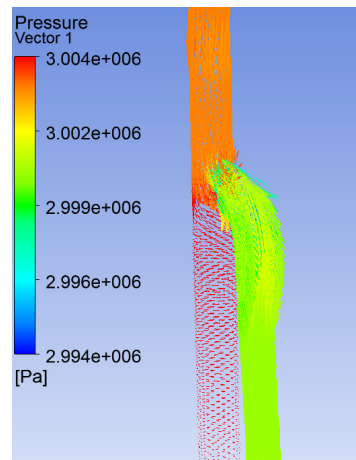
Fig 4 Diagrammatic of pipeline pressure vector

The rated different pressure 3MPa was given between the two sides of the pipeline. The trends of pressure are almost consistent in the elbow area. It is shown that the pressure concentration of the pipeline is mainly on the in-charge road, and there is no obvious stress concentration on the inside of the bend. As seen in Fig 4.

Considering that there is not much difference in pressure in different places, the pressure in the pipeline is even, there is no obvious stress concentration at the bend. Therefore, stress is not the cause of pipeline damage.

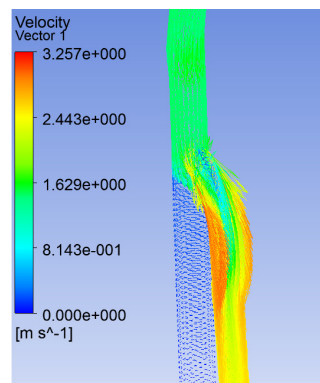
Fig 5 Diagrammatic of pipeline velocity vector

Fig 5 shows the flow velocity cloud diagram of the pipe. The maximum velocity of flow in the pipe is concentrated on the inside of the bend, and the maximum velocity is 3.257m/s. The velocity distribution of pipeline is very different.

Considering that the flow rate is too high to cause erosion and corrosion of the pipe, the local velocity concentration of the bent may probably lead to the breakage of the pipe.

In the design of pipes, the diameter and bending radius of the pipe should be increased as much as possible, the concentration of velocity at the bend should be reduced as much as possible, and the erosion corrosion should be alleviated.

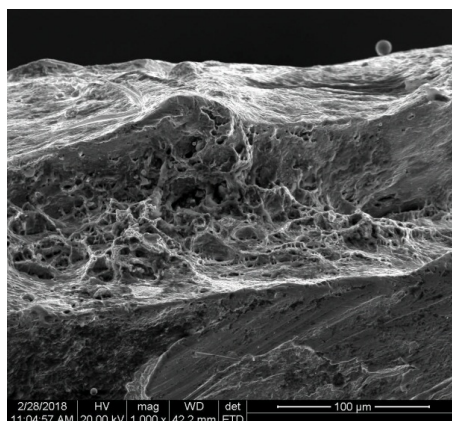
Fig 6 Diagrammatic of pipeline fracture topography

The pipeline fracture was analyzed by scanning electron microscope (SEM). The SEM analysis showed that some of the fractures surfaced were badly worn, and some of the fractures were simple characteristics. The energy spectrum of the region is shown in Fig 6, which mainly contains C, O and Cu, and it also contains corrosive elements such as S and Cl.

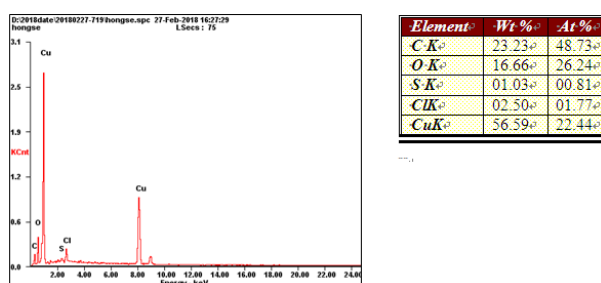
Fig 7 Diagrammatic of pipeline fracture energy spectrum

Fig 7 shows the diagrammatic of pipeline fracture energy spectrum. The chemical composition analysis results are shown in table 2. The chemical composition of pipeline fracture meets the standard requirements. Therefore, the damage of pipeline is not caused by uneven material composition.

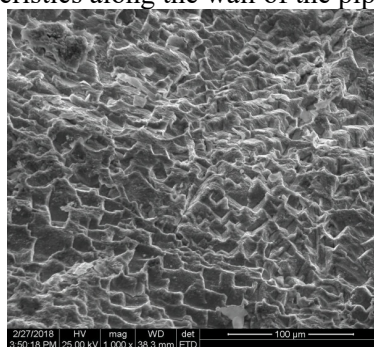
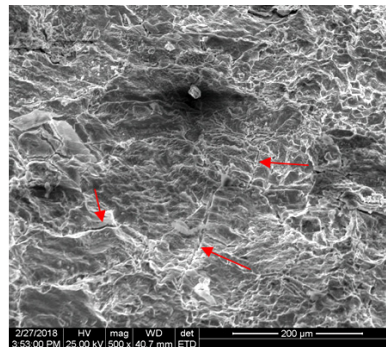
Fig 8 Pipeline inner wall topography

The pipe wall at the undamaged place was analyzed by scanning electron microscope, as shown in Fig 8. Fig 8 a) shows that the obvious corrosion pit characteristics on the surface of the pipe, and Fig 8 b) shows that the corrosion characteristics along the wall of the pipe along the crystal.

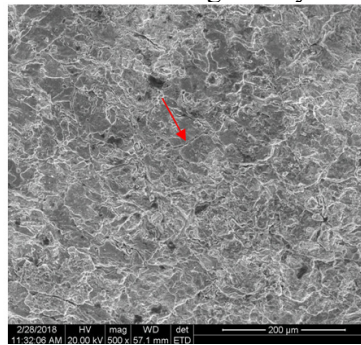
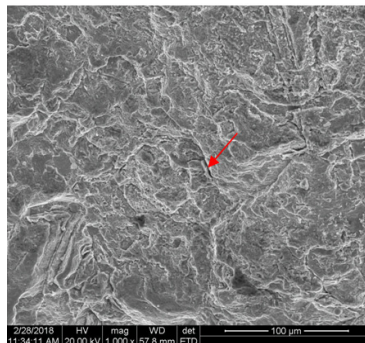
Fig 9 Enlarged profile of pipeline inner wall

When the inner wall is enlarged, as shown in Fig 9, the obvious corrosion crack characteristics along the crystal can be seen, and there is also corrosion on the surface of the grain. Even if the normal inner wall appearance, there is obvious corrosion along the crystal.

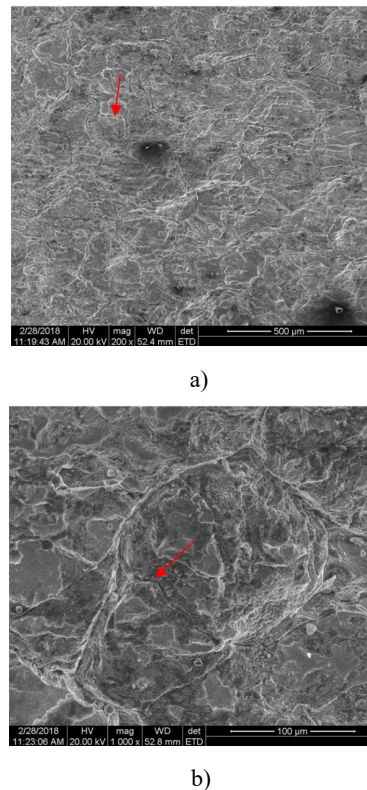
Fig 10 Enlarged profile of pipeline inner wall

As shown in Fig 10, the characteristics of parallel stripes and corrosion pits can be observed by observing the inner wall of the pipe wall of the damaged part. Pipeline corrosion is probably the cause of pipeline damage.

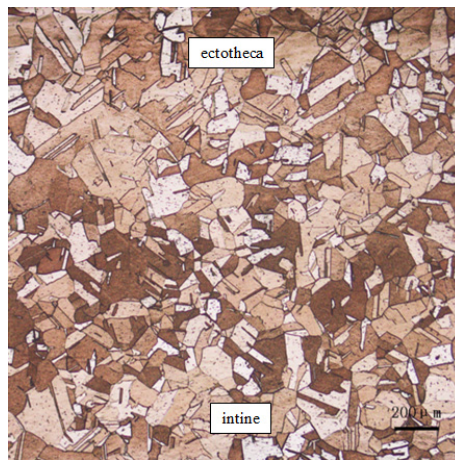
Fig 11 Thick wall tissue(50×)

The microstructure of the region larger than the thickness of 2mm is twinning α , the outer wall is straight and the inner wall is uneven, has corrosion characteristics. As shown in Fig 11. The microstructure of the thinned area is twinning α , the outer wall is also straight and the inner wall is uneven, has corrosion characteristics. As shown in Fig 12. The thickness of the wall near the fracture surface is the most obvious. The microstructure structure is twinning α . The grain is coarse and the outer wall is straight, has corrosion characteristics. As shown in Fig 13. The deformation at the fracture surface is obvious, the grain is elongated and there is a slip line.

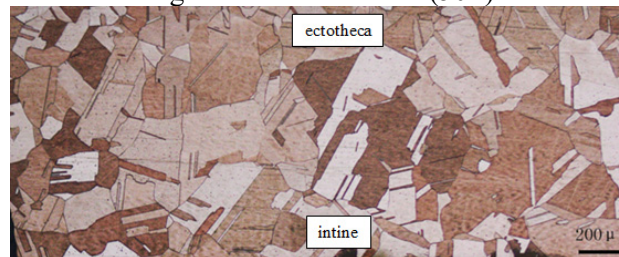
Fig 12 Thinning regional wall tissue(50×)

There is no obvious abnormality in the ectotheca section. The inner wall is thinned. The thinnest part of the fissure is about 0.5mm. The rupture is characterized by deformation. The microstructure is dimpled. Therefore, the failure of pipe section belongs to the plastic fracture caused by wall thickness thinning.

The pipe is supplied with seawater, and the inner wall of the pipe contains corrosive elements such as S and Cl. The characteristics between the normal inner wall appearance and the appearance of the inner wall of the damaged part are basically the same. Both the intergranular corrosion characteristics are obvious and the inner grain is also corroded. So the thinning is caused by corrosion, and the thinning is most obvious at the rupture.
