# Study on typical failure of concrete poles in large scale rural network reconstruction

Yi Xie <sup>a</sup>, Chao Feng, Jun Wang, Yi Long, Kejian Ouyang, Dengke Li and Wei Chen

State Grid Hunan Electric Power Company Limited Research Institute, Changsha 410007, China

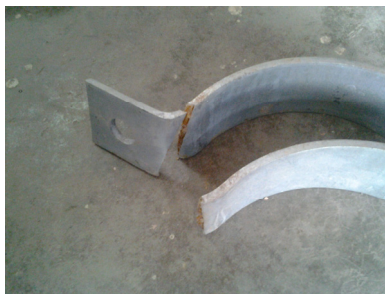
Some non-standard auxiliary electric power fittings once failed during upgrading process of rural power grid, which is shown in Figure 1.

Figure 1. Scene photograph of cracked hoop.

b) More attention should be paid to the quality supervision of auxiliary electric power fittings. Overall service stability are closely associated with hoop and bracing wire of concrete pole.

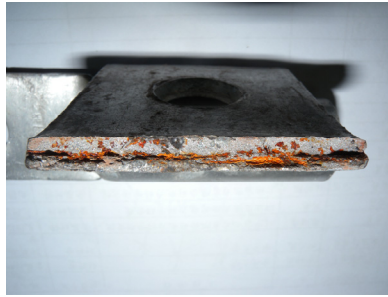
The hoop was composed of Q235B steel. The cracked position was located on elbow near the bolt hole. The fracture morphology was displayed in Figure 2. As it is shown that the fracture exhibited a smooth flat with stratification existing in the core. Only center line and its vicinity were corroded which is easily visible.

Figure 2. Fracture appearance of hoop.

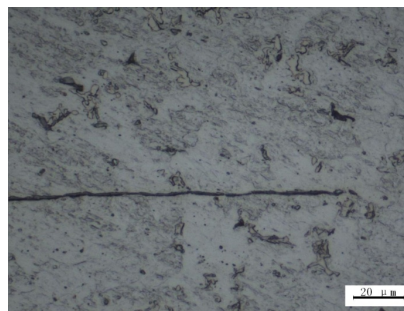
The metallographic observation result indicated that the matrix structure of hoop were composed of ferrite, pearlite and bulky ribbon inclusions. The metallograph was shown in Figure 3.

Figure 3. Metallographic structure of hoop.

The ribbon silicate compounds not only destroyed the continuity of Q235B steel matrix, but also led to mechanical performance deterioration especially plasticity, tenacity and fatigue limit. During the manufacturing process of hoop, the microstructure of lateral corner were elongation deformed along the direction of cold bending after the cold bending treatment. Meantime, the microstructure of inside corner endured extrusion deformation resulting in the work hardening to some extent. On this condition, the steel plate were in the state of mechanical property deterioration of reverse bending. The hoop cracked during field bending test. Normally the hoop was tightened by bolts during installation process leading to the state of reverse bended. Hence, in the presence of inhomogeneous microstructures and silicate inclusions, the hoop would crack in the course of service.

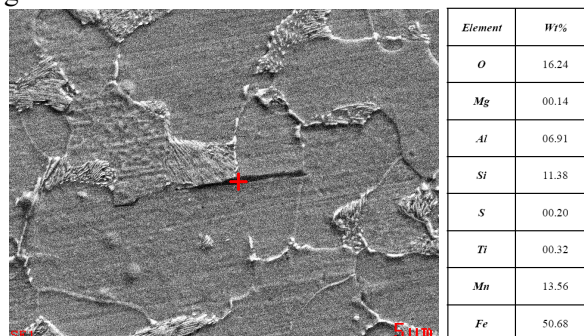
The composition of inclusion was further analyzed by FE-SEM and energy dispersive spectrum (EDS) as was shown in Figure 4. It turned out the ribbon inclusions were mainly silicate compounds.

Figure 4. FE-SEM picture and EDS result of inclusion.

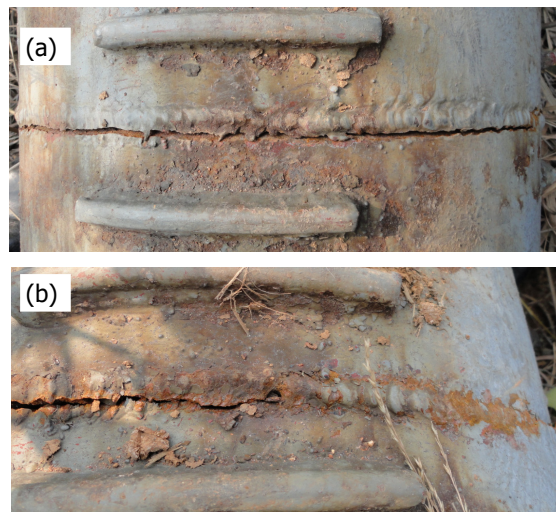
Once cracks occurred on the steel ring of concrete poles for 35 kV transmission line in 2011. The steel weld of Concrete Pole No. 23 completely disconnected from each other. However, the cracks extended covering half of the steel weld of Concrete Pole No. 25. Further inspection indicated that the width of weld crack was 3 mm which coexisting with flaws on the weld surface, such as incompletely filled weld, overlap and undercut. As is displayed in Fig.5.

Figure 5. (a) Low magnification macrophotographie of weld crack, (b) High magnification macrophotograph e of weld crack.

According to the GB50233-2005 standard, the width of concrete pole steel weld should be 13.1 to 15.1 mm regarding to dimensional requirement of weld bead. Further surface and dimension inspection indicated that both the two weld with of Concrete Pole No. 23 and Concrete Pole No. 25 were less than 12.75 mm which does not meet the standard requirements.

c) Quality supervision of infrastructure construction is also of great importance. Installation quality problem could be avoid by strengthening the management of site welding.

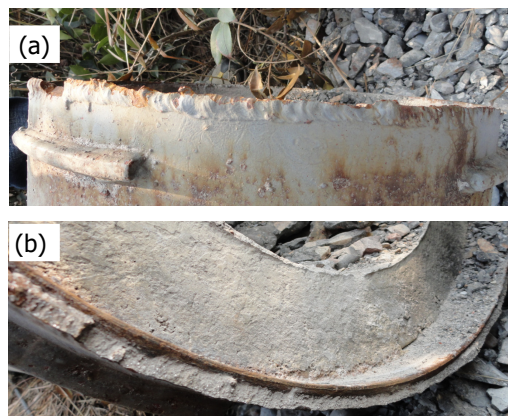
In the view of weld fracture, root edge of V-groove which occupying one half of the whole welding possessed flat truncated edge. The upper weld was comparatively thin, as is shown in Figure 6. The obvious incomplete root penetration was directly caused by improper procedure during welding process.

Figure 6. (a) Side view of upper weld crack, (b) Top view of upper weld crack.
