Study on typical failure of metal parts in circuit breaker

Abstract. On the base of accident investigation of metal parts failure in circuit breaker in recent years, reasons of material defects in metal parts, i.e. material composition, mechanical properties, microstructure and inclusion defects, were summarized in this paper. In the end, the corresponding control measures were proposed.

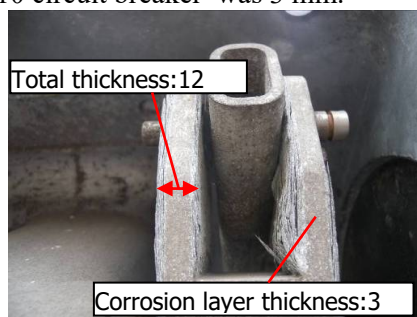
ends of connecting lever was 12 mm. However, the corrosion layer thickness of No.508 circuit breaker already reached 4 mm which is one-third of the total thickness. Meanwhile randomly distributed corrosion pittings were also observed on the cover plate of connecting lever. In addition, the corrosion layer thickness of the other No.510 circuit breaker was 3 mm.

Figure 1. Macroscopic picture of No.508 connecting lever.

a) The reason of connecting lever peeling corrosion could be attributed to the unqualified heat treatment aging. The cracked connecting lever should be replaced by new one after anodic oxidation treatment. The thickness of oxide film should be no less than 15 μm .

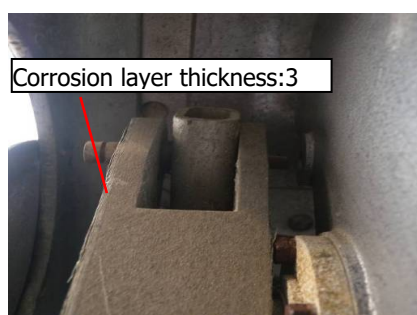
Figure 2. Macroscopic picture of No.510 connecting lever.

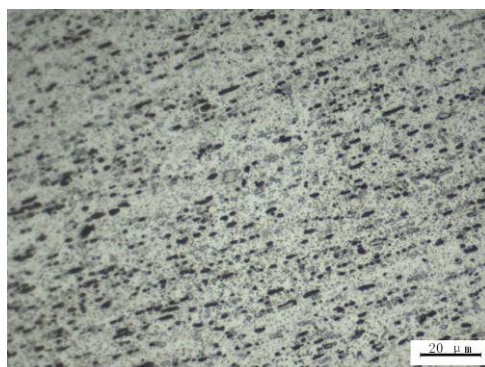
The microstructure analysis of connecting lever indicated that the matrix was after machining process which with bulky second phase scattering around. It is displayed in the Figure 3. Under normal circumstances, the delivery conditions for the surface condition of 7A04 aluminum alloy is heat-treated. However, the defective product has not been heat-treated or conducted well.

Figure 3. Microstructure picture of connecting lever

The 7A04 aluminum alloy used in circuit breaker was rolling formed. The grains stretched along the rolling direction during forming process which allowing the intercrystalline corrosion developed into peeling corrosion along the direction of rolling plane. The 7A04 aluminum alloy possessed native denudation sensitivity which was determined by its composition. In order to improve the antistrip performance, overaging and regression re-aging treatment were usually applied. Due to the strict requirements of these heat treatment process in terms of heat preservation temperature and holding time, manufacturers often obtained unqualified products which easily leading to exfoliation corrosion.

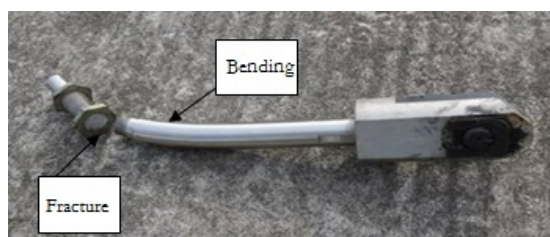
The vertical link bended near the thread joint and cracked right at the thread root. As is shown in Figure 1, on sign of oxidation corrosion was observed in the fracture.

Figure 4. Macrograph of cracked vertical link.

b) The rupture of vertical link was mainly caused by insufficiency of solid solution and inhomogeneity of structure. Solution treatment was indispensable for 1Cr18Ni9 stainless steel while used as main load bearing rotating components. Otherwise, the 1Cr17Ni2 stainless steel should be a better choice instead of 1Cr18Ni9 stainless steel.

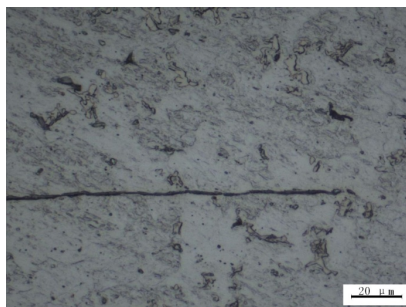
The metallographic observation result indicated that the matrix structure of hoop were composed of ferrite, pearlite and bulky ribbon inclusions. The metallograph was shown in Figure 5. Corresponding chemical composition analysis result indicated that the cracked vertical link meets the standard requirements of GB/T 1220-2007.

Figure 5. Metallographic structure of hoop.

The mechanical properties test illustrated that the tensile strength, yield strength and elongation was 592 MPa, 163 MPa and 48.7%, respectively. However, according to the standard requirement of GB/T 1220-2007, the yield strength of 1Cr18Ni9 stainless steel should be no less than 205 MPa. The sample was considered as an unqualified product.

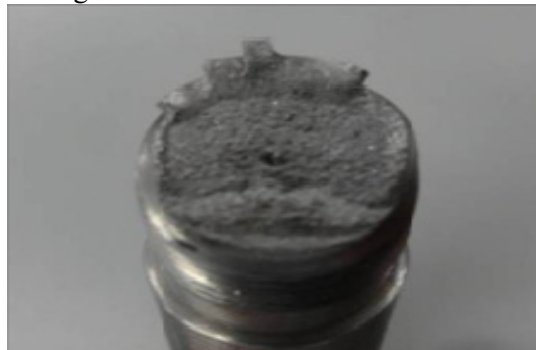
Fracture morphology analysis showed that the fracture comprised of three parts: semi-arc fatigue crack source, smooth crack propagation extent and ultimate fracture region, as is displayed in Figure 6. Distinct fatigue striations were also found in further FE-SEM analysis which also declaring the feature of fatigue-broken, as showed in Figure 7.

Figure 6. Macrograph of vertical link fracture.

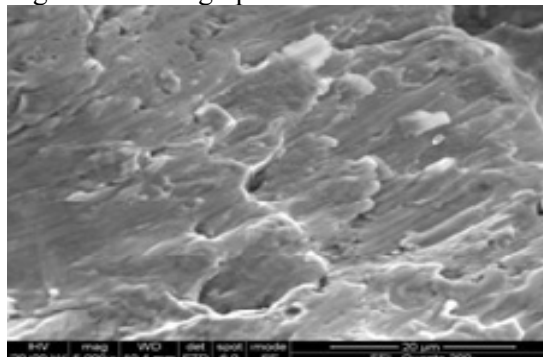
Figure 7. FE-SEM picture of fatigue striations.

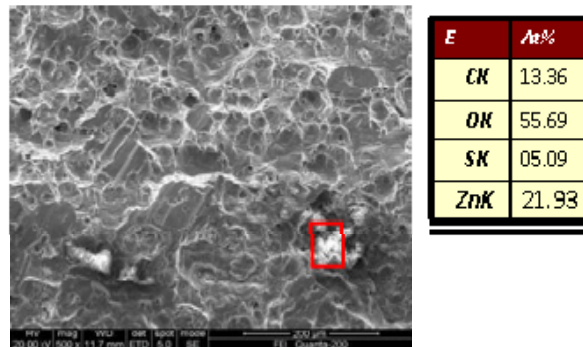
Electron dispersive spectrum (EDS) of fracture indicated that there were inclusions mainly containing Zn and O randomly scattered around which may be residual deoxidizer during smelting process of link. Corresponding data was displayed in Figure 7.

Figure 8. FE-SEM and EDS results of fracture.

The microstructure picture of cracked link was showed in Figure 7. There were many large second phase particles distributed on austenitic matrix. The EDS analysis results indicated that the second phase were mainly composed of Fe and Cr, as seen in Figure 8. The microstructure of link seemed quite abnormal that Cr was enriched in massive large second phase. In addition, the sample exhibited comparatively large magnetism which further verified the sample was not fully austenitized.

The manufacturer only examined the composition of 1Cr18Ni9 stainless steel leaving the microstructure analysis out. No solid solution was performed to most of the product unless there were special requirements. Hence, insufficiency of solid solution and inhomogeneity of structure rendering the 1Cr18Ni9 stainless steels were not suitable while used as main load bearing rotating components.
