Tree architecture models, canopy maintenance, and associated root problems of angsana (*Pterocarpus indicus* Willd.) in the urban trees of Yogyakarta

Abstract. Troll's architecture model of angsana (*Pterocarpus indicus* Willd.) serves as a shading tree in most of the main roads in Yogyakarta. However, its lateral roots potentially damage sidewalks and cause accidents to people. This research was aimed to understand the damage types associated with the root problem, the relationship between stem diameter and root development, and angsana maintenance. Data were collected during January-July 2015 by inventory, tree identification, and interview. We categorized the types of damage into three scales, respectively: scale 1. Cracks in pots if the trees grow in pots, slight cracks on the road surface; scale 2. Roots start to slightly appear on the road surface and cause cracks in the road or damage the pots; scale 3. Roots appear on the road surface and cause a bend that harms road users or pots raised by roots. There is a relation between the size of stem diameter and its damage. Angsana starts to cause damage with a diameter of 20–29 cm on the divider and 30–39 cm on the sidewalk. We s

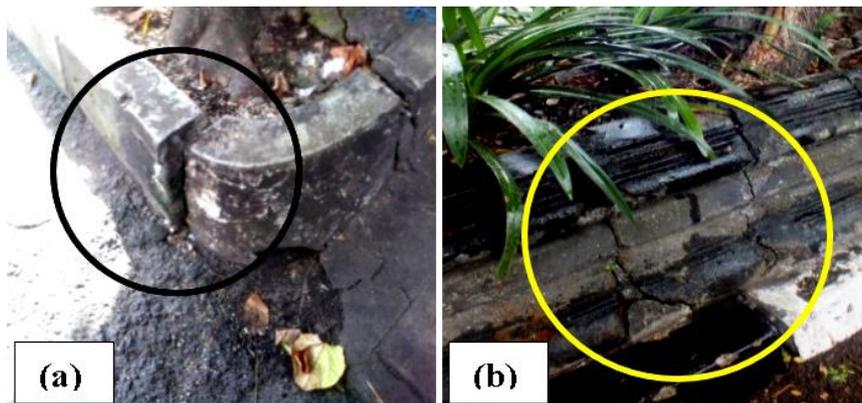
2.1.1. Score 1. Score 1 is reserved for trees growing in the pots that have roots causing cracks in pots (figure 3) or trees grow in the roadside that has roots causing slightly cracks on the road surface.

Figure 3. Damage score 1: roots cause cracks on pots (a) & (b) (image source: [23]).

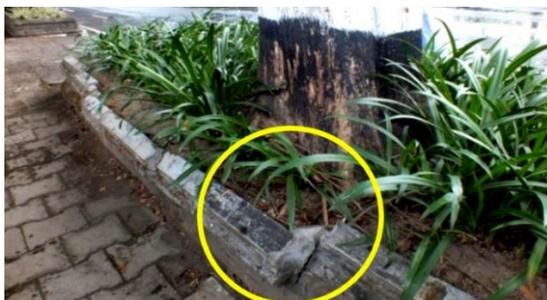
2.1.2. Score 2. Score 2 is reserved for trees with roots that start to slightly appear on the surface and damage the pots or roots slightly appear on the road surface (figure 4) and cause the road become cracks (figure 5).

Figure 4. Damage score 2: roots start to slightly appear on the surface and damage the pots (image source: [23]).

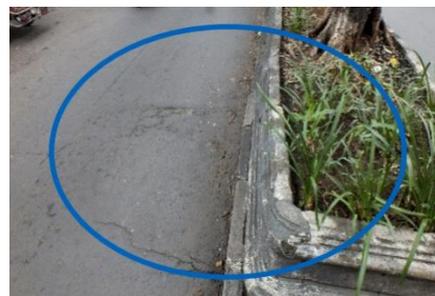
Figure 5. Damage score 2: Roots slightly appear on the surface of the road and cause cracks in the road (image source: [23]).

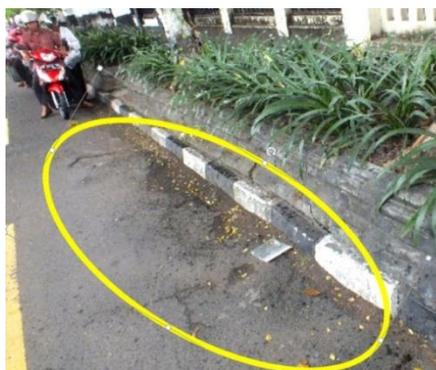
2.1.3. Score 3. Score 3 is reserved for trees that have roots that appear to the surface of the road and have the pots raised (figure 6) or cause a bend that can harm road users (figure 7).

Figure 6. Damage score 3: roots appear to the road surface and make the pots raised (image source: [23]).

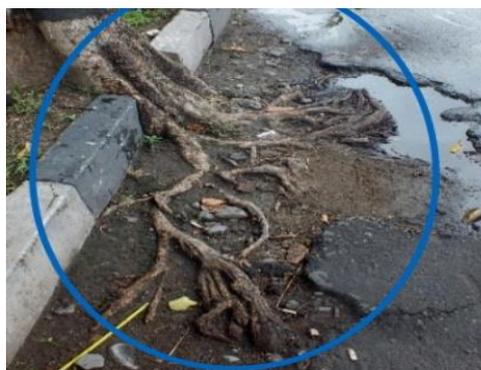
Figure 7. Damage score 3: roots appear to the road surface and cause a bend that can harm road users (image source: [23]).

The treatment of roots is different with canopy treatment. Root treatment activities are only done when it is needed. For instance, when angšana roots have emerged to the surface of the road and disrupt people who pass by. Residential and Regional Infrastructure Service will monitor this condition every two days. Furthermore, through monitoring activities, the damage impact caused by the angšana roots can be recognized through the reports of the surrounding communities. We acknowledge that not many activities are conducted specifically to prevent rooting to the surfacing and cause damage to the public facilities. Related agencies such as the Environment Agency and the Residential and Regional Infrastructure Service acknowledge that they used of concrete buis in the beginning of planting activities as an effort to minimize damage to the infrastructure in the future. Despite the soil that cover the trees with asphalt, concrete, or other materials, it might inhibit the supply of water and air to the roots. Supporting better site condition surrounds the trees will help them thrive in good condition.

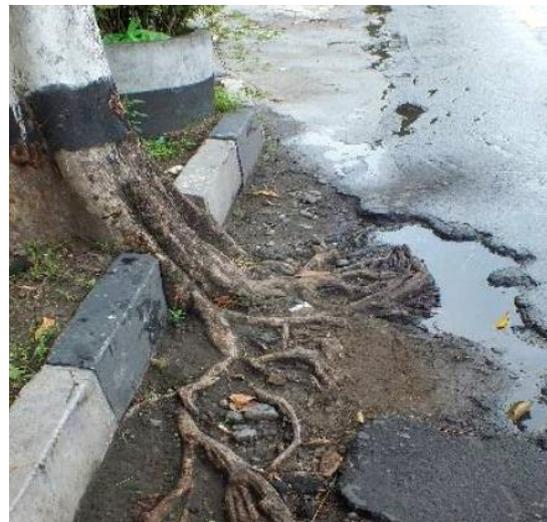
Figure 12. Damage characteristics of score 3 by the root of Angsana in Glagahsari street (image source: [23]).

We recorded 51 angana trees, but only 7 trees that caused damage at Glagahsari street. Figure 12 and figure 13 displays the extent of damage encountered on this road is score 2 and score 3. Six trees have a score of 2 with a diameter range of 30–39 cm. One tree has a score of 3, which has the highest level of damage. This tree is categorized in the diameter class of 40–49 cm.

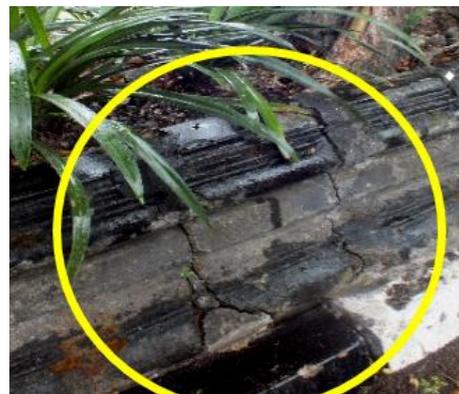
Figure 15. Damage characteristics of score 1 by angana roots in Glagahsari road (image source: [23]).

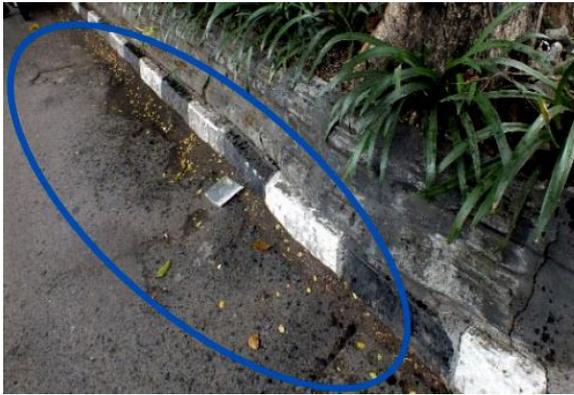
Figure 16. Damage characteristics of score 2 by angšana roots in Glagahsari road (image source: [23]).

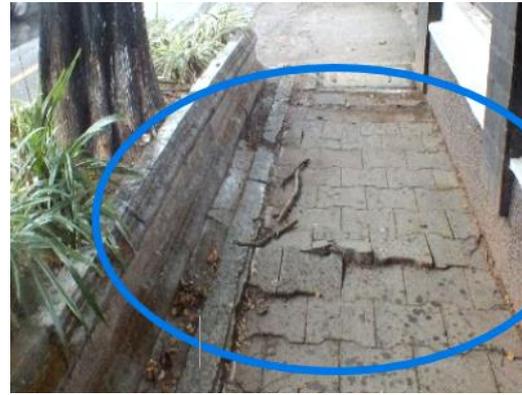
Figure 17. Damage characteristics of score 3 by angšana roots in Glagahsari road (image source: [23]).

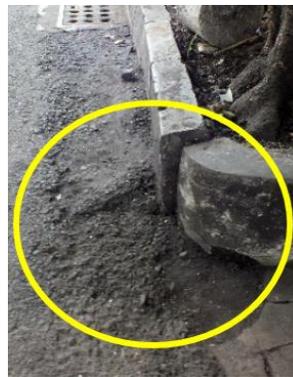
3.1.4. Laksda Adisucipto road. The Laksda Adisucipto road has a total length of 414 meters, width of 14 and a sidewalk of 2 meters on two sides of the road. We observed the distance of 53.31 meters (12,9%) and recorded 3 trees with damages characteristics of score 2 and score 3 (figure 18). Two trees, which are categorized in score 3, have the range diameter class of 50-59 cm and ≥ 60 cm, while the other one (score 2) has a diameter class of ≥ 60 cm. In Laksda Adisucipto street, the angšana root damaged the sidewalk (figure 19) and cracked the asphalt in the roadside (figure 20).

Figure 19. Damage characteristics of score 2 by angšana roots in Laksda Adisucipto street (image source: [23]).

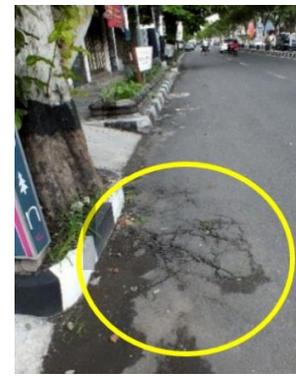
Figure 20. Damage characteristics of score 3 by angšana roots in Laksda Adisucipto road (image source: [23]).

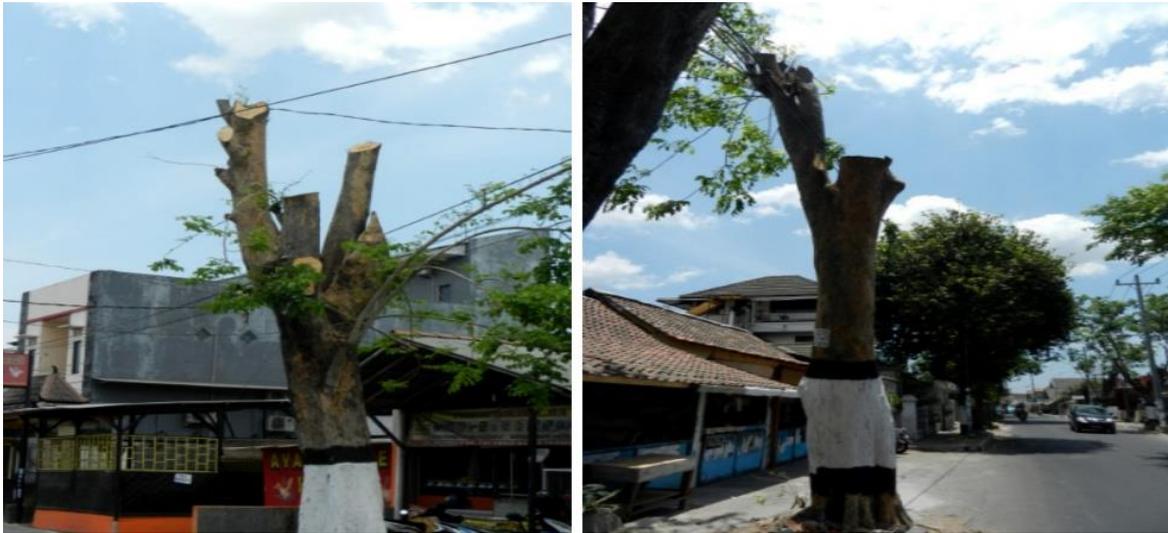
Figure 21. The cutting of the crown of angšana due to an electric wire problem (image source: [28]).
