The evaluation of damage mechanism of unreinforced masonry buildings after Van (2011) and Elazig (2010) Earthquakes

D Güney¹, E Aydın², B Öztürk³

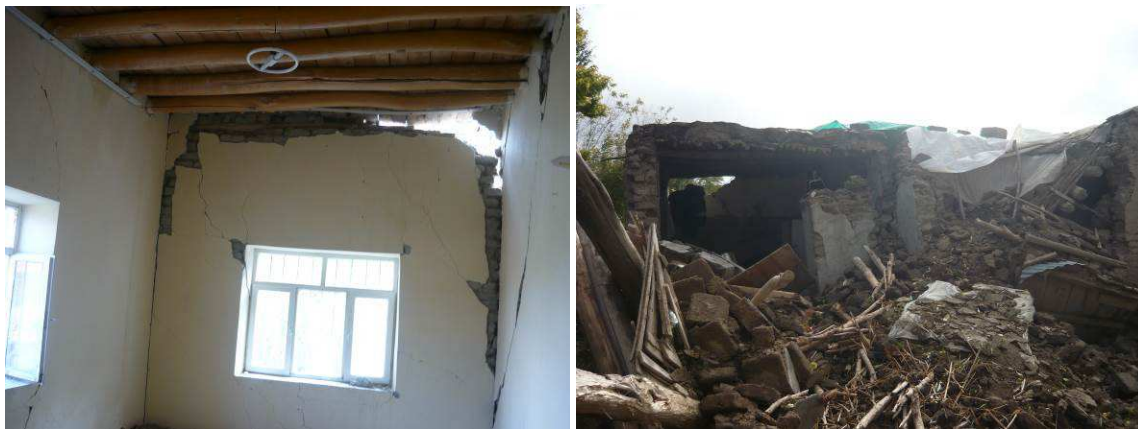
Many damaged buildings have flexible floor diaphragm, which prevents the transfer and distribution of lateral forces in a uniform manner as shown in Figure 14.

Figure 14. Flexible floor diaphragm
