# Optimization of the Composite Repair Work using 5H Satin Dry Glass Fabric and Epoxy Resin LY5052/HY5052 Materials through the Vacuum Bagging Technique

Hartono<sup>1)</sup>, Mochammad Rifai<sup>2)</sup> and Handoko Subawi<sup>3)</sup>

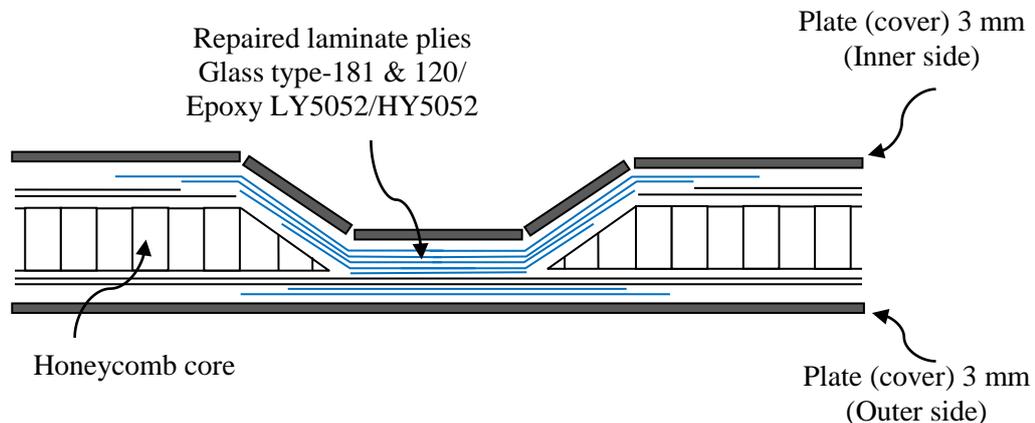
**Figure 2.** Cut section of sandwich panel after rework (no scale)

The sixth class failure modes mentioned above is not relevant to the current study. This work describes the modification of fairing skin to place additional stringer in the middle side along the fiber composite fairing panel. In this case, the core section was cut along the stringer location. Principally, the work changed the sandwich configuration to become laminate side in the middle of sandwich panel (Fig.2).

The new laminate was performed with the placement of dry fiberglass type-180 (2 plies laminate), type-120 (2 plies covering honeycomb), type-180 (2 plies laminate), type-120 (2 plies covering honeycomb), and nylon peel ply. After overnight curing in vacuum bag condition, the nylon ply was removed, apply mixed resin and Aerosil. Aerosil was evaluated as a compatible nanofiller to be combined with epoxy resin for touch up repair area of the airframe structure.<sup>10)</sup> The layup was continued up to 8 plies of dry fiberglass type-180, and cover with nylon peel ply. The layup then cured overnight. The next turn was lay up on the upper side of composite panel. First, set the stringer and preview set of hole as required. Then the upper side of skin was laid up by 2 plies of dry fiberglass type-180 and peel ply. Then allowing to cure naturally overnight.
