Mechanics and complications of reverse shoulder arthroplasty: morse taper failure analysis and prospective rectification

HLD Hoskin¹, E Furie^{1,3}, W Collins², TM Ganey¹ and DR Schlatterer¹

Abstract. Since Sir John Charnley began his monumental hip arthroplasty work in 1958, clinical researchers have been incrementally improving longevity and functionality of total joint systems, although implant failure occurs on occasion. The purpose of this study is to report the fracture of the humeral tray Morse taper of a reverse total shoulder system (RTSS), which to date has not been reported with metallurgic analysis for any RTSS. There was no reported antecedent fall, motor vehicle collision, or other traumatic event prior to implant fracture in this case. Analysis was performed on the retrieved failed implant by Scanning Electron Microscopy (SEM) and Electron Dispersion Spectroscopy (EDS) in an attempt to determine the failure method, as well as to offer improvements for future implants. At the time of revision surgery all explants were retained from the left shoulder of a 61-year old male who underwent a non-complicated RTSS 4 years prior. The explants, particularly the cracked humer

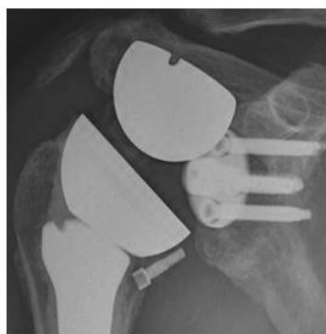
Fig. 1 Glenoid component disengagement reported with various designs of reverse total shoulders (Ref. 18).

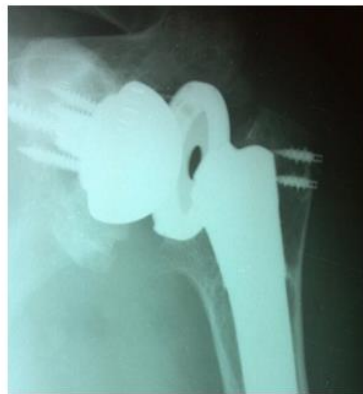
Author EF offers a similar case that prompted this review and eventually became the foundation for this case report. In part, he summarized, “A 61-year-old male was evaluated 4 years following a non-complicated left RTSS. The patient was doing well until the sudden onset of pain, “heaviness” and limited motion after light lifting, coming in approximately 3 weeks after the onset of symptoms. Physical exam revealed no obvious deformity. Motion was limited to 90 degrees flexion, 75 degrees abduction and 45 degrees external rotation passively with pain. No evident open wounds, swelling, ecchymosis or erythema. Radiographic evaluation revealed a separation of the humeral tray at the trunnion with retention of the reverse Morse taper humeral component within the stem. Despite aggressive efforts to remove the taper, it remained within the humeral stem.” EF also noted no antecedent trauma prior to the catastrophic RTSS failure. **Fig. 7** displays the radiograph of the separated humeral tray/taper component. Also pictured is the stem/taper and tray once removed from the patient; note how the edges of the fracture site are relatively smooth compared to those viewed in the former example (**Fig. 8**).

Fig. 7 (left)
Radiographic evaluation revealing failure of the humeral tray-Morse taper component.

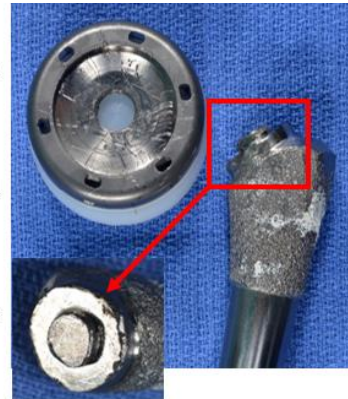
Fig. 8 (right) Humeral tray/polyethylene cup component and Morse taper retained within humeral stem. Note smooth edges of fracture site.

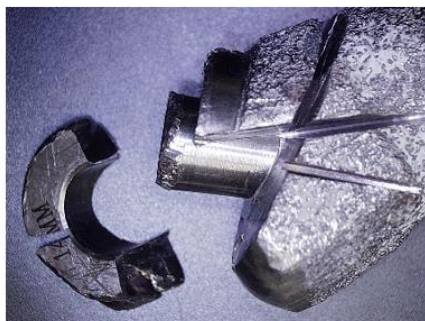
Analysis of the failed implant began with separation of the Morse taper from the humeral stem; the taper was so firmly inserted that the insertion site at the superior end of the stem had to be cut out with a Dremel handheld rotary tool (**Fig. 9**). During the procedure to fix the failed RTSS, surgeons aggressively attempted to remove the dissociated taper from the stem using pliers or a similar device. The removal attempts badly damaged the surface of the trunnion at the tray/taper connection, making taper analysis more difficult than that performed on the tray (**Fig. 10**).

Fig. 9 Result of the removal of the embedded taper using a rotary tool. Every effort was made to ensure no damage was inflicted on the taper during removal.

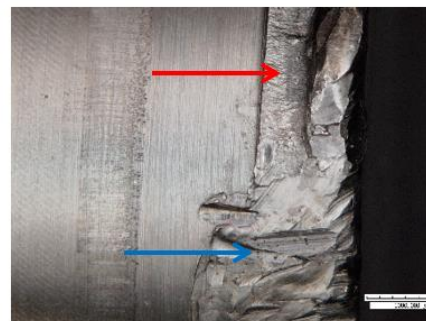
Fig. 10 HIROX imaging provided evidence of uncompromised areas on the taper. Here, the difference between uncompromised (red arrow) and compromised (blue arrow) areas is displayed.

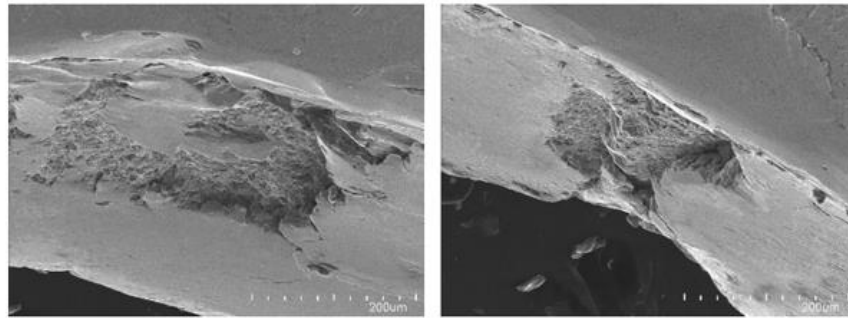
Figs. 11-12 SEM imaging of different areas of the inner rim of the humeral tray reveal similar fracture patterns in different locations.

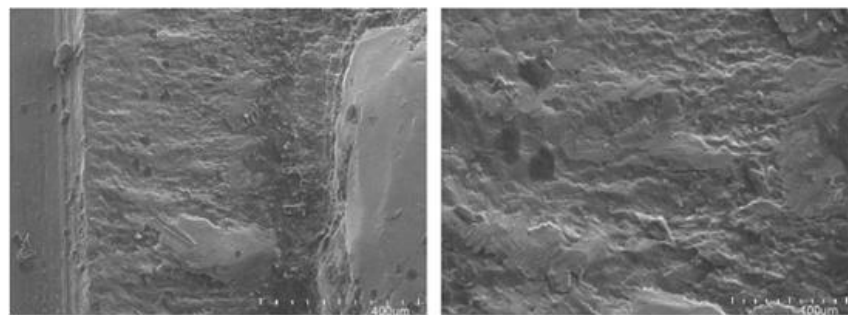
Figs. 13-14 SEM imaging of the same uncompromised area of the inner rim of the humeral tray, 120x (left) and 350x (right).

Based on the results gathered from SEM and EDS analysis, it is likely that several factors contributed to the mechanical failure of the implant. The striations observed on the uncompromised areas of the taper (**Figs. 13, 14, 15, 18**) are an indication of brittle-like failure, most likely caused by fatigue. The combination of rotational and toggle-like forces acting on the weld site produced wave movements [14]. This wave-like motion would have occurred any time the patient engaged in activities requiring flexion, abduction, and/or external rotation, and constant cyclic loading over the course of nearly four years ultimately resulted in failure of the implant. Once enough brittle-like failure had occurred over time,

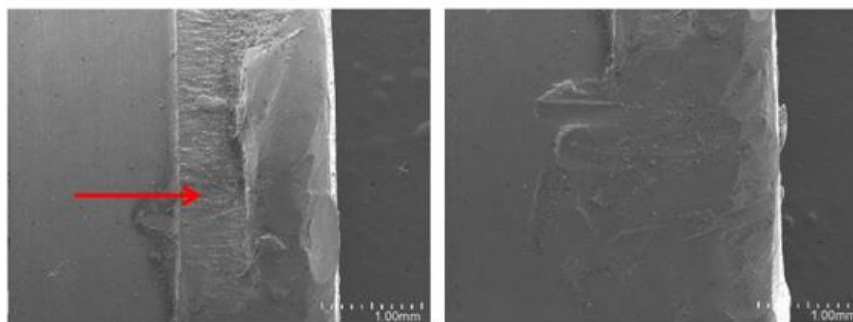
Fig. 15 uncompromised areas such as that shown here yielded acceptable fracture data (red arrow).
Fig. 16 Compromised areas of the trunnion such as this one yielded no usable data.

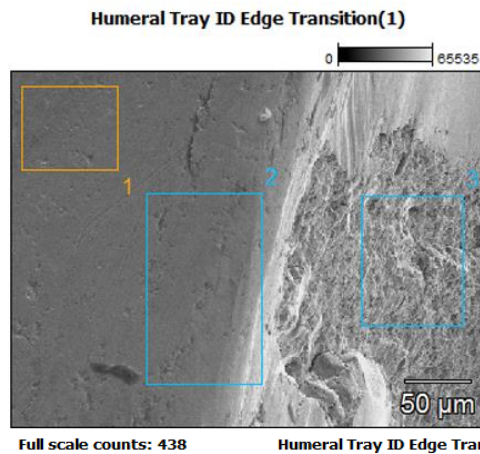
Gross visual inspection of all explants revealed that implant failure was a result of Morse taper dissociation from the humeral tray at the weld. SEM further confirmed the likelihood of torsional failure due to the presence of jagged edges at the fracture site. EDS detected elevated levels of C and O at the edge transition of the humeral tray and not on the taper. **Fig. 17 (area 3)** indicates the presence of various elements, transitioning from the planar area of the tray to the inner rim. Comparison of the presence of elements on the planar area of the tray, the edge of the inner rim, and on the inner rim itself enabled determination of failure method. The presence of other trace elements (Na, P, Si, Cl, etc.) was assumed to be due to handling during testing.

Fig. 17 EDS of the humeral tray. The planar area of the humeral tray (1) revealed the presence of mostly titanium and aluminum, which is ordinary considering that the composition of the alloy is Ti6Al4V. The rim of the tray (2) showed similar elemental findings. However, the fracture site (3) displays elevated levels of carbon and oxygen, which provided significant information regarding how the implant failed.

In titanium alloys, carbon and oxygen are used as stabilizers that help raise the temperature at which titanium can be cast. Since the presence of stabilizers reduces ductility and fatigue strength, the interstitial elements are removed after casting [11]. Considering this, the presence of C and O could suggest that not all of the interstitials were removed during the manufacturing process, resulting in decreased fatigue strength. The presence of C and O might also be attributed to various bodily deposits. The lack of significant traces of foreign elements suggests either no filler metal was used or a $\text{Ti}_6\text{Al}_4\text{V}$ filler metal. According to the American Filler Metals Company, a titanium alloy surgical implant should be Grade 23 $\text{Ti}_6\text{Al}_4\text{V}$ with a filler metal of equal composition and grade. Grade 23 titanium alloy has lower levels of Al, C, O, and other interstitial elements to improve toughness, fabricability, and weldability [11]. Additional destructive metallurgical examination is required to evaluate the nature and location of residual C, O, and other metal processing aids. To eliminate residual biological deposits, a combination of solvent cleaning and high temperature ashing procedures could be undertaken.

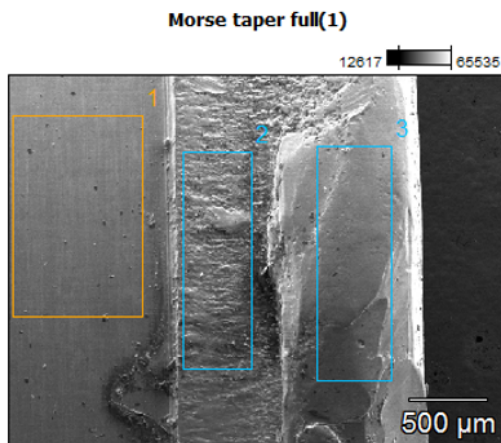
EDS was performed on both compromised and uncompromised sections of the trunnion of the Morse taper (**Fig. 18**). EDS was executed on the smooth shaft, uncompromised fracture site, and a compromised area. Insignificant levels of C and O were detected at the fracture site on the taper, and lack of foreign elements suggests that either no filler metal was used to weld the two pieces together, or that the filler metal is also composed of Ti₆Al₄V.

Fig. 18 EDS of the Morse taper at the failure site. The smooth shaft of the taper (1) revealed the presence of mostly titanium and aluminum, which is ordinary considering that the composition of the alloy is Ti6Al4V. The uncompromised area of the fracture site (2) showed slightly increased levels of carbon, oxygen, and nitrogen, which are all interstitial elements. The compromised area (3) displays traces of iron and cobalt, which most likely originated from tools with which surgeons attempted to remove the taper from the stem.

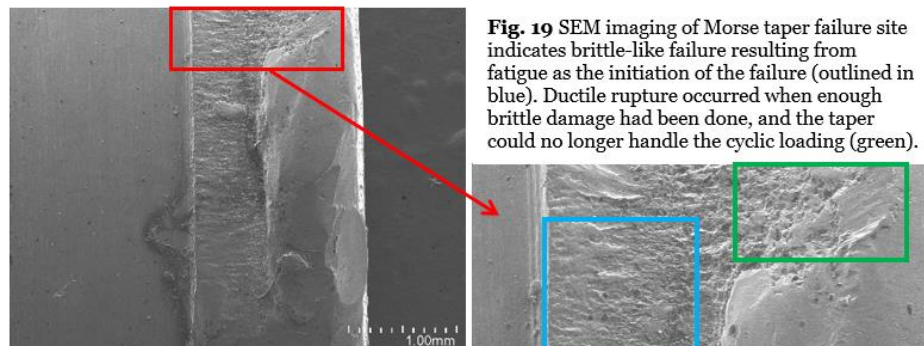
the trunnion of the taper pulled away from the humeral tray, fully separating the pieces by means of ductile rupture (**Fig. 19**) [15].

Fig. 19 SEM imaging of Morse taper failure site indicates brittle-like failure resulting from fatigue as the initiation of the failure (outlined in blue). Ductile rupture occurred when enough brittle damage had been done, and the taper could no longer handle the cyclic loading (green).

Despite the cyclic loading and forces placed on the shoulder during everyday activities, the main issue surrounding the failure of this implant is the poor design of the system. The entire system is undersized considering the actions the shoulder is expected to be able to carry out; the short length of the Morse taper, thinness of the humeral tray, weaker metal system, and small surface area of the weld site between the taper and tray all pose probable causes of failure. Fortunately, the design flaws of this particular system were quickly recognized, and engineers took action to recall the titanium alloy implants, recasting the pieces using stronger materials. Time will tell if the alterations were sufficient.
