Construction Shortfall and Forensic Investigation on Soft Ground

M Saravanan¹ and B N Ibrahim¹

¹Nexus EC Sdn Bhd, Kuala Lumpur, Malaysia

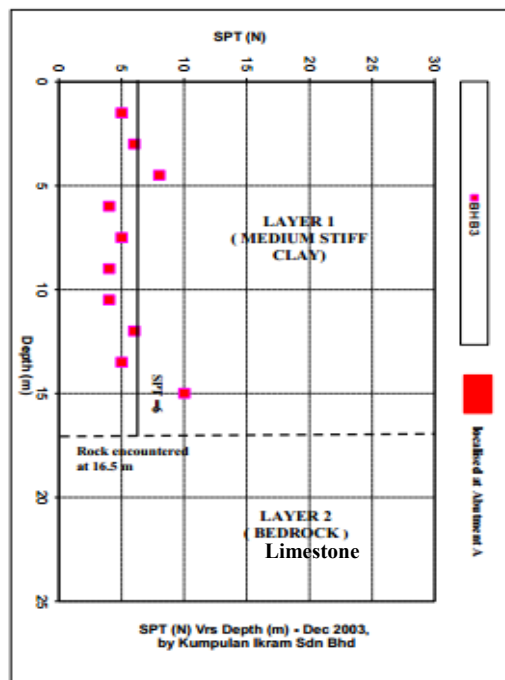
Figure 1.0. SPT-Nvalue (Blows/300mm) for Abutment A (SI in 2003).

Serious design error could be related mis-interpretation to SI works. Site supervisions are important as report in this example of 5m high embankment failures. The design of 5m high embankment were carried out on ground reported to be Medium Stiff CLAY / SILT without any indication of Soft CLAY/SILT deposit. The SI works performed in 2003 reported field data as shown in Figure 1.0.

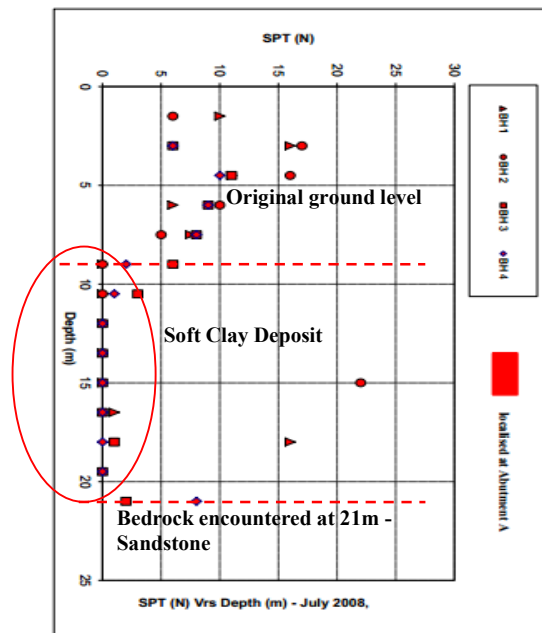
Figure 2.0. SPT-Nvalue (Blows/300mm) for Abutment A (SI in 2008).

The SI works performed were not cross check with the site geology. During the forensic investigation after failure, eleven (11) number of boreholes were carried out which are three (3) numbers (in year 2007) and eight (8) numbers (in year 2008) were performed. The new SI reported the presents of very soft ~ soft CLAY deposit as shown in Table 1.0 and Figure 2.0.

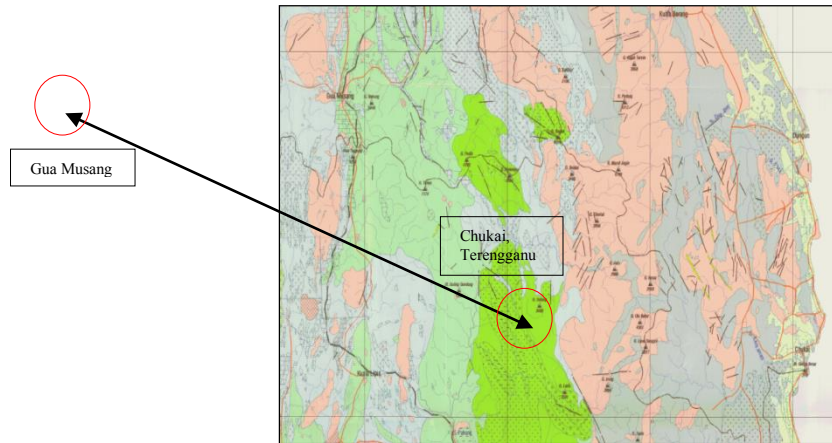
Figure 3.0. Geological Map showing site project (Chukai, Terengganu) and Gua Musang (Limestone area).

The bedrock encountered and reported to be Sandstone and Limestone. Cross comparison with Geological Map of Malaysia the area reported to be Quaternary Marine and Continental deposit. The area were not likely to have Limestone as bedrock formation. The nearest Limestone found to be at

Gua Musang about 160 ~ 175km away (refer Figure 3.0 and 4.0). The bedrock reported in SI 2007 and 2008 were Sandstone. The present of competent geologist and supervisor are critical for the site data verification.

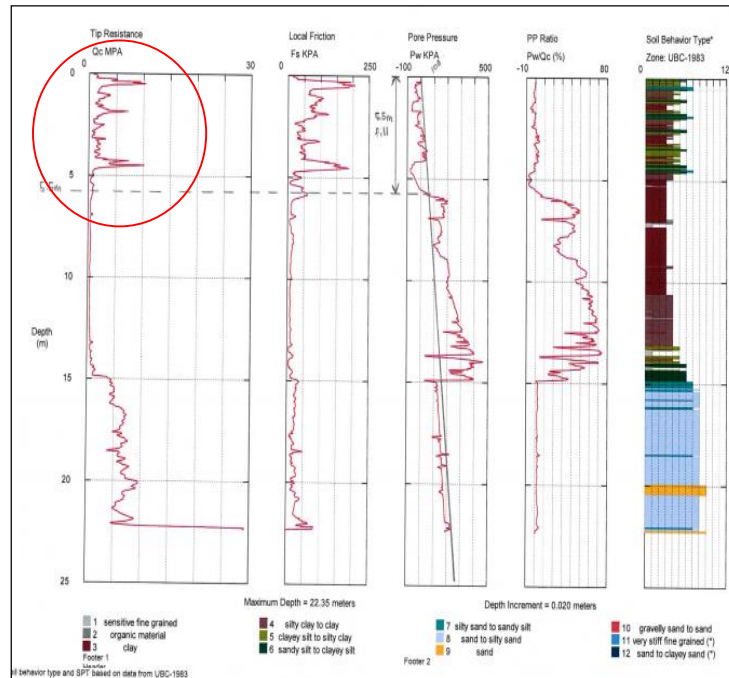
Figure 5.0. CPT data from site with pond filling.

filling over of old pond or river. This formation contains lot of voids that creates negative pore pressures (much lesser than natural water pressure with depth – refer Figure 5.0 and 6.0).

Hence, as reported in the CPT data, this site consist of material most likely to be loosely deposited earth (transported and dumped) into natural pond. Presents of pond and historical closure of ponds could have direct consequences to the type of foundation to be adopted. Performing CPT test can be very useful to provide vital information to supplement boreholes data. Further cross comparison can also be made using Ground Penetration Radar (GPR). The performed GPR reported pockets of voids and also signs of ground subsidence as shown in Figure 7.0 and 8.0. The findings are relatively consistent with CPT findings. However, Boreholes data were not able to identify the loosely deposited earth. Subsoil stratum obtained from boreholes are shown in Figure 9.0.

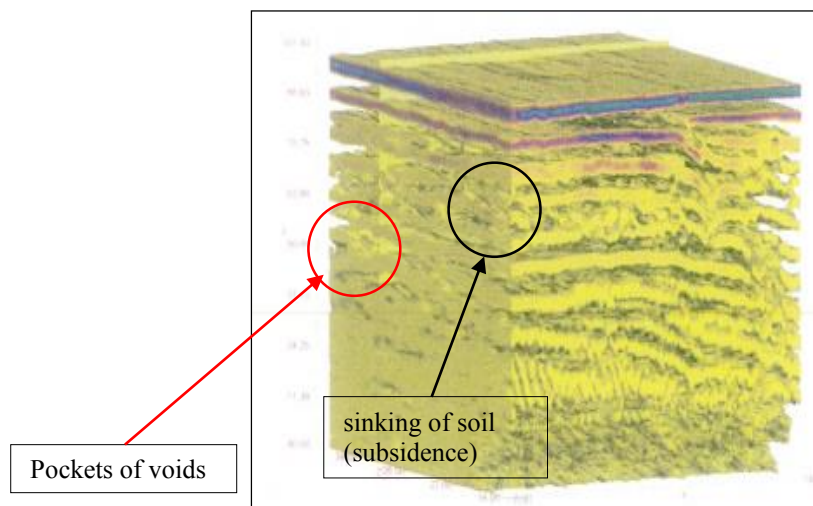
Figure 7.0. Localise pocket of voids and subsidence based on GPR scanning.

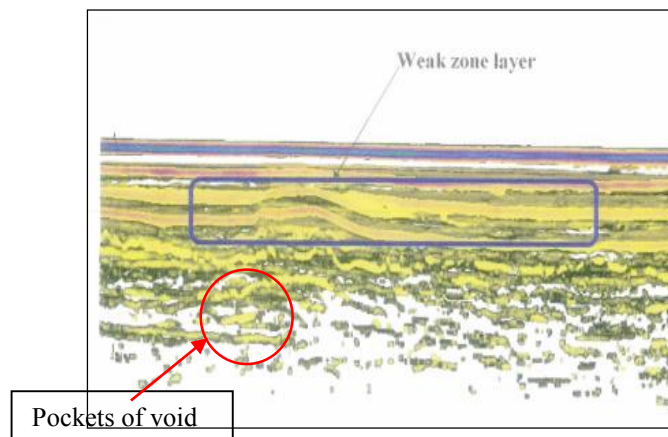
Figure 8.0. Localise pocket of voids.

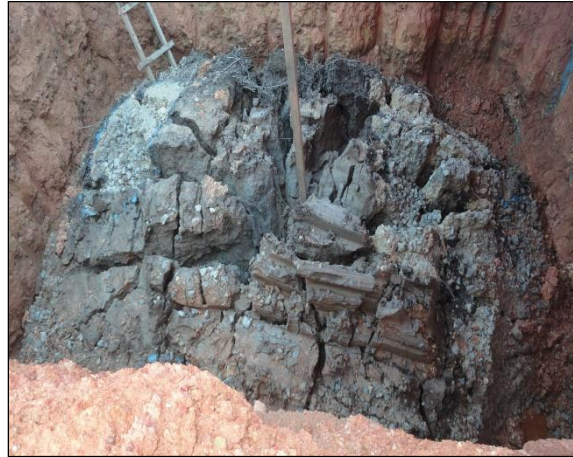
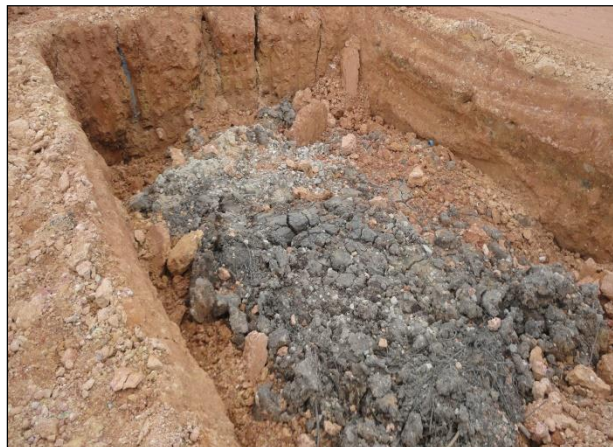
Plate A and B: Photo showing failed stone column (non reinforced stone column) and column being clogged with soft Clay and preventing the pore water discharge during consolidation process and the infill material decentigrate.

The risk and project delivery responsibility for designing and constructing stone columns in ground weaker than the listed above, should not be shouldered by client and consultants. Consultant should not recommend the usage of stone column in such ground condition. Alternatively, instead of stone column, designer / consultant shall recommend more reliable ground improvement work (i.e. Pre-fabricated vertical drain or Encased stone column or pile foundation).

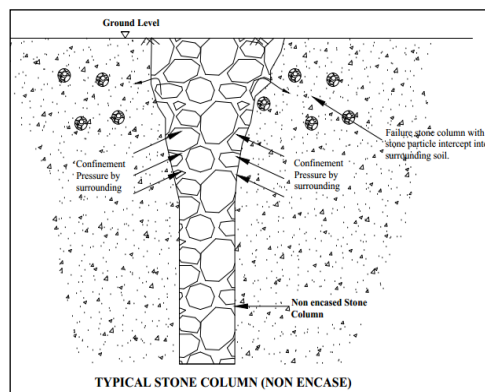
Plate D. Image showing decintigrate of stone column in soft ground due to lack confinement strength of surrounding soil.
