Challenges in Construction Over Soft Soil – Case Studies in Malaysia

N O Mohamad¹, C E Razali¹, A A A Hadi¹, P P Som¹, B C Eng¹, M B Rusli¹ and F R Mohamad¹

¹Geotechnical Engineering Branch, Public Work Department of Malaysia, Kuala Lumpur

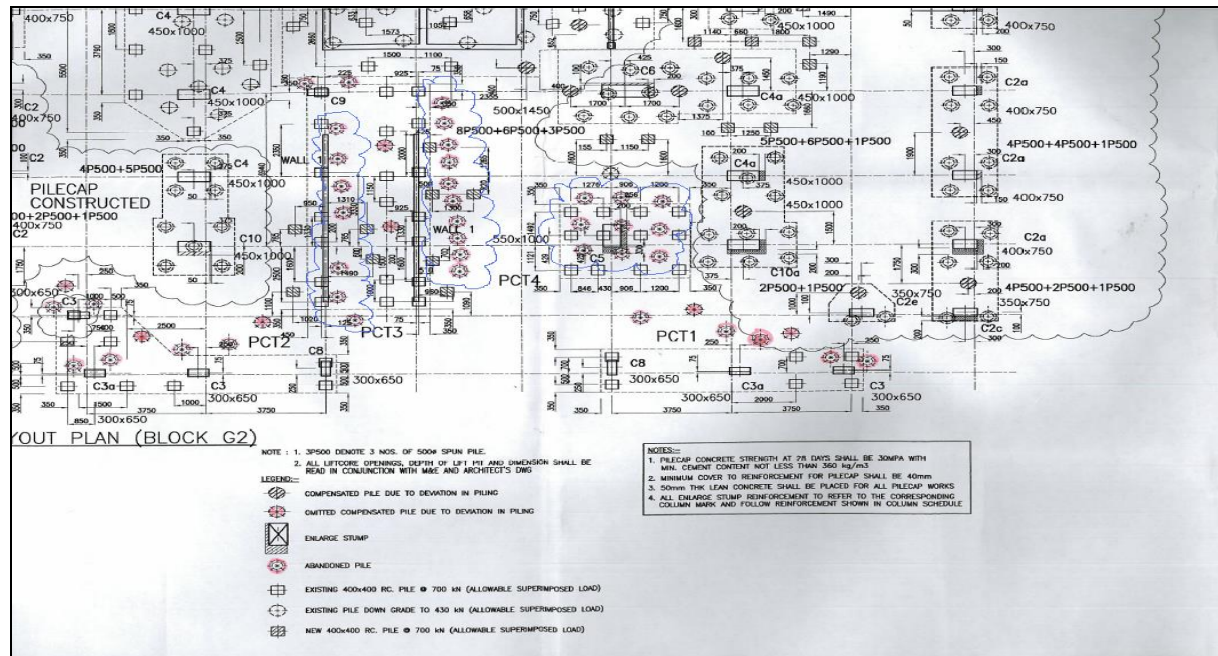
platform. Upon completion of piling work, most of the installed piles were found to be deviated from original position after some times. Piles were also found to be severely tilted and damaged at the location of the proposed lift pit and layout of the affected piles is shown in Figure 1.

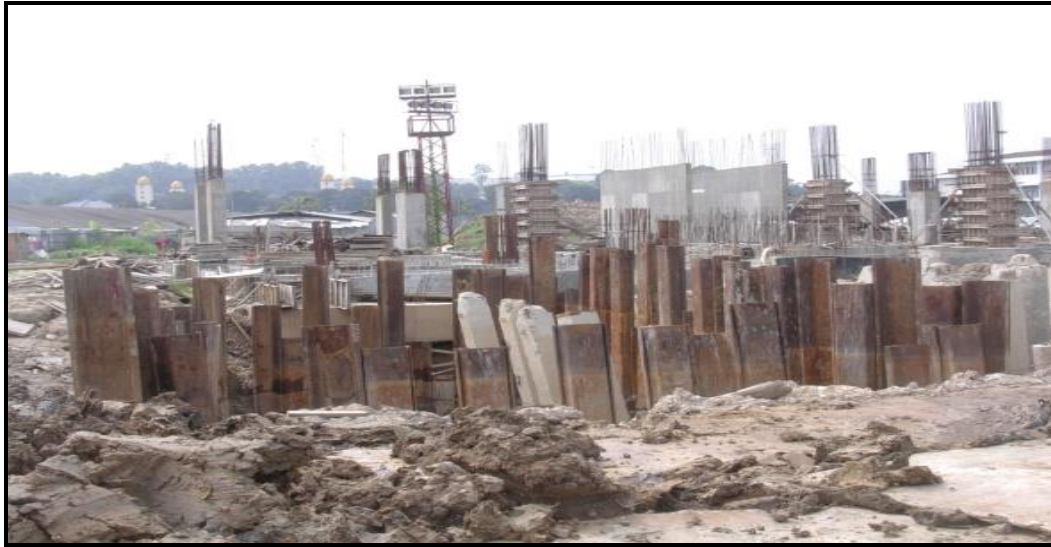
Figure 2. Sheet piles and piles adjacent to the excavation pit tilted.

Probably due to the cost and time constraints, temporary sheet pile wall was installed at only one side of the excavation area. The excavated earth which was supposed to be transported out of the site was also temporary placed on the crest of the pit as shown in Figure 3. This improper construction practices adopted by the contractor had contributed to the failure of sheet pile wall as the placement of that unsuitable material had induced surcharge load to the ground that caused lateral movement of the unsupported side of the excavated pit.

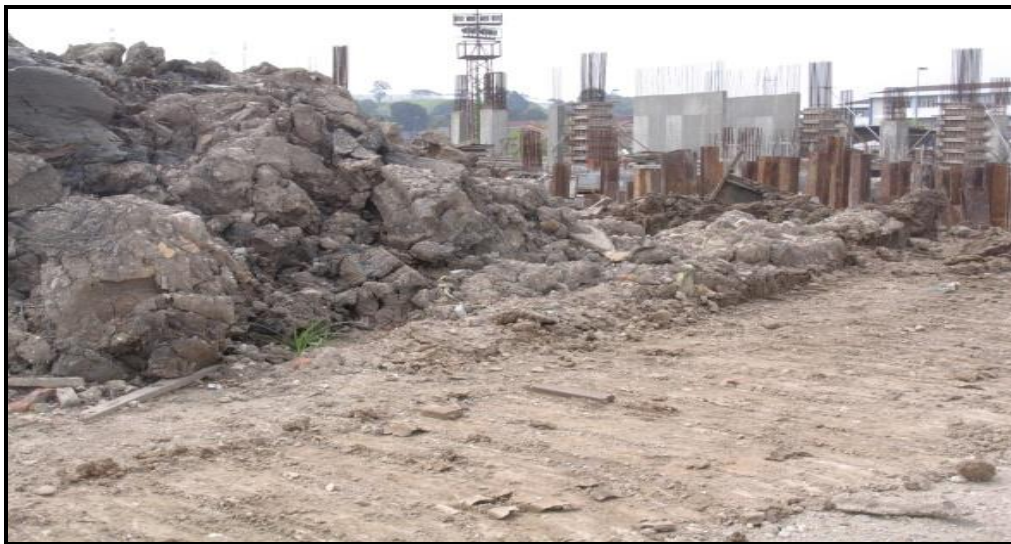
Figure 3. A large quantity of excavated earth dumped at the crest of excavation pit.

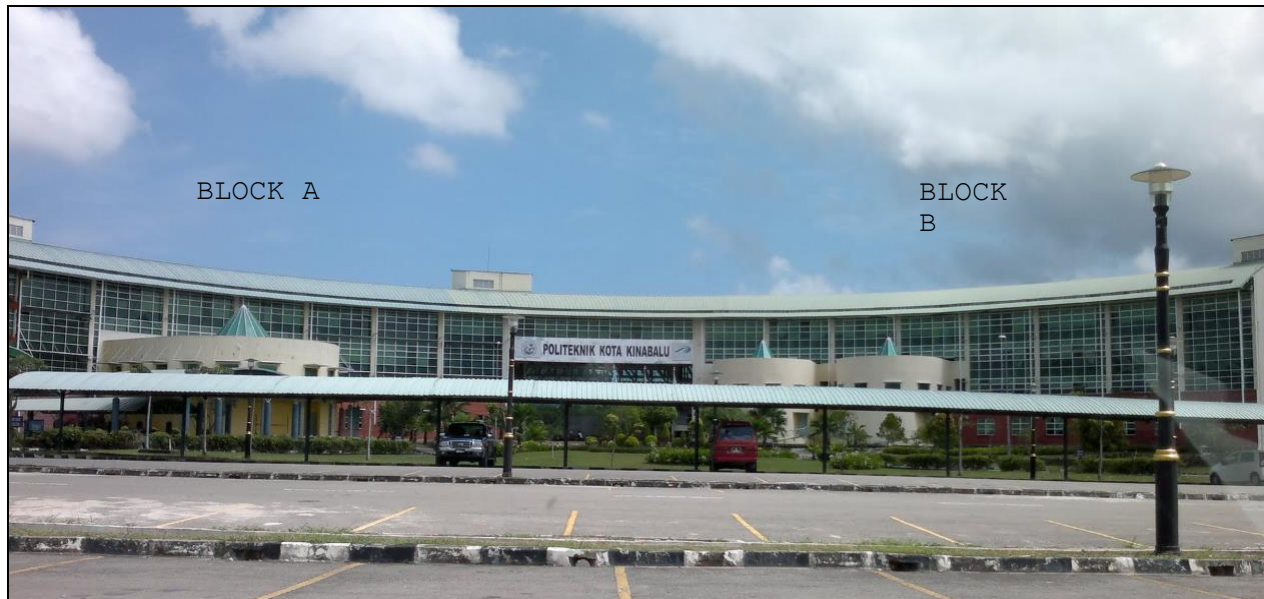
Figure 4. Block A and B Polytechnic Kota Kinabalu

Polytechnic Kota Kinabalu is located at Kota Kinabalu Industrial Park (KKIP), Jalan Politeknik, Kota Kinabalu, Sabah. The construction of this project was commenced in 1999 and finally completed in 2003. Topographically, the project site is located on the low lying area which required extensive earthwork in order to achieve the proposed platform. Once completed, the first academic session at the new campus starts its operation on the 1 September 2003. Structural cracks were later detected at one of the main building in the campus, i.e. Core Facilities Building and the Teaching Restaurant. At the point of investigation, the drainage system such as perimeter drains had also experienced serious settlement.

A separate settlement monitoring on columns also recorded a maximum reading of about 52mm settlement within a period of 15 months. The result of column settlement monitoring records had indicated that columns of Core Facilities Building had settled at different rates. Therefore, the major cause of the cracks is expected to be trigger by differential settlement that occurred on the foundation of the building.

The finding is in line with the design review carried out on the original design which found that the negative skin friction was not considered in the design. Theoretically, the effect of negative skin friction will induced an additional force on the piles thus reducing its effective capacity. Therefore, the main cause of the problems possibility due to the overloaded piles when subjected to the negative skin friction develops over time as a result of settling ground. This phenomenon has led the occurrence of differential settlement of the pile foundations that causing cracks to the building.

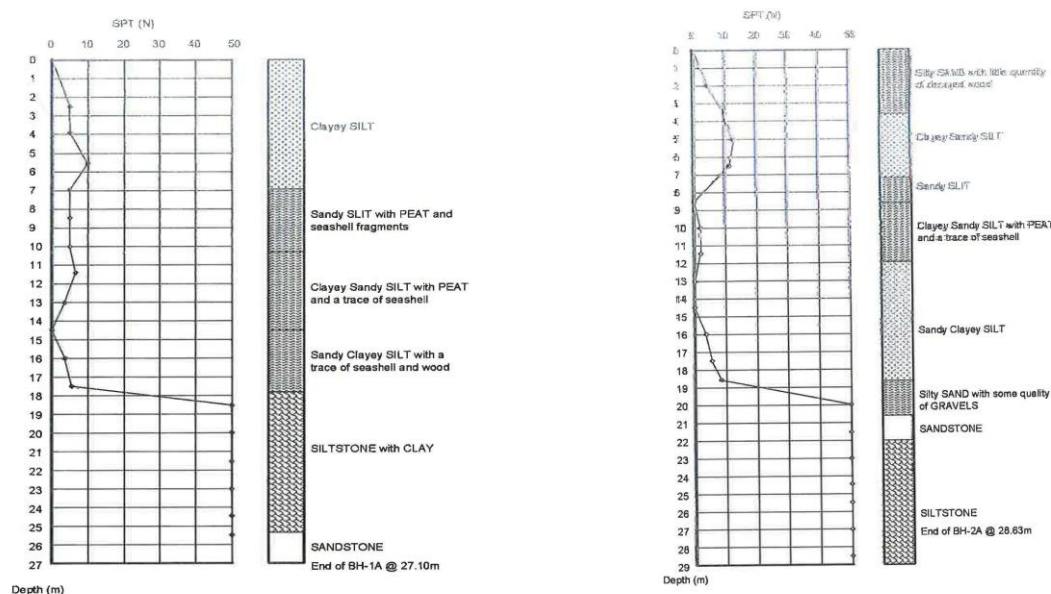
Figure 5. Cross – section of boreholes profile

From the boreholes result indicated the presence of fill material at the site with a thickness of about 7.2m. This layer is underlain by 10.6m of very soft to firm clayey sandy silt with some organic matters. A hard weathered siltstone and very poor weak sandstone was encountered at the depth of about 18.0m to 20.0m onward measured from the ground level (Figure 5).
