Research on fire hose couplings damages

Abstract. This paper presents a part of a research on the damaging of fire hose coupling. These are important components of the hydraulic systems used by firefighters to deliver one or more suppression agents into the fire. The operating regime parameters, working environment and general functioning conditions during fire suppression operations may lead to malfunctions and/or damaging of the couplings.

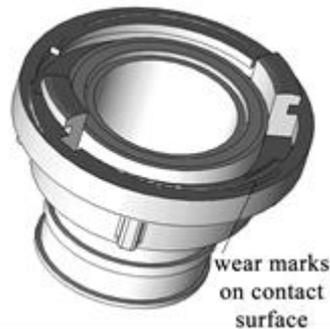
- Incorrect connecting, vibrations plus penetration of sand and/or other abrasive materials from the environment in the connected area could lead to leakage and fretting wear marks on the flanges- important but non critical failure- shown in Figure 7.

Figure 7. Wear marks on the flanges

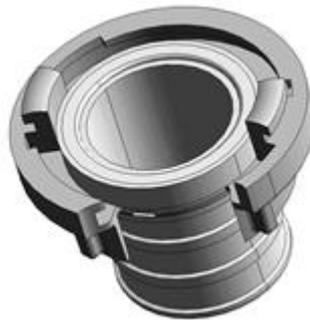
- Mechanical shocks that occur during firefighting operations, due to incorrect manipulation and operating environment such as concrete floors around and inside buildings could lead to the cracking of the couplings' body- important, potentially critical failure-shown in Figure 8.

Figure 8. Cracking of the couplings body (“the Storz head”)

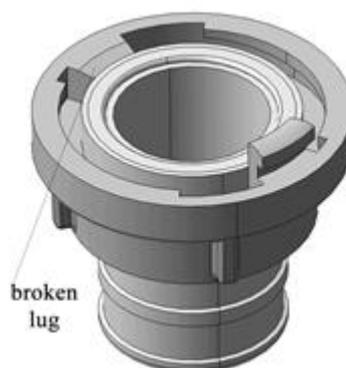
- Hydraulic shocks (“water ram”), mechanical shocks due to incorrect manipulation of the equipment, vibrations that generate fretting fatigue could lead to the breaking of the lugs - critical failure-shown in Figure 9.

Figure 9. Breaking of the lugs

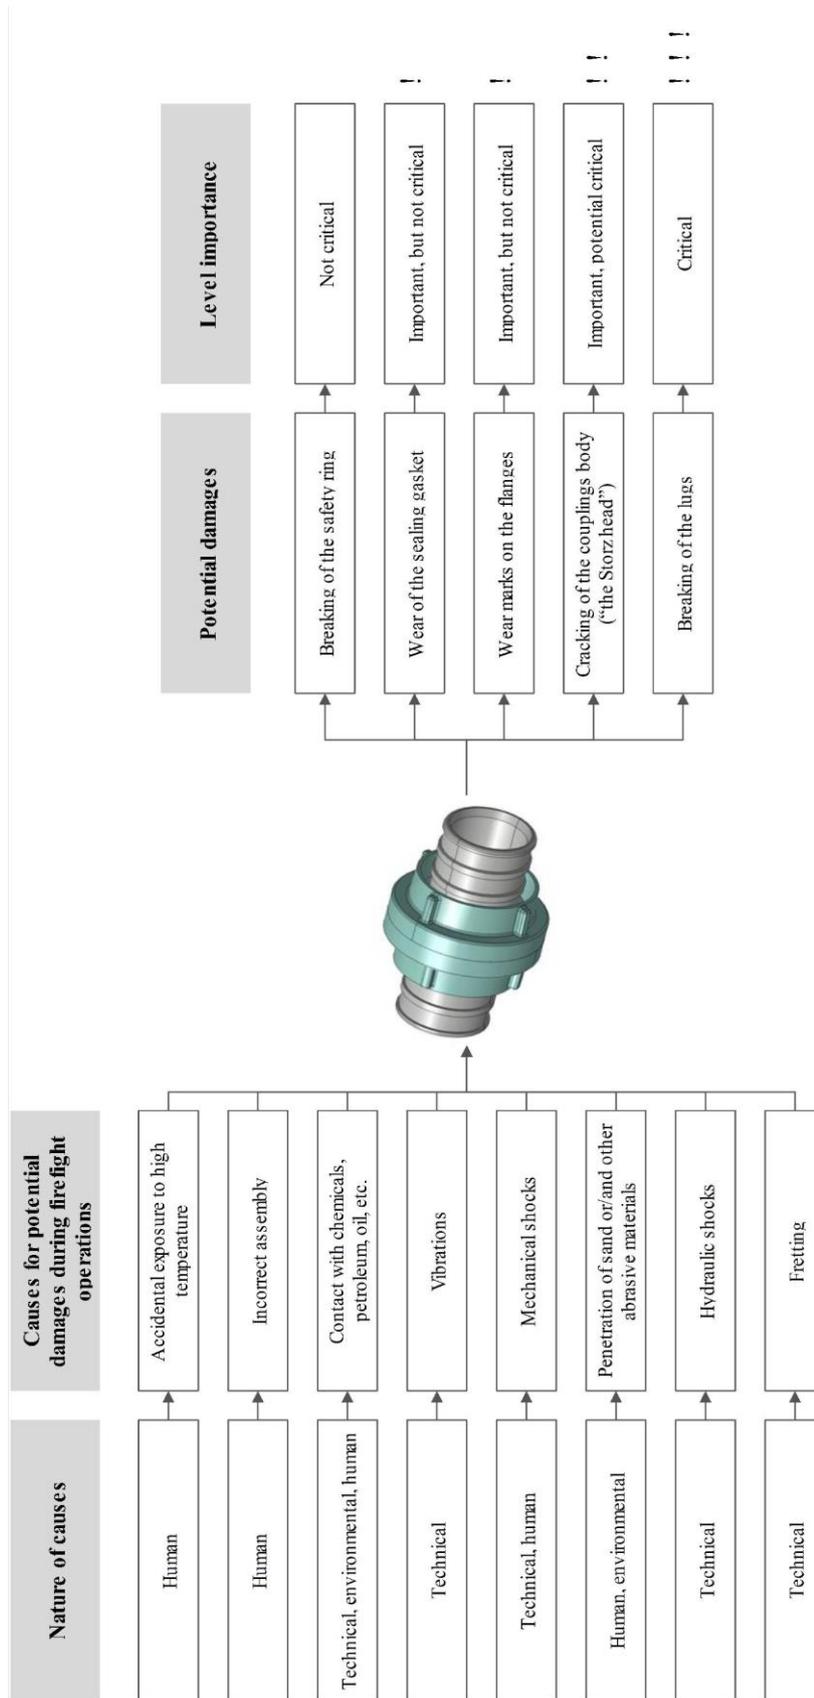
This leads to the basic failure mode and effects diagram for potential coupling damages during firefighting operations shown in Figure 10.

Figure 10. Basic failure mode and effects diagram for potential coupling damages
