# An investigation on the fracture of linkage connecting wing flap of aircraft

**Abstract.** Linkage that connected wing flap and supports was found broken several times during from 2011 to 2014. Flights data was checked, no heavy landing or exceed limiting speed warning were found. To investigate the root cause of the failure process, macroscopic and micrograph of the fracture surface were researched with optical micrograph and scanning electron micrograph. Results show that the surface of fracture was dimples and shearing fracture structure which mean transient breaking features. Nearby the fracture, a lot of scratch and paint marks were found, that indicated that the rod may collapsed by impacted with some mechanical components. But the distance to the nearest component is within the tolerance, during ground inspection. Basing on stability analysis of column, the linkage will be bending deflection with elastic deformation, when compress exceed a critical value, which decrease the distance. But it will be recovered, during ground inspection for lower compress. Finite Element methods were used to demonstrate the bending deformation too. Basing on the reports and analysis, enhance

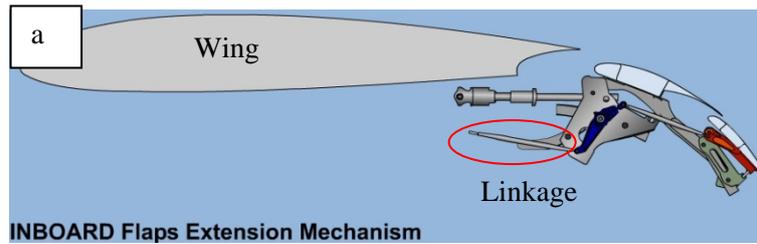
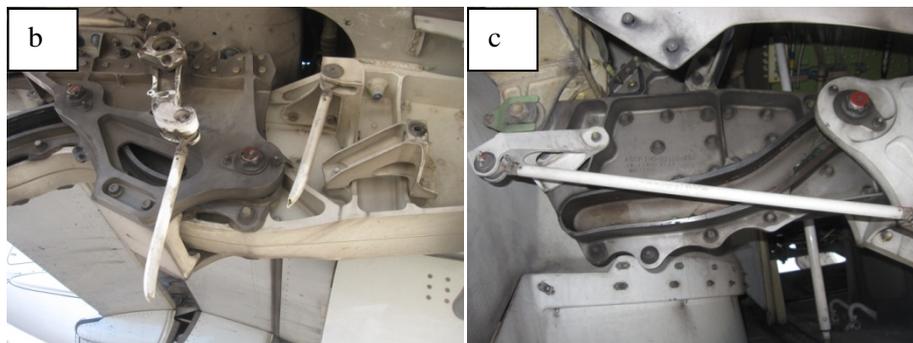
The extension mechanism of flaps is shown in figure 1a, a mechanical component with thread screw fixed at main wing, allowing movement in two directions used in the flap extension and retraction system. The installation location of flap connecting rod is shown in figure 1a with red circle, one side of linkage connected to the body with universal connector by simply supported, the other side connected to slide rail by simply supported too. So the condition of loading is compression stress along axial direction.

The connecting linkage was found broken or bend three times in two years for some aircraft, and no heavy landing signs were found for the failure process. The broken linkage is shown in figure 1b comparing with normal linkage in figure 1c. The bending or broken position close to the middle of the connecting rod and no obstacle components was found during the extension and retraction process.

**Figure 1.** Assemble sketch map of linkage rod and unfolded mechanism of open the flap

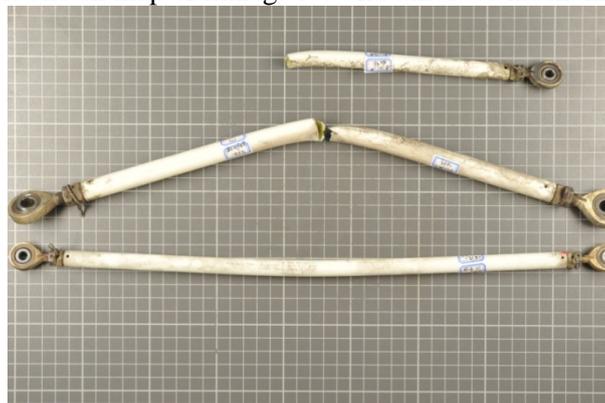
Fractured and bending linkages were shown in figure 2, the rod pipe was fabricated with 2024 aluminium alloy, the surface of pipe was coating with white colour paint, no corrosion products along axial of the connecting rod and no broken at the connected side were found. The angle of bending is about 12 degree for failed rod. A universal connector at the end of each rod in figure 2 is flexible rotation without any jamming condition, and no damage and impacting marks were found on the connector.

**Figure 2.** Fractured and bending connecting linkage

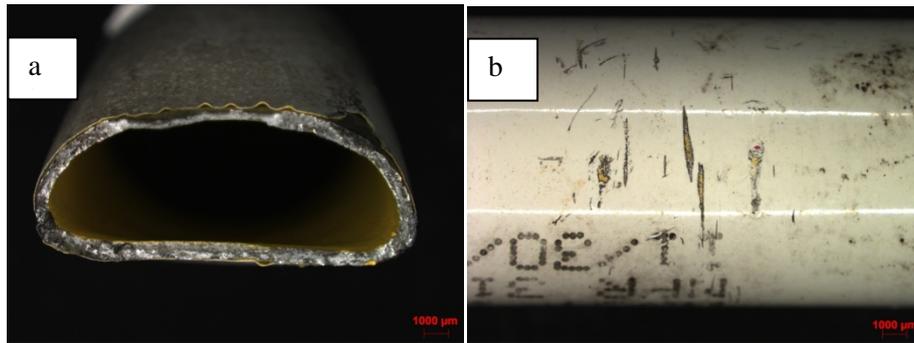
**Figure 3.** Macroscopic fracture surface and side wall of the broken linkage

Macroscopic fracture surface of broken linkage were shown in figure 3, cross section of normal linkage is circle, but the damaged one is ellipse. Flank wear and impacted marks are show in figure 3 b, surface coating was cut off from the linkage. From the trend of the impacted marks, it may instantly contact with some components. But after inspection in land situation, no object was found alone the travel path of the linkage.

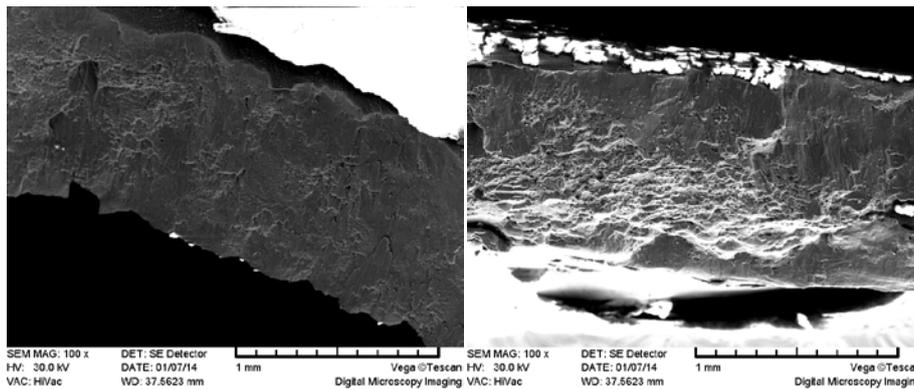
The microstructure of fracture is shown in figure 4, the surface of fracture is type oblique and fluctuation, full of dimples and quasi-cleavage tear ridges without any fatigue lines, which mean that the process of the break is transient behaviour never inoculation process.

**Figure 4.** Scanning electron micrograph of fracture morphology

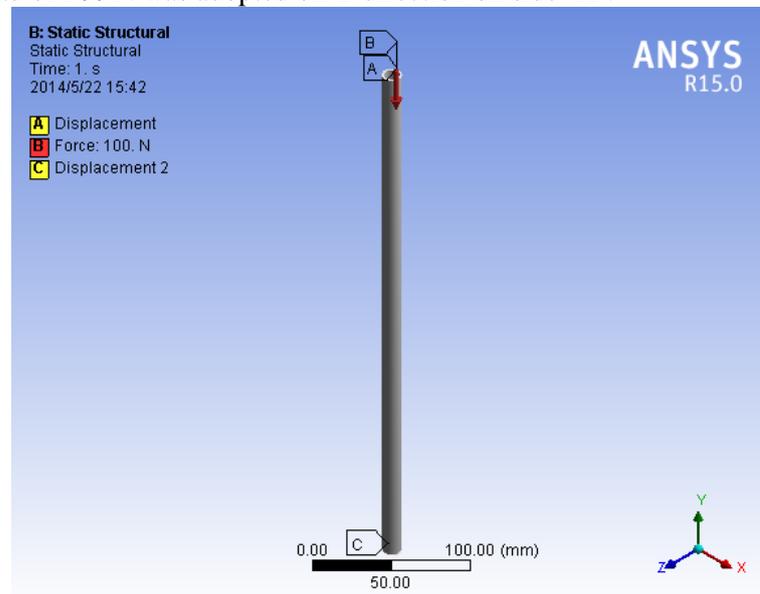
**Figure 5.** Boundary conditions setting of compressive linkage

Boundary conditions setting as follow, according to the practical situation of flap linkage. 1) Displacement constraint of X, Y, Z directions were adopted on side 'C' (in figure 5), and rotation of three directions were free. 2) Displacement constraint of X and Z directions were adopted on side 'A' (in figure 5). 3) Preload of 100 N was adopted on Y direction on side 'A'.

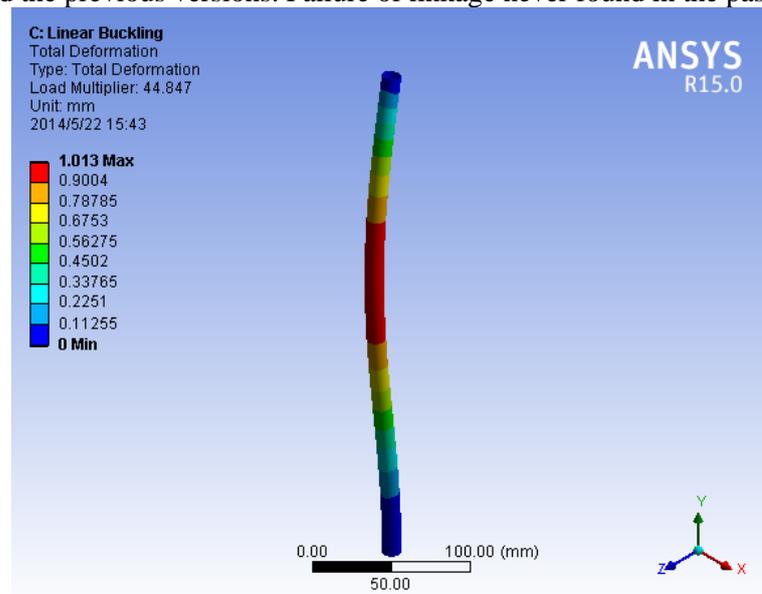
Deformation cloud of simulation result is shown in figure 6, bulking deformation in the middle of the linkage. That provides lateral displacement about 1.1 mm, decrease the gap between linkage and objects. The critical load for bulking deformation is 2.2 KN, approach to calculated result.

When unload, the linkage recover in elastic deformation. So maintenance and service engineers never found any objects could impact the linkage. The bulking deformation occurs on release and

retraction flap in the air condition, with air load on the wing flap. In the land condition, without any load bring to the linkage, bulking deformation never emergence.

The failure module of linkage on wing flap is impacted with objects and shear fracture in the middle side. Because of instability on bulking deformation under compressive load, the middle of the rod move toward perpendicular to the axial direction.

Figure 6. Bulking deformation of compressive linkage

The solution of the problem is increase the strength of linkage, that resistant the bulking deformation. So one selected alternative component of linkage with more strength flexural rigidity is provided, and replaced the previous versions. Failure of linkage never found in the past two years.
