Reasons for crack nucleation in welded joints of main gas-pipelines after a long-term operation

Abstract. A crack of operational origin in the welded joint of the main gas pipeline is analyzed. The reasons for its nucleation and impact on technological microdefects that were formed earlier during the welding are found. Micromechanisms and stages of nucleation and propagation of the crack are investigated.

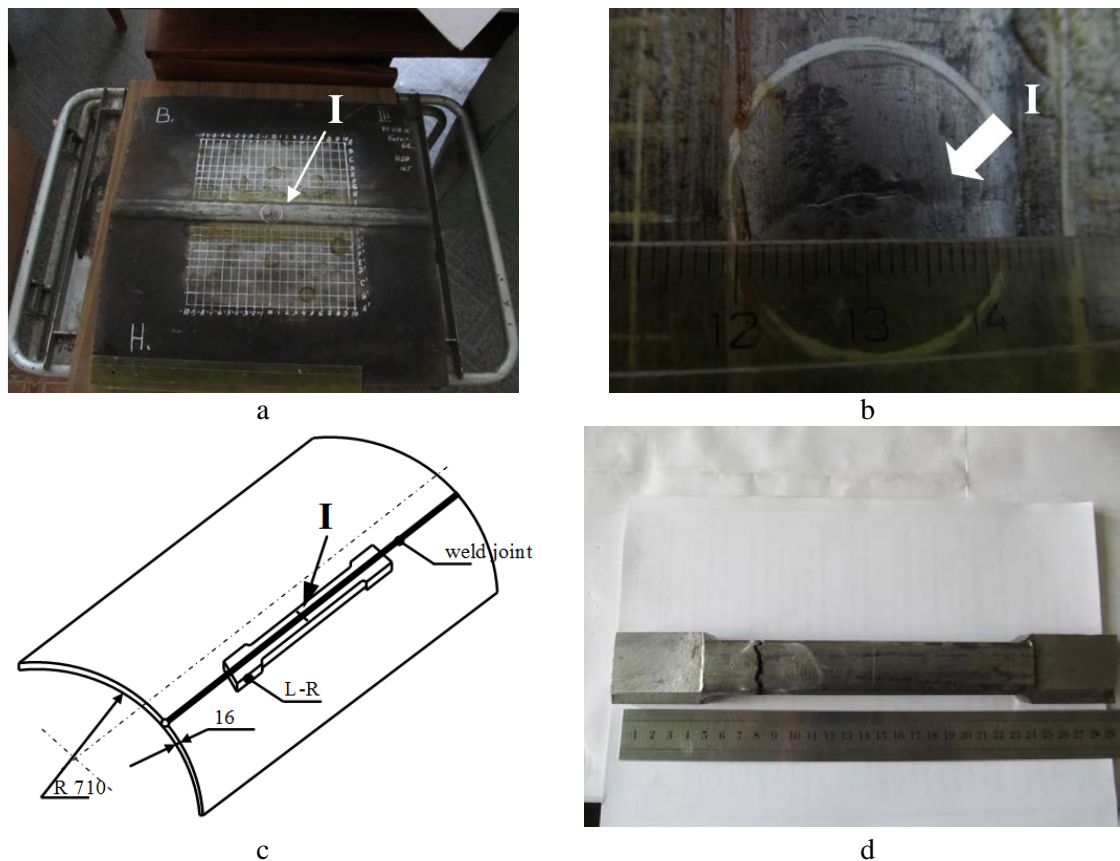
To study the reasons of defect nucleation in welded joints as well as crack propagation from them (I), Figure 1a, b, comprehensive studies of a fragment of the main gas pipeline were conducted. They included mechanical testing (to evaluate mechanical properties of the metal in the weld zone), visual

Mechanical testing of the specimen cut along the welded joint of the pipeline with an operating defect was performed under static uniaxial tension with the use of hydraulic testing machine R100 (Figure 1c, d). Fractographic analysis of the specimen's fracture surface was performed with the help of scanning electron microscope REM-106.

Figure 1. The general view of the pipe fragment (a) and the welded joint with a crack (b), the specimen cutting scheme (c) and the fractured specimen (d); I – defect.

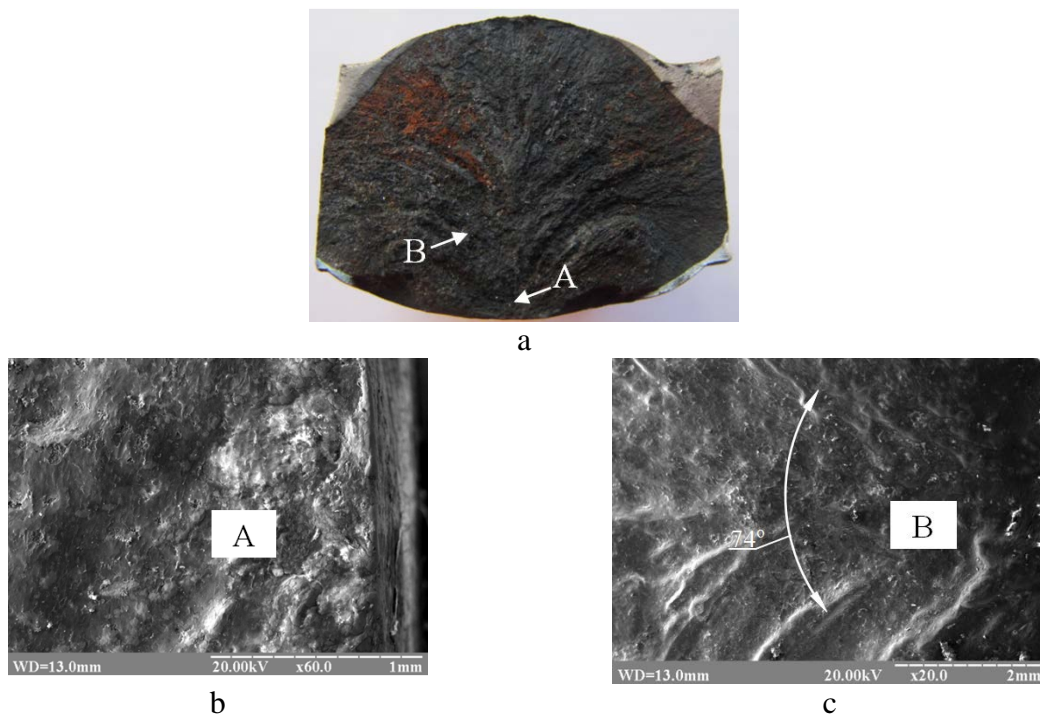
The analysis of the specimen fracture surface has shown that it is covered with a layer of oxide scale without a metallic luster typical of cold cracks. In our opinion, the defect is a typical cold crack, Figure 2a. It was formed in the zone adjacent to the outer surface of the welded joint.

Based on the analysis of the fracture surface in the vicinity of the macroconcentrator with the use of the scanning electron microscope, the areas of nucleation (A) and growth (B) of the defect were revealed. It should be emphasized that almost the entire surface inside the defect was covered with a layer of corrosion, Figure 2c. However, its presence does not preclude observation of a 'chevron pattern', which 'rays' are oriented at the angle of 70-80 degrees to each other, Figure 2c. Given that the edges of the chevron pattern are always oriented towards the direction opposite to the crack propagation, the concentrator which initiates fracture behind the 'convergence' of the chevron pattern was revealed. This allows us to conclude that the crack occurred in the subsurface layer of the welded joint and propagated from the outer to the inner surface.

Figure 2. The general view of the opened crack in the welded joint, and the zone of its start (b) and propagation (c)

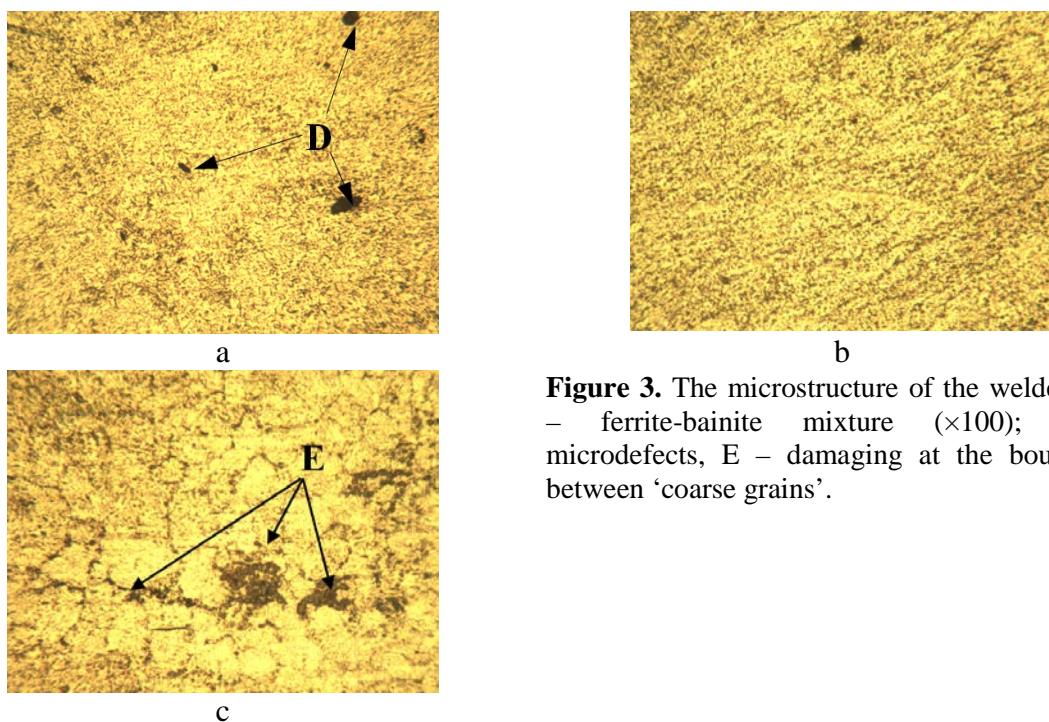
Figure 3. The microstructure of the welded joint – ferrite-bainite mixture ($\times 100$); D – microdefects, E – damaging at the boundaries between 'coarse grains'.

Fine crystallites of the 'ordered' structure were found in the structure of the welded joint. These crystallites can serve as an indicator [2, 4] of the direction of crystallization of the weld metal from a liquid state, Figure 3a. The structure of the weld metal represents a ferrite-bainite mixture, Figure 3b. In the vicinity of the area, where the crack nucleation took place, a weld overheating region was found, where 'coarse grains' were found. Their shape accounted for a significant length of weakened boundaries, and contributed to the formation of laminations during the crack formation process, Figure 3c. Metallographic studies conducted on etched thin sections allowed revealing small micropores in the area of crack propagation, which may serve as evidence of hydrogen impact on the weld material [5]. Defects of this type are known, which were found in the vicinity of a through transverse crack in the pipeline with a diameter of 1420 mm. The estimated technological reason for their formation is very rapid and uneven cooling of the welded joint. While analyzing metallographic images taken from the area of the welded joint, it was found that most probably the crack emerged on the surface of the welded joint in the areas with coarse grains. Numerous micropores with a diameter of a few micrometers and cracks oriented along the boundaries between several grains served as additional factors [6], which contributed to the formation of a macrodefect.

In our opinion, cracks were formed in the weld zone under the influence of damage accumulated in the grain boundaries [7, 8]. This damaging took place in the first hours after welding, however, it was scattered and could not coalesce, because the level of welding stress at the site was inadequate for its growth. After mounting the pipe in the pipeline, the local growth and coalescence of microdefects took place under the influence of operational factors. To our mind, this technological effect could be the 'imposition and summation' of welding and technological stresses, resulting in the localization of microdeformation processes. The additional impact could result from hydrogenation of the welded joint. Therefore, from the analysis of the damage, we can conclude that the defect was formed due to adverse structural and mechanical factors: the size of austenitic grain, a significant gradient of the grain structure in the weld zone, and the 'consolidation' of grains.
