Critical study of current situation of Vrăncioara tailing pond on Cavnicului Valley, risks and consequences

I Bud, S Duma, D Gusat, I Pasca and A Bud

Technical University of Cluj Napoca, North University Centre of Baia Mare, Faculty of Engineering, Romania

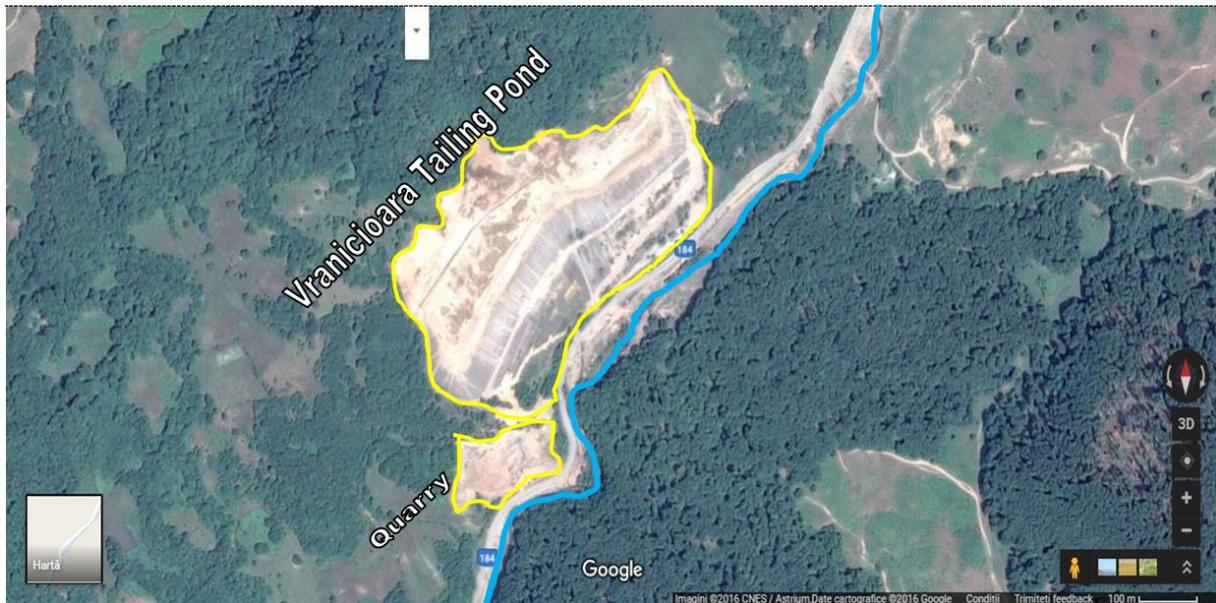
Figure 1. Vrăncioara tailing pond location, open pit placed at less than 100 m distance

Close to the tailing pond, at less than 100 m, it has been opened an andesite mining exploitation which use perforation and mining blasting. The seismicity calculations have taken account the vibrations generated by explosions showing that in the situation of a classic blasting the stability risks of the pond are imminent. The dynamic loads increase the risk of liquefaction or thixotropic phenomena appearance [4].

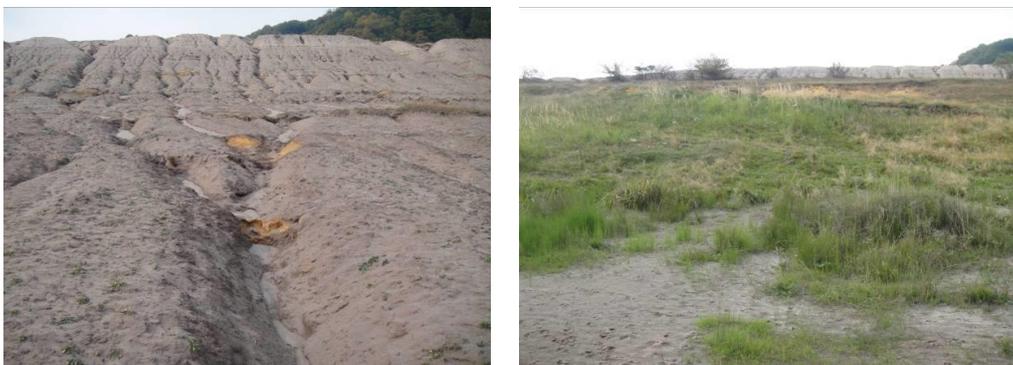
The construction of the pond was accomplished by simple settling with an average slope of 16° on the bottom and a slope much more accentuated $25 \dots 26^\circ$ toward the top. The tailing pond location land has a slope of $8 \dots 9^\circ$, with an inclination from N to S. The tailing pond capacity was exceeded by the additional storage, representing more than 2,5 million m^3 , with a height of 39 m and extending on 15,5 ha surface. In the upper part the deposit was streaked by numerous ravines generated by precipitation waters and the complete absence of vegetation. In the lower area, a part of the material entrained by water has covered existing vegetation.

Figure 2. The effects of surface water

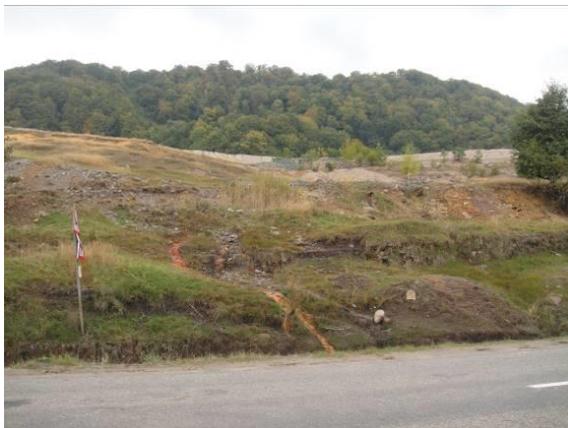
Figure 3. a) Vranceioara Tailing Pond before rehabilitation

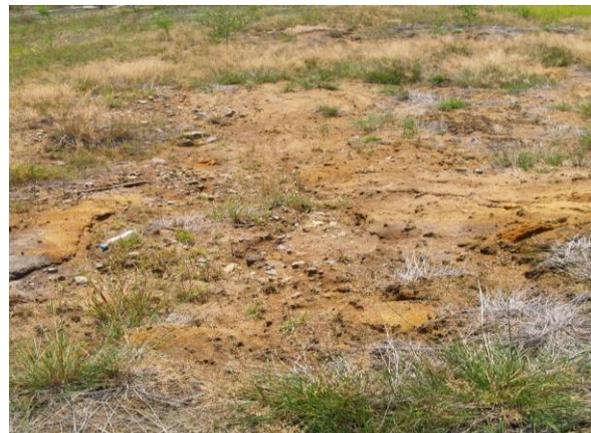
Figure 3. b) Vranceioara Tailing Pond after rehabilitation

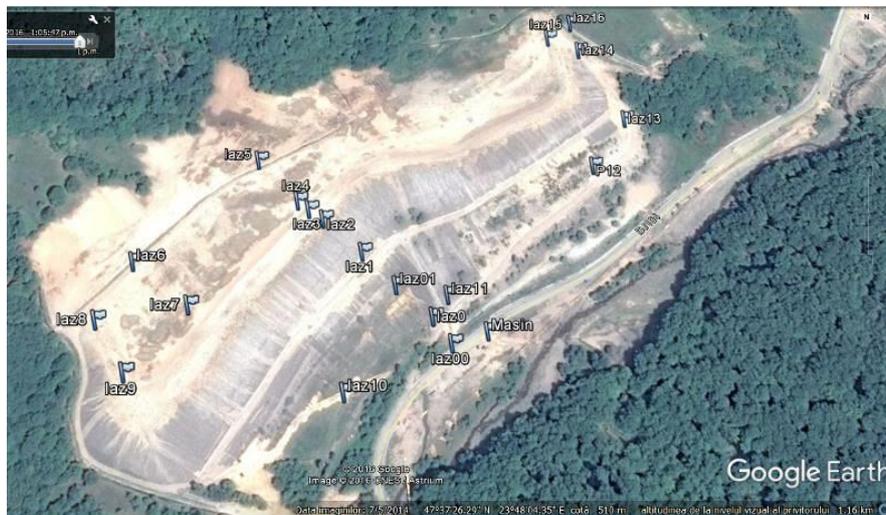
Figure 5. Measure points to identify slope inclination (system WGS 84 – EPSG:4326)

- on the top of the slope there are areas where the slope exceeds the Technical Normative, requirements i.e. under max 33% (1: 3) in absolute 18,26°;
- the final slope after stopping settlements, according to Technical Normative, must be at least 5%, but the tailing pond geometry remained the same with canopy, beach (slope reverse) and lake/sink (between points Iaz3 Iaz 4 and 5 in Figure 5) .

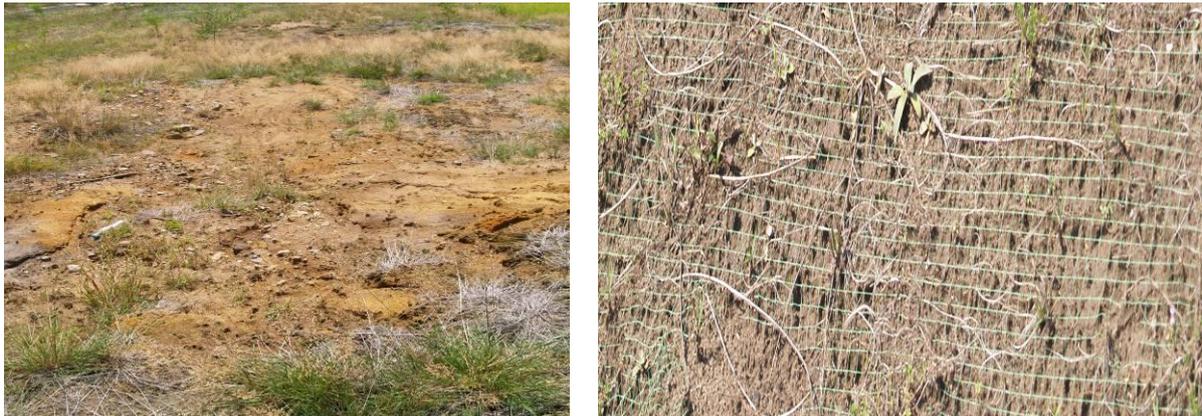
The reality on the field proves the absence of any cover layer (of support, of mineral or artificial waterproofing, textile as a protective layer for the membrane, layer for rainfall water drainage, textile as separating layer (Figure 6).

Figure 6. "Rehabilitation works"

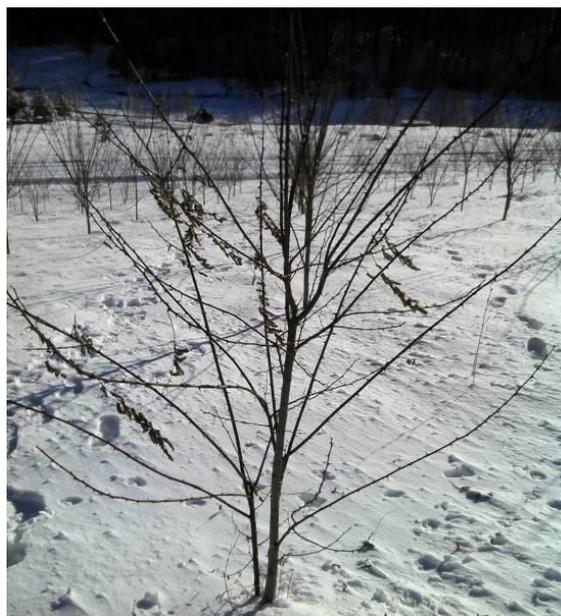
Technical Normative [5] provides that the re-cultivation layer must have a minimum thickness of 1 m and bushes and trees shall be planted. On the slope surface the existence of re-cultivation is not relevant and an acacia plantation was made (Figure 6 and Figure 7).

Figure 7. Acacia plantation on the tailing pond slope

Trees do not contribute to stability because landslides occur at greater depths than fixing root area; instead they contribute to raising hydrostatic level, having as consequence the reduction of stability coefficient. If the waterproofing - drainage layers would be properly placed (Figure 7), the tree roots would affect their structure.

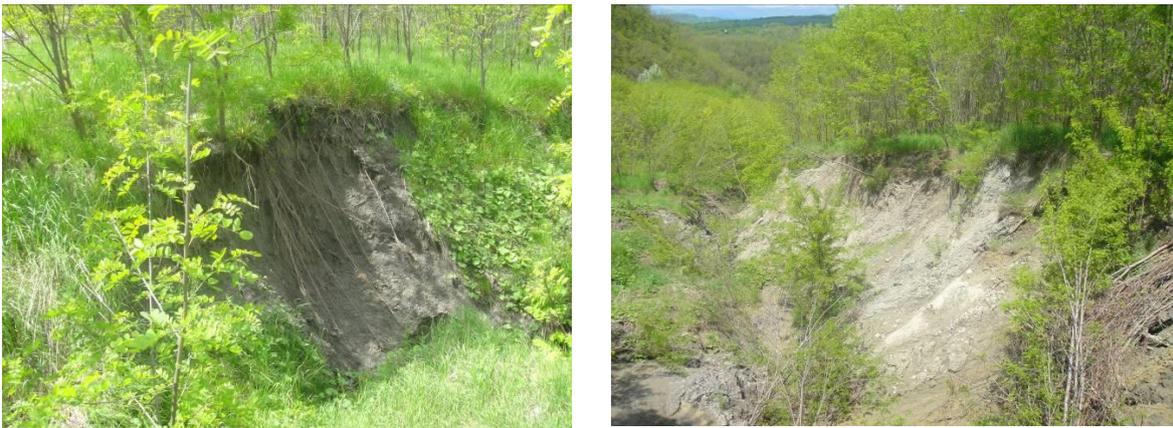
The apparent rehabilitation of slope surface with trees, in the cases of inclination angles close to the limit stability is proven as an improper solution (Figure 8).

Figure 8. The case of Berbești tailing pond, Vâlcea county– instability phenomenon in area cultivated with acacia

Figure 8 highlights phenomena of sliding and erosion in a mining waste deposit (tailing pond) rehabilitated by acacia plantation, without correcting the slope embankment in the area of safety.

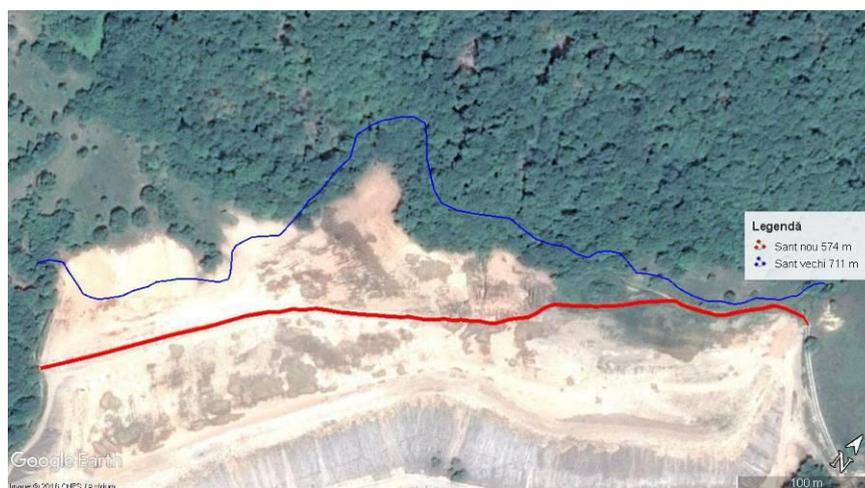
The ditch guard is designed to collect surface water from the slopes upstream the deposit and is to be placed around the deposit body, outside its perimeter. In the case of Vrâncioara tailing pond, the ditch guard is positioned in the body (length 500 m) in the area where the material has minimum particle size (Figure 9).

Before rehabilitation there was a ditch guard securely positioned upstream of the dam body with a length of over 700 m, that in time was clogged and partially destroyed. If rehabilitation would be made under the Technical Normative rules, after a new geometrization respecting minimum and maximum slope, the new ditch guard position could be changed by location upstream of the dam body plus the overlays. The construction of a ditch guard in the tailing pond body just increases the contact surface between the reactive material, water and oxygen.

Figure 9. Old (711m) and new (574m) ditch guard
