# Cause Analysis of Pressure Plate Breakage of Valve Limit Switch in Turbine Bypass System of Nuclear Power Plant

<sup>1</sup>Suzhou Nuclear Power Research Institute Co. Ltd., China

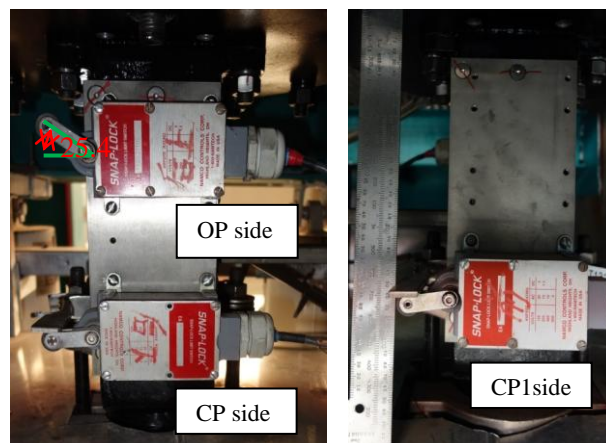
The breakage pressure plate of the GCT121VV valve has CP1, OP and CP 3 limit switches. As shown in Fig.1, the OP side is used to display the fully open position of the valve, the CP side is used to show the valve clearance position, and participate in the final power setting settings functions, and the CP1 side is used to the feedback valve is open. On both sides of the stem connector, the limit switch has a pressure plate. There are two fracture plates on the site, see Fig2.

**Figure 1.** The limit switch of GCT121VV valve.

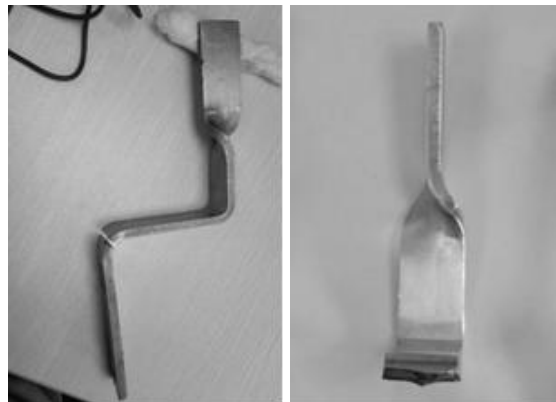
**Figure 2.** The fracture morphology of GCT121VV limit switch pressure plate.

By inspecting, there are significant processing creases at the corner of the pressure plate. The cross section of the pressure plate is located at the crease. There was no significant plastic deformation in the rest of the area except for the slight plastic deformation of the outer side. The fracture surface can see fatigue beige line, see Fig.3.

- 1) Replace the same type of valve limit switch plate for GCT-c system of the nuclear power plant to ensure that the replacement plate has no quality defects, including no creases and micro cracks at the corner. And to check the blanks spare parts, requiring the manufacturer to provide quality qualified pressure plate.
- 2) To verify the installation of the nuclear power plant limit switch, adjust the limit switch which does not meet the requirements.

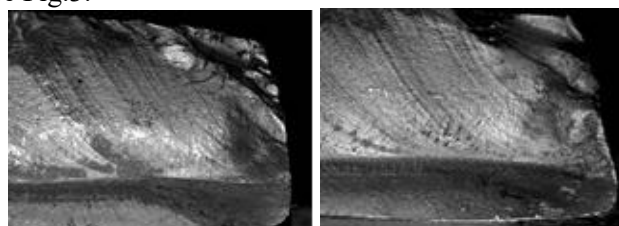
**Figure 3.** The analysis photo of pressure plate.

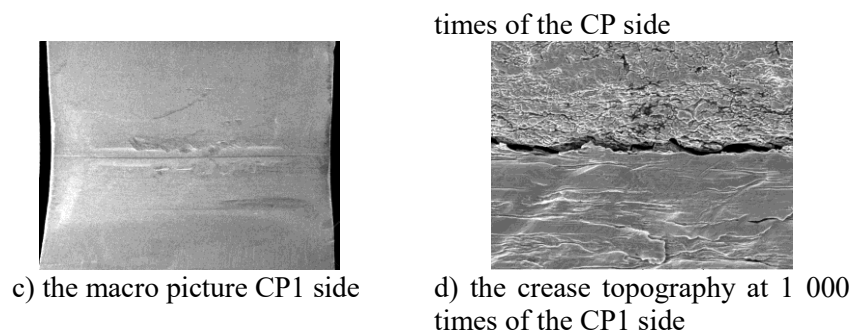
a) the macro picture CP side;

b) the crease topography at 1 000

**Figure 4.** Microstructure of crease at the corner of the pressure plate.

Microscopic observation of the crease at the corners show that there are obvious micro cracks on the edge of the CP side and the CP1 side, and the micro cracks of surface are the original manufacturing defects <sup>[2]</sup>.

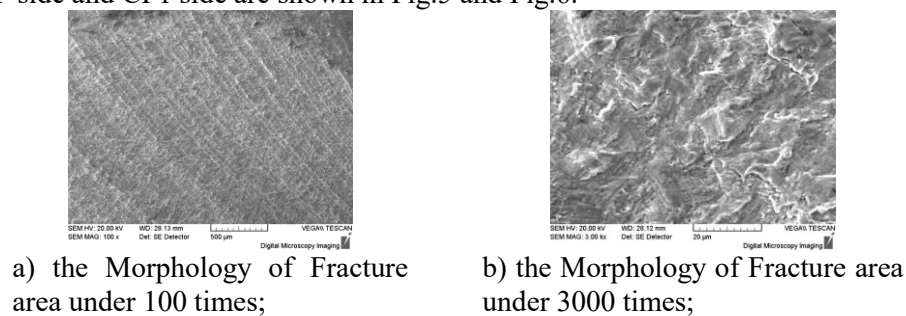
**Figure 5.** The Fracture surface of CP side (extension area).

It is found that the fracture of CP side, CP1 side fracture plates are cracked by the inner surface of the inner arc and expanded at the angle of the outer arc side, and finally at the corner of the outer arc. Fracture extension area macroscopic visible white stripe lines, microscopic visible obvious fatigue characteristics.

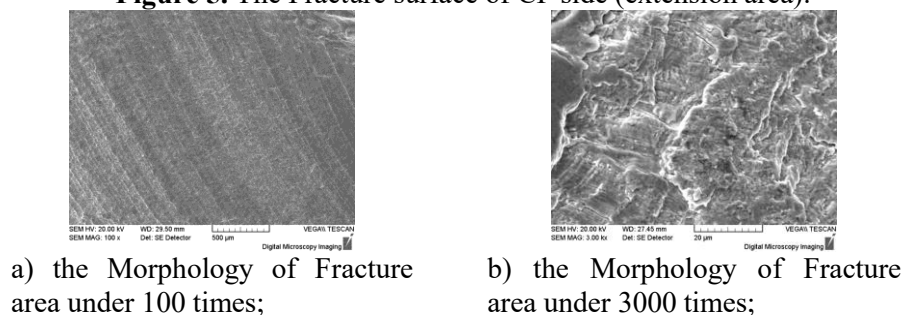
**Figure 6.** The Fracture surface of CP1 side (extension area).

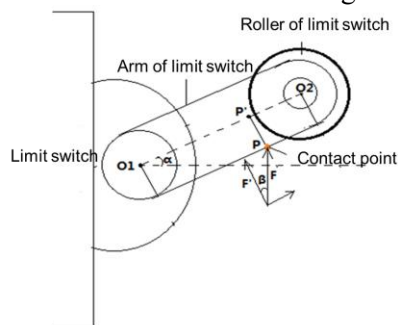
According to the size of the pressure plate and the installation operation, the stress state of the pressure plate is simulated. The limit switch action torque is 23in • lbs (about 2.599Nm), the swing arm length is 38.4mm. The force is about 67.4N when the limit switch just action (action stroke 10 °) by calculating, and the force is about 170N when the limit switch act to pressure to the limit position (Full stroke: 37 °). The force situation of limit switch is shown in Fig.9.

**Figure 9.** The force situation of limit switch.

When the lower limit switch of GCT121VV valve is operating, if the pressure plate cannot be pressed to the roller directly during the action, the force arm will be shortened. Inspecting GCT121VV valve installation, finding that the upper limit switch arm and the pressure plate has contact marks. When the wheel directly contacts the arm it will cause the force increasing.

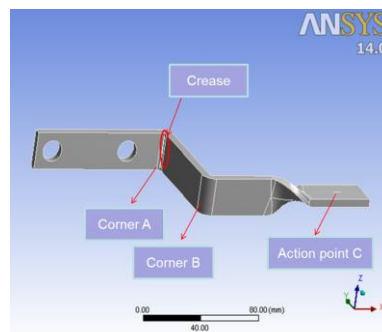
mm, the crease depth is about 0.2 mm, the crease and the width are 0.2 mm. The inner surface of the bolt hole is set to a fixed confinement boundary condition, and a concentrated force  $F$  which is vertically downward in the plate width direction is applied at the C of the right side of the platen. The simulation model is shown in Fig.10.

**Figure 10.** The Simulation model of pressure plate.

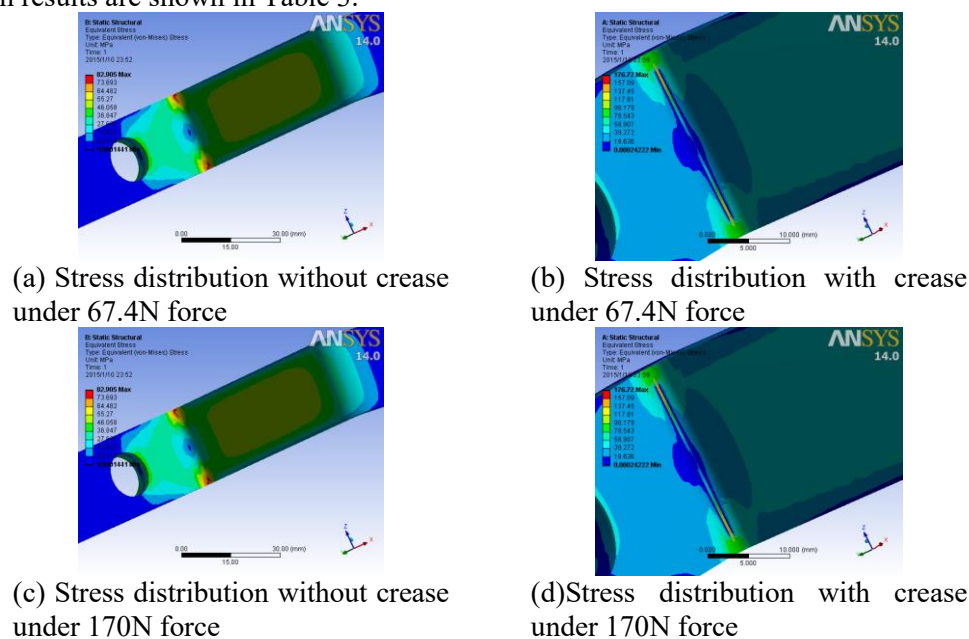
**Figure 11.** The stress nephogram of pressure plate under different force.

The stress distribution of the two kinds of press plates under different loads is simulated by finite element simulation, which is with and without processing creases. When the limit switch act, the roller is not contact with the pressure plate, and the force is 67.4N; when roller contacts plate, the force is

170N. The simulation results are shown in Table 3. The results show that the maximum equivalent stress of the corners is 445.7MPa, and the 316 stainless steel generally allowable stress of 480MPa.

The maximum stress of the crease plate at 170.0N (i.e. the plate pressures on the roller and close to the limit switch) is 445.0MPa, closing to the allowable stress of the material 480.0MPa. Compared with the non-crease plate, the stress of the crease part of the crease plate is obviously increased, and the stress concentration at the crease is obvious which is consistent with the failure of the failure plate, and it greatly reduces the strength of the pressure plate<sup>[5]</sup>. Inspecting the valve and finding that the valve is improper install. the upper limit switch on the valve arm and the pressure plate has contact marks, resulting in full stroke force of valve is more than 170.0N, the pressure plate crease stress exceeds the allowable stress.
