Study on Cracking Mechanism of Hardened Planetary frame

Abstract. Planetary carrier made by 45 steel appear quenching crack, which is analyzed in chemical composition, hardness test and metallographic microscopic structure. The reasons of quenching crack of planetary gear include the unreasonable structure of the planetary carrier, thinner annular wall on the base of the upper part, and in dangerous area of the 45 steel in the process of quenching. The faster cooling rate of quenching results in a centripetal stress with the thick-wall part, which is greater than the ultimate bearing capacity of the material.

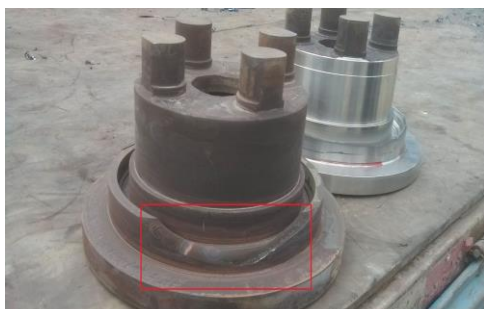
Figure 1. Position and morphology of quenching crack of planetary carrier.

Quenching crack appears on the inside of the annular upper part of the base of the planet carrier (thickness 10mm, depth 17mm, see figure 1). The crack extends radially to the inside of the annular portion at about 45 ° and along the circumferential direction, upwards and towards both sides, causing large crack of the annular portion. The macroscopic morphology of the quenching crack is shown in figure 2.

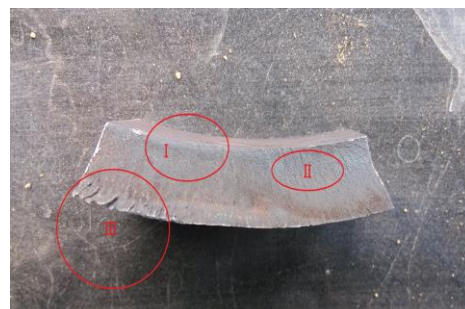
Figure 2 Macroscopic morphology of quenching crack.

It can be seen in figure 2, the crack starts at position I, rapidly expands outward at position II, cracks at position III, which is a significant final rupture region.

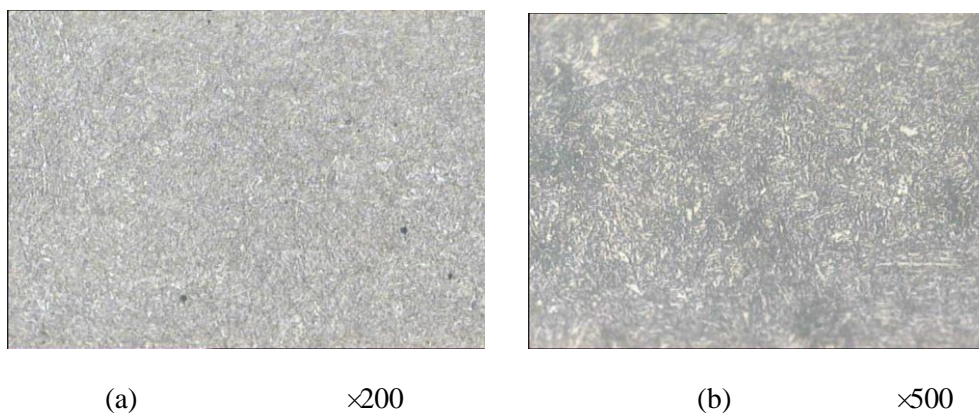
Figure 3. Metallographic microscopic structure in the center of the annular site.

Comparison of figure 3 and figure 4, the metallographic microscopic structure is completely the same in the crack at the initial stage and the center of the annular site, namely, the tempered sorbite structure with homogeneous distribution, without uneven organization and impurity that may cause cracks in the metallographic microscopic structure. Therefore, it is possible to eliminate the potential of quenching crack due to harmful tissue[4].

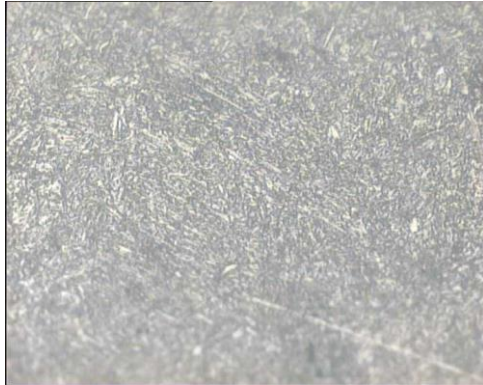
The Metallographic microscopic structure of the crack at the initial stage is also the tempered sorbite structure with homogeneous distribution(see figure. 4), consistent with the theoretical results.

Figure 4. Metallographic microscopic structure of crack at the initial stage.

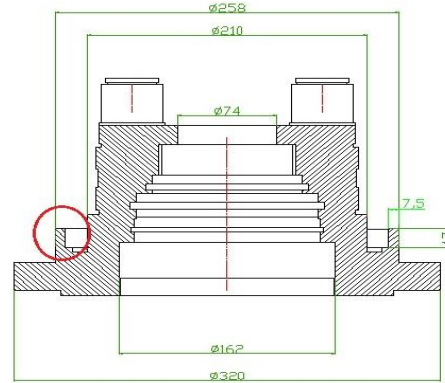
Figure 5 . Structure Dimension Drawing of the planet carrier.

The position with red circle in figure 5 is actual position of quenching cracking, the thickness of wall, smaller than other position clearly, belong the position easy to cause hardening break. Due to the small thickness of the wall, the actual cooling rate will be faster than that with the thicker wall (Lampstand of Planet carrier).In the process of quenching cooling, the cooling contraction of the annular part will precede the lower part (Lampstand of the Planet carrier), resulting in the asynchronism of cooling shrinkage.

In a moment, when the annular part nearly finish the cooling shrinkage, due to slower cooling rate of the bottom(Lampstand of planet carrier), its cooling shrinkage behavior fall behind the annular parts, and then the bottom(Lampstand of planet carrier) will continue to cooling contraction; meanwhile, the cooling contraction of the bottom will be limited by the annular parts, there will be a centripetal (contraction) stress on the root, when the stress exceeds the ultimate strength of hardened and tempered NO.steel, which will cause quenching crack; The quenching crack will start from the weakest part of the annular part, and then rapidly expand, eventually complete crack. On the other hand, the NO.45 steel dangerous size of quenching is 8~15mm, the wall's thickness of annular part is just in the range, so that the possibility of quenching cracking greatly increased. Therefore, the size of the planet carrier is the direct reason to cause the quenching crack.

The annular groove on the upper part of the Lampstand should be processed after quenching and tempering. Or enlarge the radius of the fillet on the root of the annular groove.

Adding an annular flat steel in the annular groove on the Lampstand before quenching. Or improve the placement of the workpiece in the quenching basket.
