Degradation and Reinforcement of Industrial Gas Tank Support Structures. Thirty-Year Long Monitoring

Janusz R. Krentowski ¹, Piotr Knyziak ²

Abstract. An analysis of reinforced concrete supporting structures of more than a dozen liquid gas tanks mounted on tower support structures located at different sites on Poland's territory is presented. Stability testing of the degraded structures was carried out over a period of 30 years and pointed out significant defects that prevented safe operation of the tanks containing hazardous medium. Analysing complex stress states, as well as displacements of shell structure components, the authors developed a concept of strengthening the structures. Initial repair works, which had been carried out without proper supervision, failed to meet the mandatory requirements and were not compatible with the original design solutions. After several years of operation of the reinforced structures, their degradation states were assessed again. The next stage of repair works was carried out under the supervision of the authors together with authorized representatives of the investors.

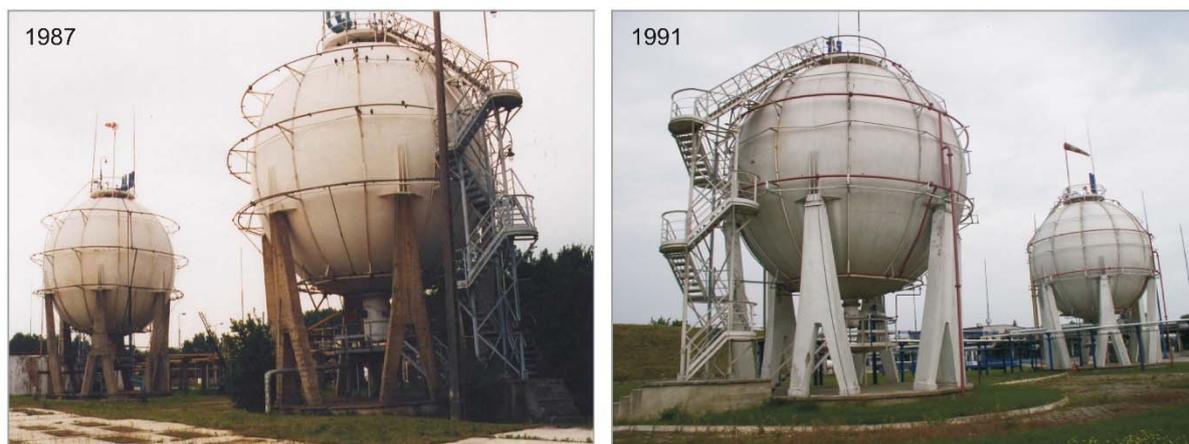
Gas tanks as building structures should comply with certain required standards concerning the calculation, design, construction and operation of engineering structures [3, 4]. Examples of the tested spherical tanks with their damaged supporting elements are shown in figure 1. It is necessary to carry

Figure 1. Examples of examined gas tanks with a capacity of 600m³ in 1987 and 1991

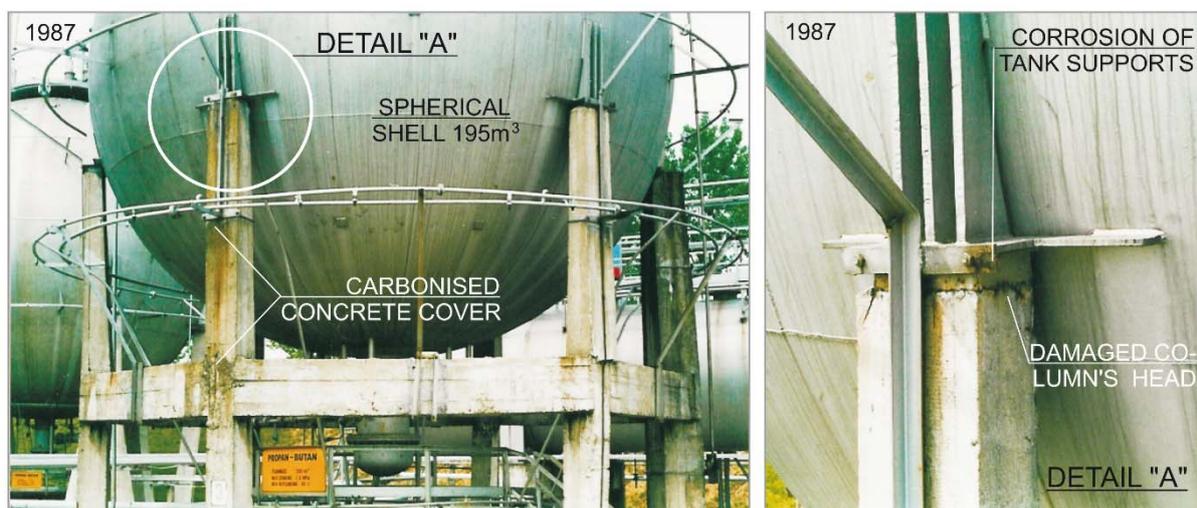
Figure 4. Structural faults of the support structures of tanks with a capacity of 195 m³

The corrosion process in properly implemented and used concrete structures (figure 4), working in environments defined as class XF1, XF3 according to aggressiveness standards, is expected to be initiated only after about 50 years. However, in an environment polluted with aggressive substances such as SO₂, NO_x, Cl belonging to classes XA1 and XA2, the corrosion process is significantly accelerated. This was found to be the case practically in all of the assessed structures. The above destructive phenomenon with the highest degree of deterioration was found in the parts of the supporting structures buried in the ground.

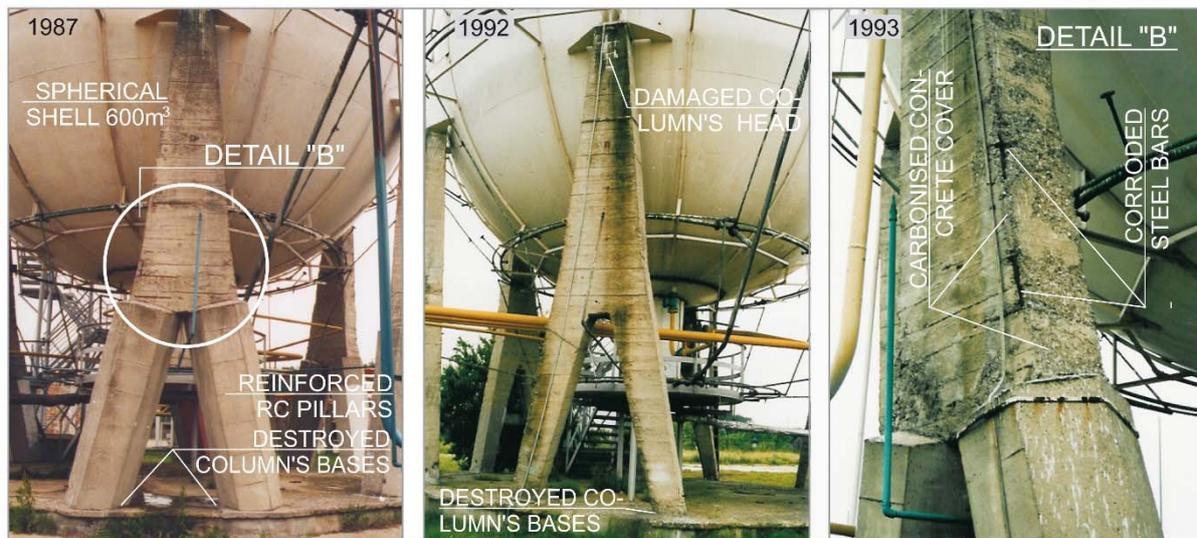
During the operation of the carbonized elements, the corrosion products increased their volume and generated tensile stresses, which resulted in concrete cracks and loosening of the large parts of coating surfaces [5]. These damaged parts made it easier for the aggressive environment factors to penetrate into the structure and, as a result, intensify the corrosion processes, while corrosion losses diminished the bearing capacity of reinforced concrete elements. The diversified inclination of the 600 m³ tank's columns ($>6^\circ$, cf. figure 3) constituted the main cause for the weakening of the lower column zones. The cross-section of the trestle support zone, including the losses produced during the long years of operation, turned out to be particularly dangerous and insufficient for safe transfer of the operating loads. Faulty support zones of the column heads failed to provide correct load transfer onto the supporting elements. Degraded supporting structures posed a threat to the safety of the tanks, and deformation processes were the cause of asymmetry in the shape of the balanced membrane structure of the tank steel shells.

Figure 5. Structural faults of the support structures of tanks with a capacity of 600 m³

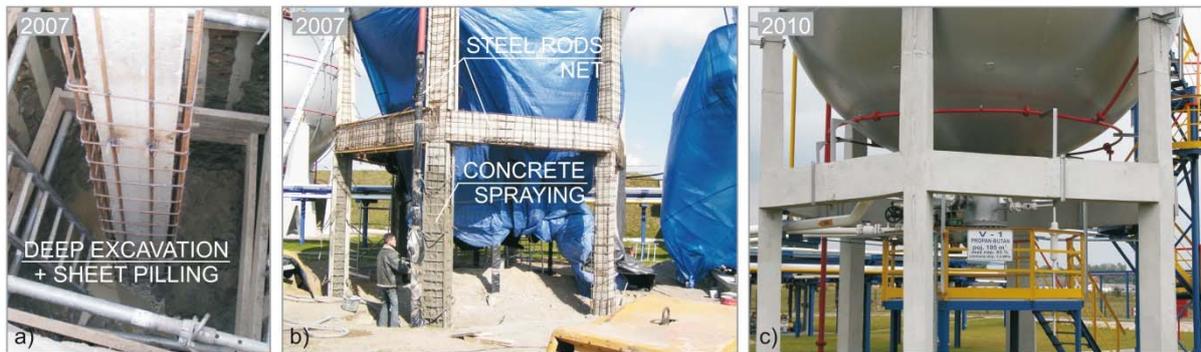
Figure 6. Details of the implemented tank reinforcement structure: a) underground zone, b), c) over-ground zone

Repair works, carried out in the years 2003 – 2007, and began with protecting the parts of the structure resting in the ground. Excavations were made around the columns to unearth the upper part of the foundation plate. The excavations were made secure with tight walls. The actual width of the excavated trenches was determined by the safety standards required for people carrying out this type of repair work. The degraded reinforced concrete structure was first made clean with water stream and then protected against the corrosion process by applying a reinforcing concrete layer of C25/30 class strengthened with rods of 8 mm in diameter made of ribbed steel. To attain the required conditions of adhesion, strength and tightness of the fillings, the shotcreting (concrete spraying) method was used. The concrete mixture was laid in layers to form a coating of final thickness of about 4.5 cm. To eliminate concrete shrinkage, special types of cement were used. The work involved reinforcement of two opposite side columns at the same time. The scope of the repair work is shown in figure 6.

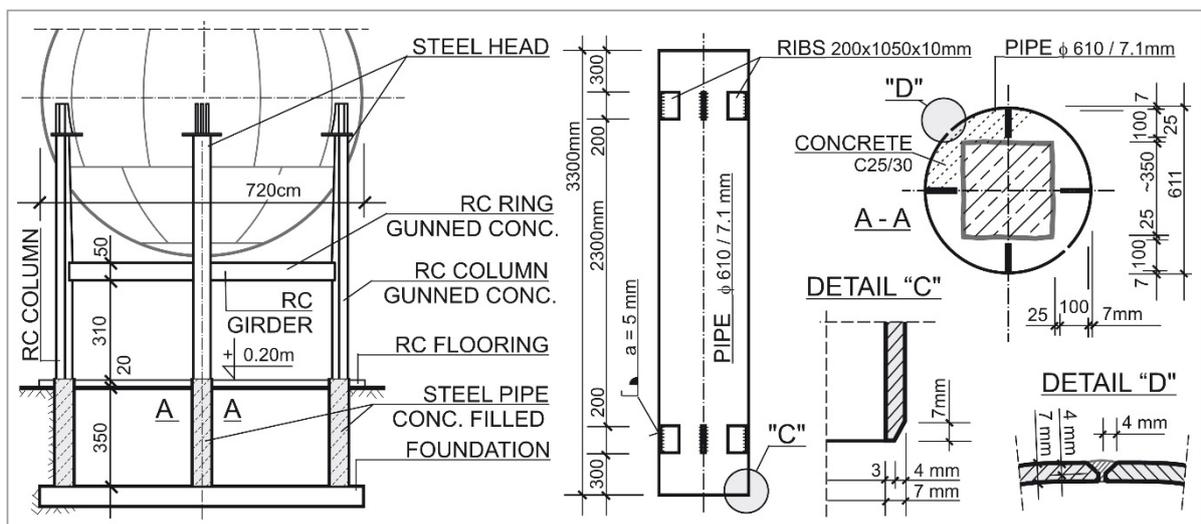
Figure 7. Reinforcement concept of the degraded elements of the 195 m³ gas tank

The proposed method of strengthening could not be used in places where there was a high groundwater level making trench work impossible. In such cases, excavations were carried out near the columns to a depth of about 60 to 80 cm below ground level, and then prefabricated elements made of a steel pipe cut in half with an outer diameter adapted to the dimensions of the reinforced column were put in and stabilized. The outer surfaces of the tubes were cleaned by sanding and secured with corrosion-resistant coating. The bottom edge of the element had been made in a shape of a "blade" to facilitate its penetration into the soil. The side edges of the element had been also sharpened in order to make it easier to join them with butt welds. The inner surfaces of the pipe were cleaned by sanding and left without any coating. The tube was inserted into the ground as deep as the upper foundation plate level. The gravel from the inside of the pipe found around the tank structure was removed by washing out and pumping. After cleaning the pipe, its interior was filled with class C25/30 concrete. The applied solution is shown in figure 7. The next stage of work was the repair of the damaged surface of the columns and girders, situated above ground level. The repair was done using shotcreting of the previously grinded surfaces of the damaged parts. The final stage of the strengthening activities was the protection of the sheet of the spherical tank supports and the surface of the column heads from reciprocal displacements in a situation of exceptional loads.

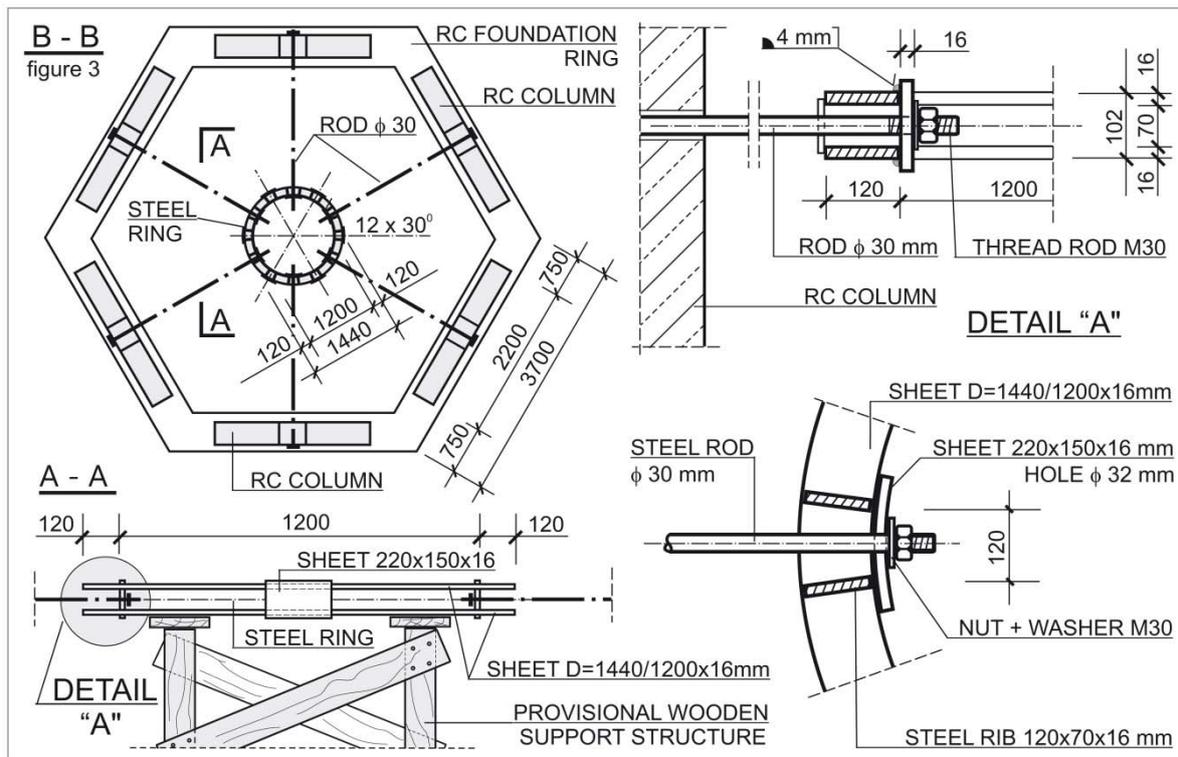
The authors' research conducted on several successive tank structures showed their pre-failure state, which made it necessary to put them immediately out of service. In the examined structures the connection of the supports with their foundations was made as articulated, which in the case of the inclined bar supports failed to ensure reliable equilibrium of the whole structure. As a result of progressing degradation processes of the structure, there was a possibility of its losing overall stability thus leading to imbalance and sudden uncontrolled disaster. As a result of repair activities, original concepts of strengthening the elements were implemented.

Figure 8. Stabilization concept of the degraded columns of the 600 m³ gas tank

To strengthen the columns' base zones, it was necessary to create special reinforcements that would take over the peripheral forces. It was achieved by placing ring-shaped concrete supports stabilized by proper connections to the foundations, which eliminated mutual displacements of the structural elements and rotation of the columns' bases. In some cases, a customized solution using a centric steel ring to take over forces from tie rods was introduced. The ring was mounted below the bottom part of the spherical shell, as shown in figure 3 and 8. The horizontal tie system made of steel rods with a diameter of 30 mm provided redistribution of internal forces in all structural elements of the tanks' support, which resulted in the compensation of effort states caused by exceptional loadings. To adjust the tension and stability in the areas of surface anchoring, trestles with nuts with M30 metric threads were used.

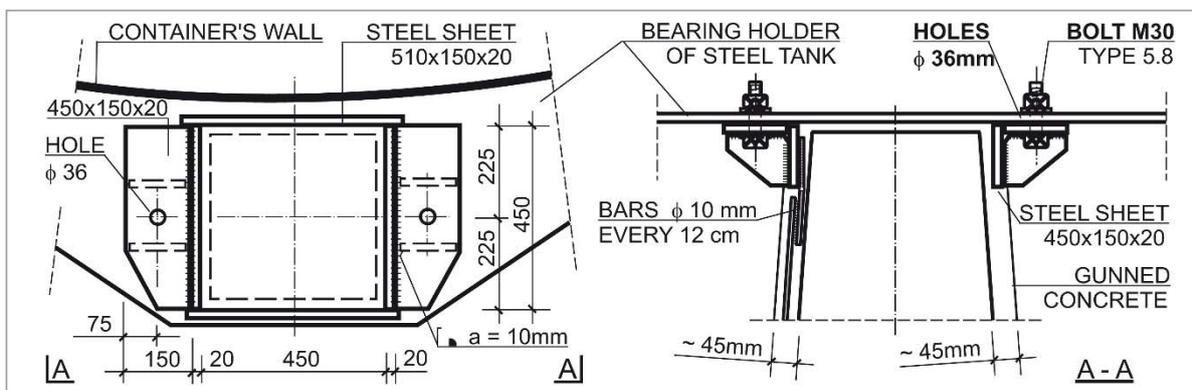
Figure 9. Stabilization concept of the support structure's head of the 600 m³ gas tank

The whole structure shaped that way provided the suitable conditions for stable equilibrium. The steel containers' support plates resting on the columns' head surfaces were also protected against mutual displacements. The implemented stabilization solution provided proper overall stability, also eliminating the impact of temperature on the state of internal stress in spherical steel shells (see in bold in figure 9). The degraded reinforced concrete structure of the trestles was protected against corrosion processes with reinforcement layers about 40-50 mm thick. To attain the required conditions of adhesion, strength and tightness of the fillings, the shotcreting method was used. As a result, it was possible to secure and form a monolithic structure of existing carbonated concrete substances and exposed reinforcement bars. In the period of extended operation, the implemented surface reinforcement protected the coating against cracks caused by changes in outside temperatures. After shotcreting, it was possible to obtain a monolithic, rigid reinforced concrete structure taking over the bending moments produced by tilted columns (figure 10a).

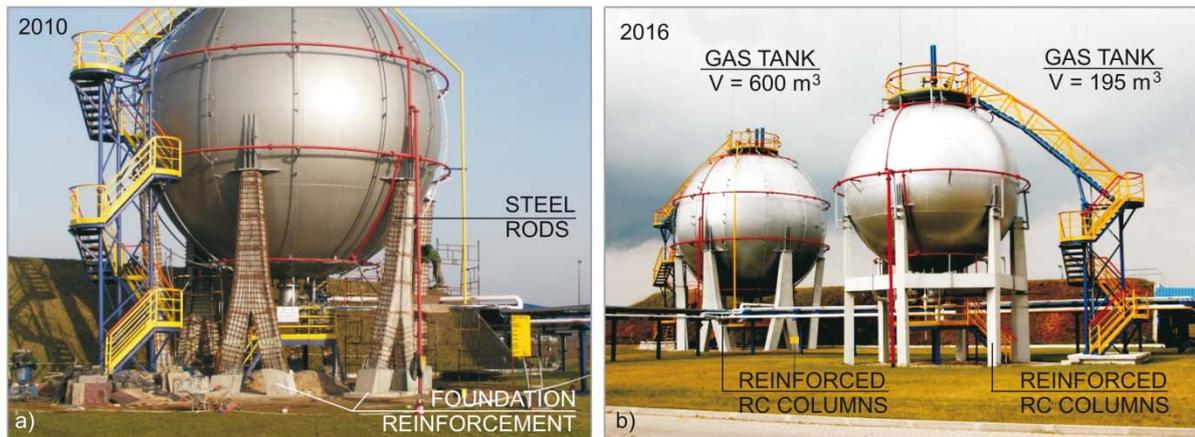
Figure 10. Details of the implemented tank reinforcement structure: a) view of the columns, b) view of the tanks after their structural reinforcement

Resulting from the undertaken tests, the structures were allowed to operate for another five-year period, and the overview of the reinforced structures after the following several years is shown in figure 10b.
