Mechanical fasteners used in historical Siberian shipbuilding: perspectives for metallurgical analysis*

Abstract. Recent discoveries of shipwrecked vessels in the northern reaches of the river Yenisei led to a number of questions concerning the history of shipbuilding in Siberia and the technical features of the first vessels of the industrial era to navigate the Northern Sea Route and the Yenisei. One of these questions addresses the features of mechanical fasteners used in the construction of the Siberian vessels. The answer to this question may provide information on how the first vessels, constructed in Siberia during the 1870's, were able to sail the high seas of the Arctic Ocean and reach European ports. In this paper, we provide a description of iron mechanical fasteners obtained from one shipwrecked vessel and discuss on the perspectives of a metallurgical analysis

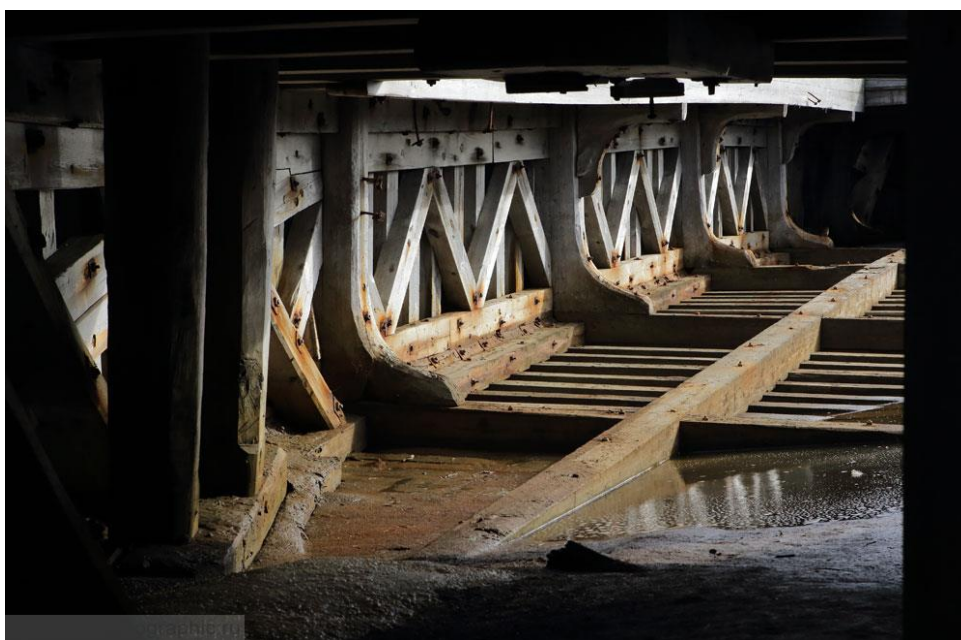
Figure 1. The structure of a barge hold (cargo box) as seen in a grounded barge wreck in the Laptev Sea (c. 1930's–1950's). Image from the 2014 expedition of Sergei Karpukhin (accessed <http://karpukhins.livejournal.com/181715.html>) (printed with permission of author)

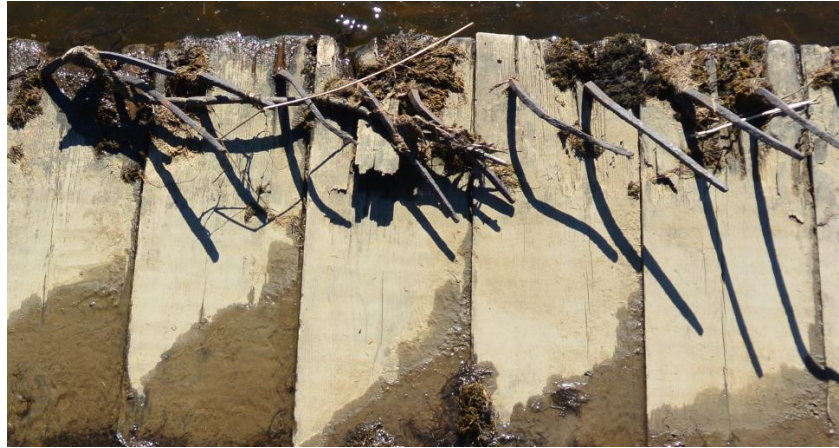
As seen from the images of the wreck, nails were the most distributed mechanical fastener used to construct these vessels. Their implementation ranged from securing the bottom planks of the below waterline hull to the floor beams, securing the hull planks to the ribs, and fastening the deck planks to the deck beams. The use of such crude nails in Siberian shipbuilding lasted deep into the twentieth century. Apparently, industrial production of such large nails lagged behind the growing demand for them as the shipping on the Northern Sea Route became ever more intense. Local nail production, however obsolete, provided a temporary solution to the problem. However, in the 1930's it was also incapable of coping with the demands for the construction of new vessels and the maintenance of existing ones as seen from archival materials [5, L. 60 verso].

Figure 2. Nails from overturned deck planks. Signs of deformation caused by bending and torque are visible

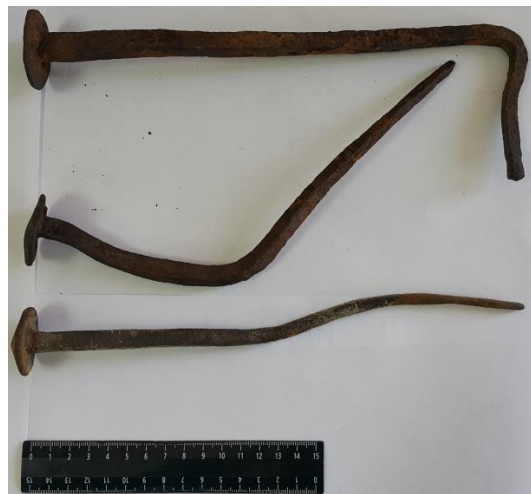
Figure 3. Three nails taken from the first wreck as specimens for metallurgical analysis. Top – Type B; bottom (2) – Type A. All specimens were bent. The first nail was bent deliberately for additional structural strength; the second specimen demonstrates deformation caused by torque (apparently the wooden member was twisted around the axis of the nail)

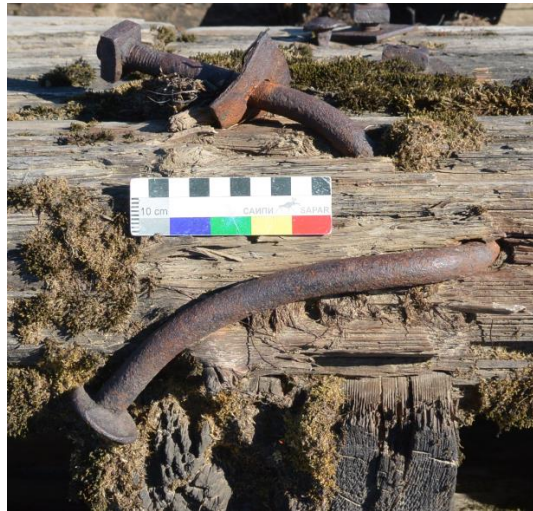
Bolts, as seen from Table 1, played a critical role in the assembly of the ship frame (Figs. 4–5). The vessels, both of which were large river barges were flat-bottomed, which, according to structural mechanics, requires a stronger frame than curved or angular bottoms. The members of the frames of both vessels consist of ribs (15 cm thick), deck beams (not preserved), cross-members (diagonal beams), which provided extra support for the ribs, and floor beams. All of these structural elements were held together by bolts. The washers that were fitted on the bolts and provided load distribution over the surface of the wooden members were all crudely made from lengths of iron or steel strips and cut to size. The majority of nuts were also crudely made, being square and even rectangular, although separate hexagonal nuts can still be seen on the wreck; these, most likely, were imported from the industrial centers of European Russia.

Figure 4. Two bolts, square washer, and square nut with scale marker. These two samples were bent

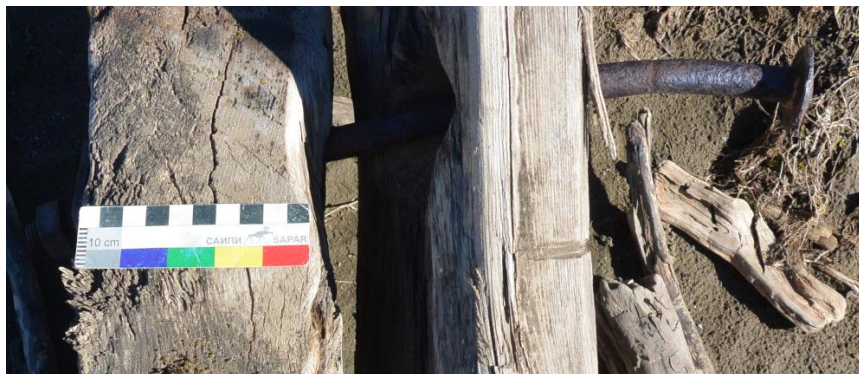
Figure 5. Demonstrates the length of the bolt holding two wooden members of the ship frame. The bolt and the wooden members are deformed due to shear stress

As we have found no signs of sheared bolts or nails, shear failure of the metal fasteners seems to have been a minor concern. However, it affected the wooden members to some degree; as the vessel rocked on the waves (usually, an up and down motion), shear stress caused deformation around the bolt holes (Fig. 5). Bearing failure of the wooden structures also seems to have been an insignificant concern, due to the properties of wood to withstand

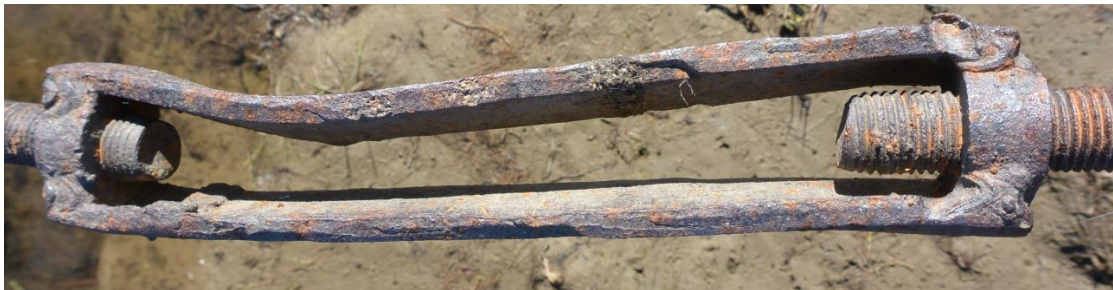
The most curious mechanical fasteners found were threaded rods and turnbuckles on wreck A (Figs. 6–7). No analogs have been found on other wrecks. It was first supposed that the rods were either alien to the structure of the vessel (installed years later to transport the wreck, supposing that it was an obstacle to navigation), or were somehow utilized to secure cargo. However, it seems more likely that these were initial structural elements of the vessel. The rods and turnbuckles supposedly held the mooring posts; they were pinned to the floor of the barge and stretched to the deck, thus, giving us information on the vessel's depth. A key feature of this component, allowing us to more or less accurately date the vessel is the design of the turnbuckles. An analysis conducted by the Department of Welding of Flying Apparatuses concluded that the turnbuckles were made by welding two iron plates to two hollow cylinders with an inside thread. The type of welding used was arc welding. Fig. 6 is a testament to this observation; traces of the weld pool are still visible on the structure. Consequently, vessel A could not have been built prior to the 1930's; even at that time there

Figure 6. A turnbuckle with two threaded rods from wreck A. The weld is clearly seen.
The upper plate buckled

Considering the threaded rods, their deformation can be clearly visible on the first wreck. As the rods are all deformed in one pattern, it can be suggested that this was a result of the deck collapsing and compressing the rods and turnbuckles, which acted as slender columns and buckled. Using Leonhard Euler's critical load equation

The turnbuckles would be the element that tensile stress would be most exerted on. The welded joints would be the most vulnerable part of the component. However, as seen from the images, either the tension was little, or the joints proved strong enough.

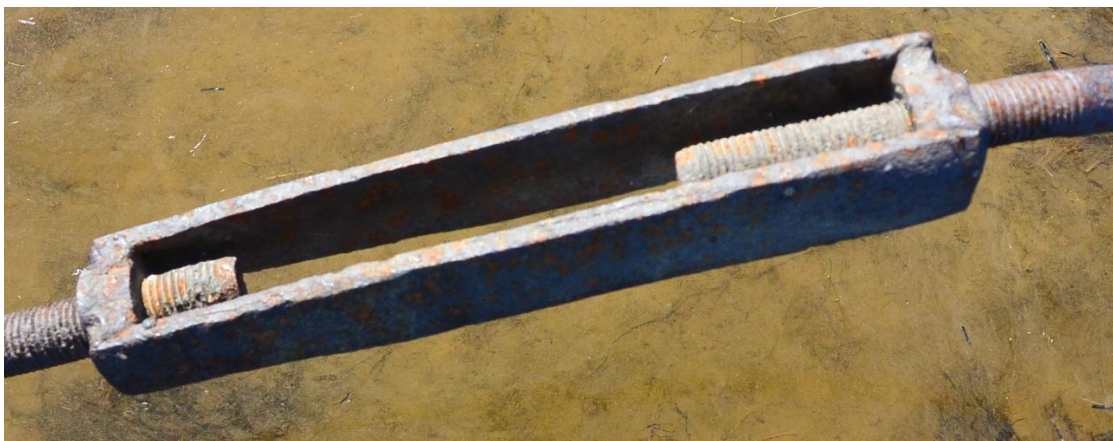
Figure 7. Another turnbuckle from wreck B
