# Research on Fracture Failure of the Underwater Welding Joint

**Abstract.** In this paper, by testing welding joints of their metallography and hardness, we analyze the metal structure. And then, the microstructure characteristics, macro and micro fracture morphology of underwater welding joint were investigated by means of metallographical examination and SEM. The fracture failure of the underwater welding joint is discussed here. The cracks are the major factors to fracture failure. The cracks spread along with the crack of the welding line, and this expand process generates dimple. The crack continues to expand under the action of tensile and the fracture fails eventually.

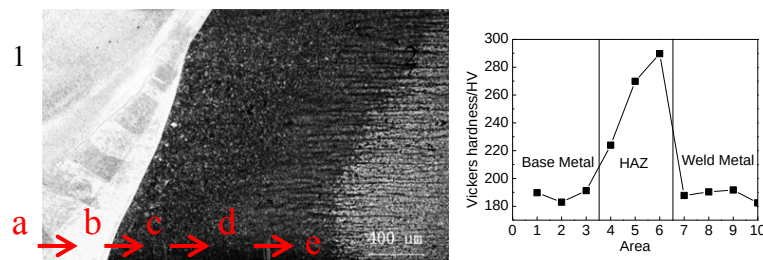
Fig.2 shows the change of metallographic structure and Vickers hardness near the fusion line. First figure show austenite weld (a), complete quenching zone martensite (b), Incomplete quenching zone martensite (c), tempered zone (d), and base metal ferrite and pearlite (e) from left to right. To verify the structures of areas, the Vickers hardness test is performed (Fig.2-2). In the pic, points 1-3 are the hardness of the base material, points 4-6 are the hardness of HAZ, and points 7-10 are the hardness of welding metal. The result is confirmed that the hardness of the heat affected area structure changes much more than that of welding line. The hardness of martensite is much higher than that of austenite, which is consistent with the previous analysis results of the joint [2].

**Figure 2.** Metallographic structure (50×) and Vickers hardness near the fusion line

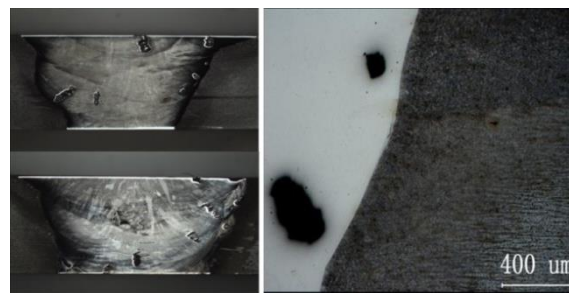
According to the Fig.3, there are some pores in the welding line, which is generated in the underwater environment when welding, and the pores are cut by mechanic processing and from the bubble holes on the surface as the Fig.3 showing. The holes are smooth on the surface and glossy, which indicating that gas is gathering in the process of the pores form. The welding area is surrounding by the sea water, and the water generated a lot of hydrogen gas in high temperature, and the hydrogen gas dissolves into the metal within the welding area. When the metal solidifies, the welding line solidified rapidly due to the extremely cold temperature, and the speed of hydrogen gas gathering and floating is lower than the metal solidification speed, so as to constitute the different sizes of pores. It could be struck out that the pores are mainly found at the edge of the welding line, especially around the welding line [2].

**Figure 3.** Pores of welding joint

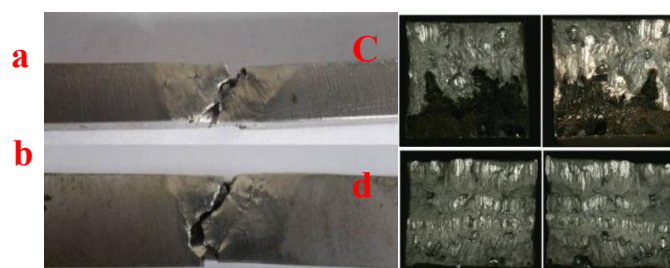
Fig. 4 shows two kinds of fractures on the welding joint, crack at the welding metal (a) and crack from the welding line(b). As the load increases, the crack spreads to the weld line till the joint broke down. A lot of cracks are found on the surface of the welding sample, which are generated by extension of the surface bubble holes under tension.

**Figure 4.** Crack morphology of welding joint

Many bubble holes are found exist at the fracture point with the low-magnification microscope. Numerous small bumps on the surface of the fracture points are formed from the bubble holes tension (Fig 4 a and b), and these bubble shells are not broken. The fracture point is spread out of the bubble

holes, which indicated that the bubble holes are not the cause of the fracture. Fig 4(c) sample has different structural colors at the fracture point, and the dark grey color structure found in the tension experiment is the beginning of the fracture of the welding area. Fig 4(d) sample has the same color as its fracture point, but there is no grey layer [3].

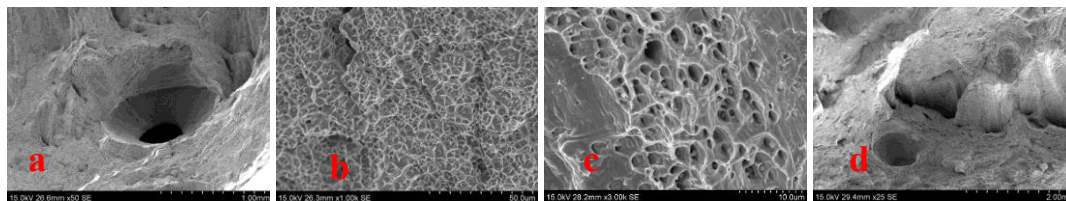
**3.4.1. Dimple Morphology** Fig.5a shows that the macroscopic shape of the fracture is fibrous, the color is gray, and the edge is under a shearing lip with a plastic deformation and a slip line. From Fig. 5b, it can be seen that there are a large number of honeycomb morphologies in the broken gap, which are composed of concave pits formed by many plastic deformations forming pores, these pits are dimple, and the bottom of the dimple contains the second phase particles or inclusions (Fig.5c). The fracture form is plastic fracture. Plastic fracture occurs after a large number of plastic deformations, the structure fracture in the direction of stress will leave a larger residual deformation, there are naked eye visible deflections, thickened, necking etc. in the vicinity of the fracture gap Plastic deformation often makes container diameter increased and shell thickness reduced. Because of the formation, growth and aggregation of microscopic cavities, the saw tooth-shaped fibrous fracture is definitely formed. The majority of this type of fracture is the wear-crystal fracture, so the fracture gap is not flashing metallic luster but dark gray. Because plastic fracture is slipping first and then fracture, the fracture mode cut off in the larger sense and the fracture is uneven [2, 4].

**Figure 5.** SEM of dimple cleavage

The edge has a shearing lip with  $45^\circ$  angle in the direction of main stress in which the dimple is formed. Fig. 5d shows the shape of the plastic fracture step, in the process of stretching, the plastic fracture is produced in many directions along with the crack propagation in each direction, and when the vertical cracks are intersected, the crack is combined and the step is formed in this place. The crack will continue to expand along the direction perpendicular to the tensile, and the intersecting crack can produce the step again until it breaks.

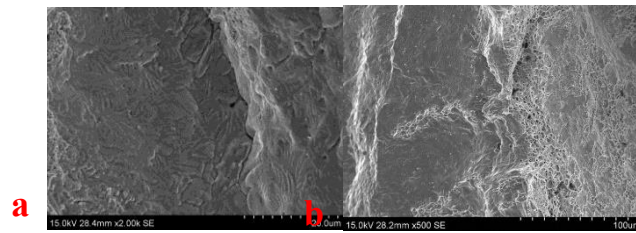
**3.4.2. Lamellar Tearing** Fig. 6 shows that the fracture is flat, the crack platform area is flat, the boundary is clear, the plastic deformation is almost few, it is a kind of cleavage plane formed by the sheet inclusions and the matrix under tensile stress, and the platform is separated by ridge tearing. There are low melting point non-metallic sundries such as sulfide, oxide and silicate existed in rolled steel plates, especially the role of sulfide, in the rolling process was extended in a flake, distributed in parallel with the surface of each layer, in the perpendicular to the thickness of the direction of the welding stress, the sundries first crack and expand, In the future, this kind of cracking occurs successively between the layers and forming a layer tearing. The morphology of the image is mainly because there is layered tearing crack in the connection, when the tensile test is done on the specimen, the layered tearing crack expands under the action of tensile force and the shape of Fig. 6b is formed in the process of expansion with plastic fracture [5, 6].

**Figure 6.** SEM of lamellar tearing
