Failure Analysis of a Service Tube

Abstract: One tube was cracked used in the primary reformer furnace in a fertilizer plant for two and half years. In order to find out the causes of cracking, the methods for chemical composition analysis, macro- and microstructure analysis, penetrant testing, weld analysis, crack and surface damage analysis, mechanics property analysis, high temperature endurance performance analysis, stress and wall thickness calculation were adopted. The integrated assessment results showed that the carbon content of the tube was in the lower limit of the standard range; the tube effective wall thickness was too small; local overheating leads to tube cracking in use process.

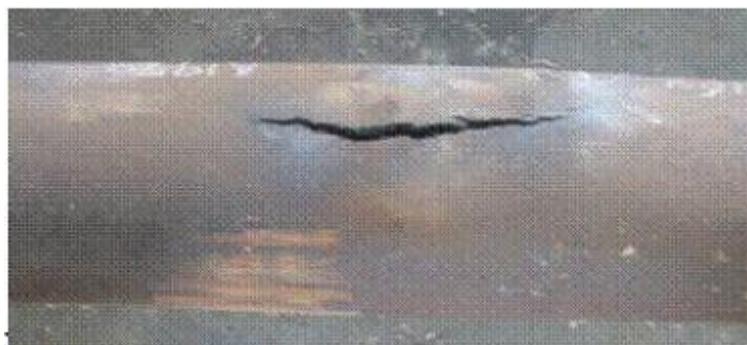
The whole part of cracking tube was removed, dissected, and sampled. The segment of physical fracture of the tube is shown in Figure1. The crack in the outer wall of tube is longer than that in the inner wall, about 218mm and 203mm, respectively.

Figure 1. The object of cracking tube

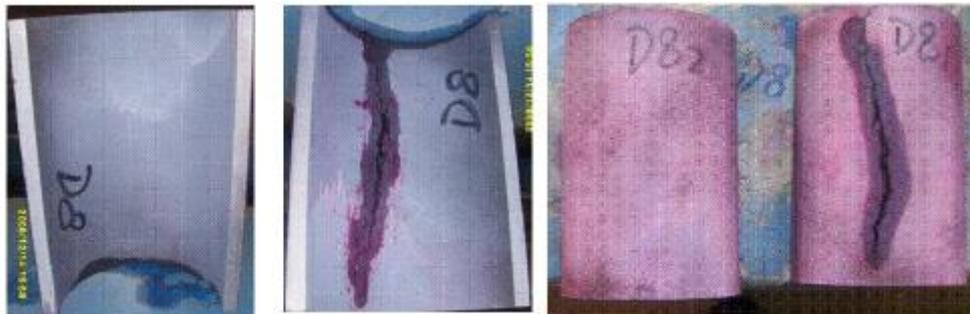
Figure 2. Results of dye penetrant testing on the surfaces both inside and outside of sample

The dye penetrant testing were used in both inside and outside surfaces of the sample in which no other defects were found in addition to crack. The inner dissected surface and the annular section were inspected also by dye penetrant testing, the results have been shown in Figure2. The main results showed that there were many long cracks in inner surface, these cracks extended from inside to outside surfaces, and a bit small cracks were found in the front end and vicinity of the fracture.

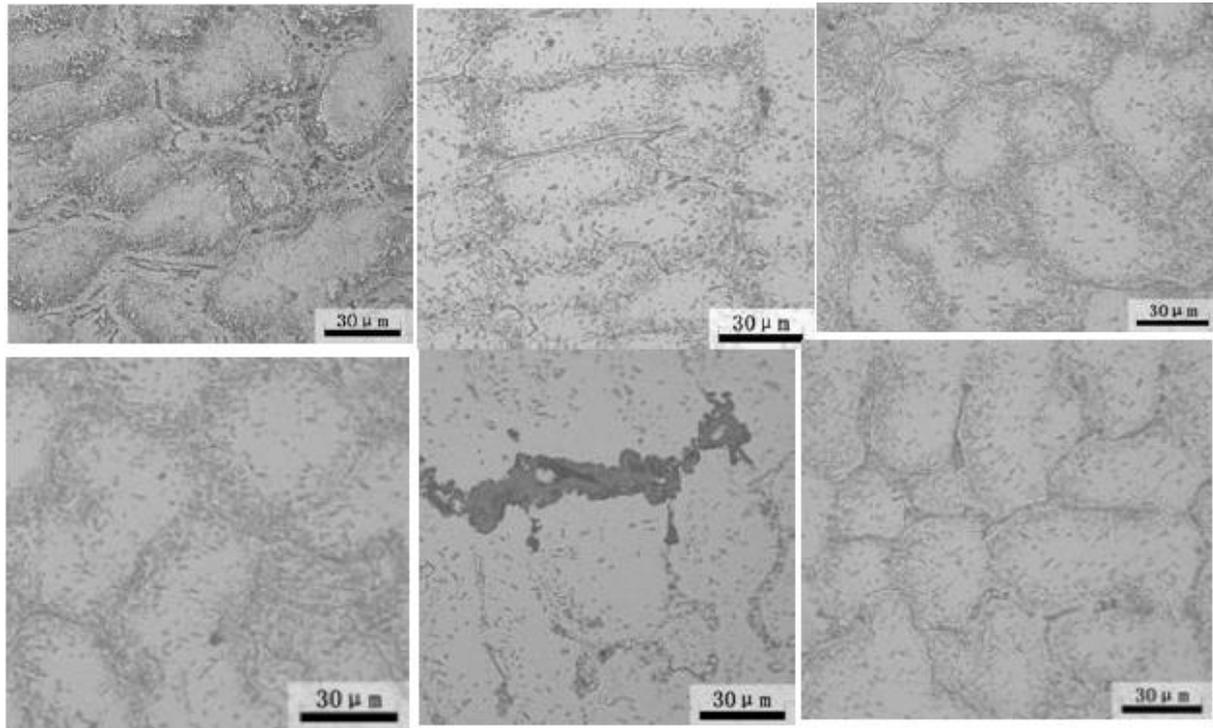
The microstructure of the tube can reflected its used temperature condition and time. From upper to lower of the tube, the microstructure was shown in Figure3. The microstructure of upper tube was the complete cast eutectic structure with a lot of fine secondary carbide, the results showed that the tube had been used at low temperature. The part was basically in good state on the above. The microstructure nearby the cracking had changed obviously with eutectic carbide as a chain-like

intermittent network, and the number of secondary carbide decreased, Eutectic carbide particles began to grow up and a little of rod-like carbide occurred. Both of them were accessed at high temperature. A sample was taken in opposite of the crack. Its secondary carbide particles decreased, gathered, and grew up, and the rod-like carbides increased. The microstructure was deteriorated. The microstructure near voids was composed of original chain-breaking carbide and the amount of the secondary carbide aggregating to the big blocks. It was clearly caused by over high temperature. According to the microstructure analysis, the temperature would be more than 900 °c.

Figure 3. The microstructures of the crack and its upper part, near part, and lower part

By above analysis of various parts, the microstructure of the upper parts was normal. In the lower parts, where exists different degree of overheating structure, the microstructure was deteriorated obviously near crack. So the tube cracking was caused by local overheating

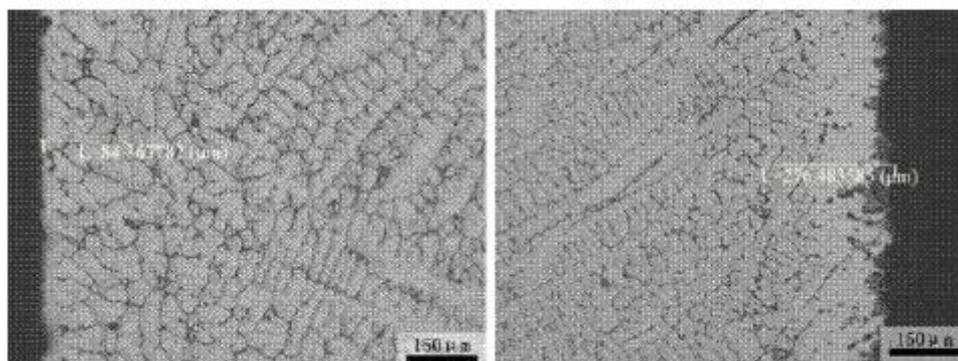
Figure 4. Damages of the internal and external surfaces

The damages of inner and outer surfaces were relatively minor, exception of the cracking, The damage in the outer surface was less than 0.5mm, and that about 0.1mm in the inner surface. This is normal oxidation corrosion in the use of furnace tube and it is not directly related to tube cracking.

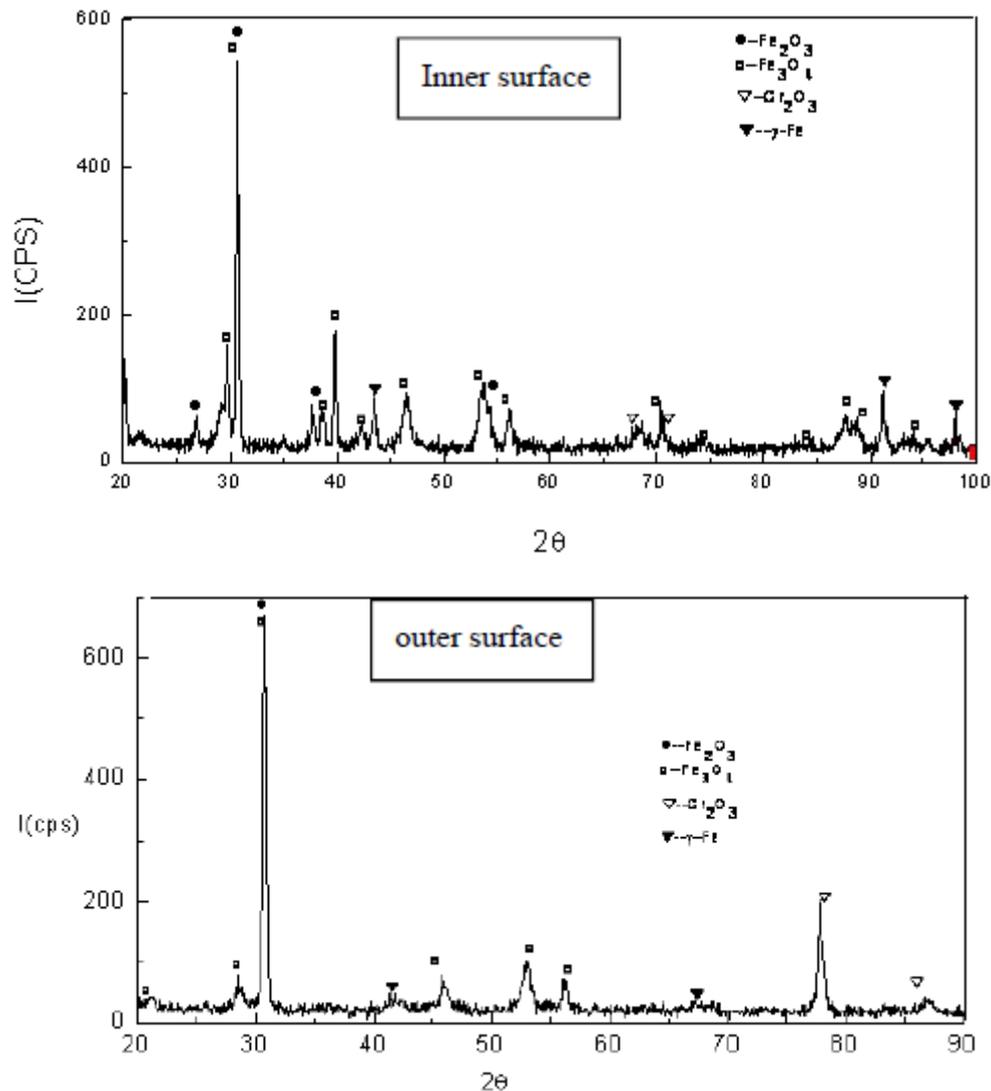
By x-ray diffraction analysis on inner and outer surfaces, there were Cr and Fe oxides shown in Figure5. Compared with other used tubes, the diffraction effects is basically the same.

Figure 5. X-ray diffraction analysis results of inner and outer surface

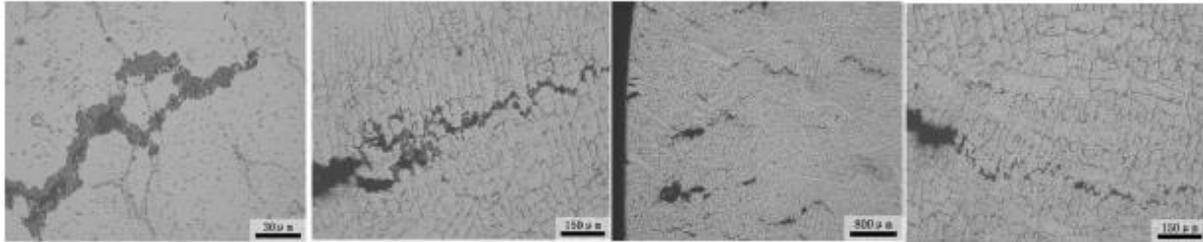
By the crack analysis, there were some creep voids existed in the front end of crack and in the vicinity of micro-cracks with a tendency of being gradually connected to micro-cracks. It was a typical structure characteristic of high temperature creep cracks caused by high temperature and stress [3,4]. All of them has no the original structure defects. The morphologies of the secondary micro-cracks in front end and creep voids were shown at Figure 6. The results showed that these creep cracks are the products of high temperature

Figure 6. Creep voids and micro-cracks
