# Analysis and Life Evaluation of CS<sub>2</sub> Reaction Tube

**Abstract:** The chemical composition analysis, macro and microstructure analysis, mechanical properties and other methods were used to analyze the state and life of CS<sub>2</sub> reaction tube for a period of time. The results showed that there is no sulfur corrosion ditch in the furnace tube, and the other one has a uniform corrosion state except for the severe local corrosion. The mechanical properties are good at room temperature. The number and appearance of  $\sigma$  phase are the main reason for making material brittle, welding property degradation and causing crack. The approximate residual life of the furnace tube is also evaluated by various means analysis and life calculation. It is recommended that the tube be replaced with a higher grade nickel-chromium alloy instead of HK40.

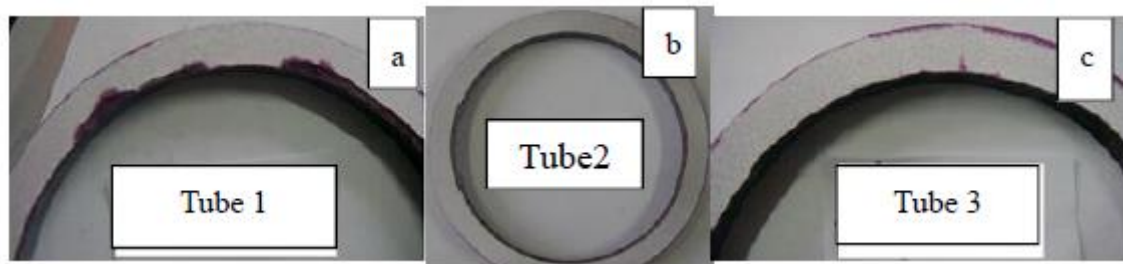
**Figure 1.** The penetration inspection results of three tube

The result of Penetrant inspection is shown in Figure 1 a, b, c respectively. Figure (a) is the inner surface of the tube No. 1 for selective corrosion and appears pit. The inner surface of pipe 2 is basically uniform corrosion in Figure (b). Figure (c) is the No. 3 crack pipe ring.

The past many cases show that a more serious sulfur corrosion groove was found in the inspection and assessment process for CS<sub>2</sub> reaction furnace tube serviced for many years. But the analyzed furnace pipes were not found to have sulfur corrosion groove.

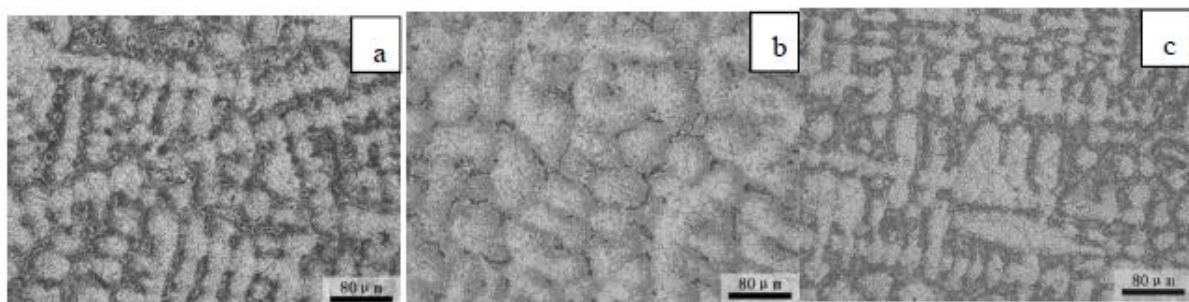
**Figure 2.** Microstructure of the matrix of three tube      oxalic acid electrochemical corrosion

The microstructure the matrix of the three furnace tube shows in Figure 2a, b, c, respectively, a eutectic carbides state remains intact in the microstructure, the secondary carbides is small and diffused, and there is a small amount of acicular  $\sigma$  phase. The state of carbides in tube 1 and tube 3 is basically the same, the number of needle-like  $\sigma$  phases to tube 3 is relatively small. Microstructure analysis for three tube used for a period of time shows that the eutectic carbides change little, which still maintain a better state and the secondary carbides are fine and dispersed which are in good condition. Precipitation of a large number of needles  $\sigma$  phase which is a hard and brittle leads to lower plasticity. This is the root cause of reduced weldability.

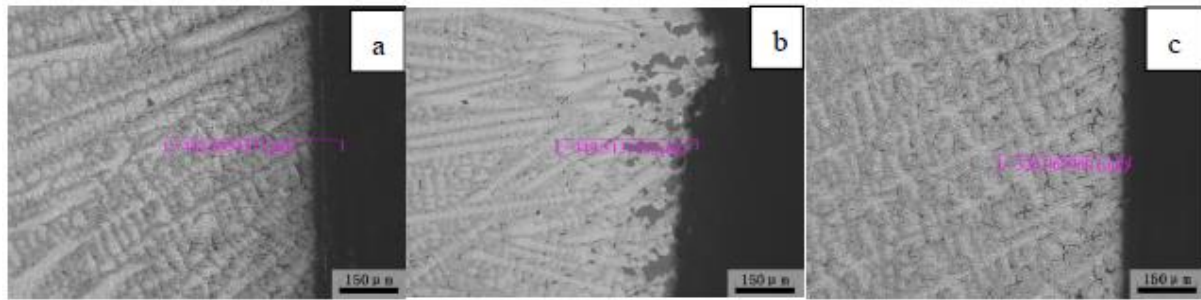
**Figure 3.** The microstructure of the outer surface of the three furnace tubes Oxalic acid electrolytic corrosion

The external surface corrosion is slight by detection for the three tube ring. The damaged layer within 0.5mm, including the transition layer. In Figure 3, a, b and c are the outer surface microstructure of the tubes 1, 2 and 3, respectively.

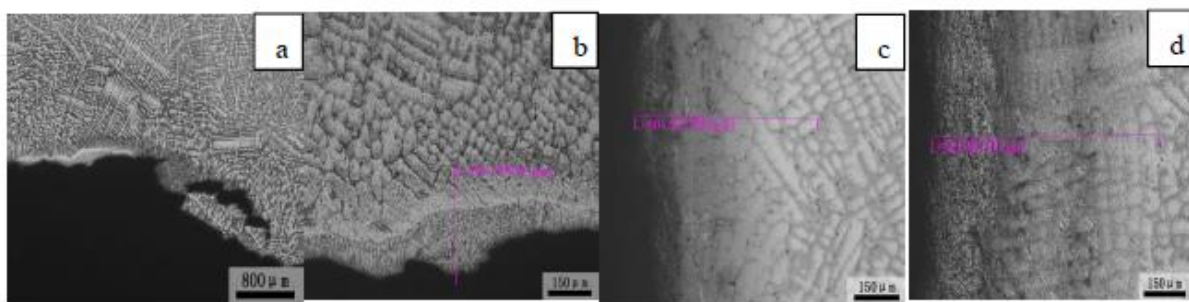
**Figure 4.** The microstructure of the inner surface of the furnace tube Oxalic acid electrolytic corrosion

The local severely corroded part of tube1 is in Figure4 (a), the more uniform corrosion sites in tube1 was shown in Figure 4 (b).The corrosion of the inner surface of tube 2 and tube 3 are shown in Figure 3c and Figured respectively. The corrosion of inner surface of tube2 and tube3 is uniform.

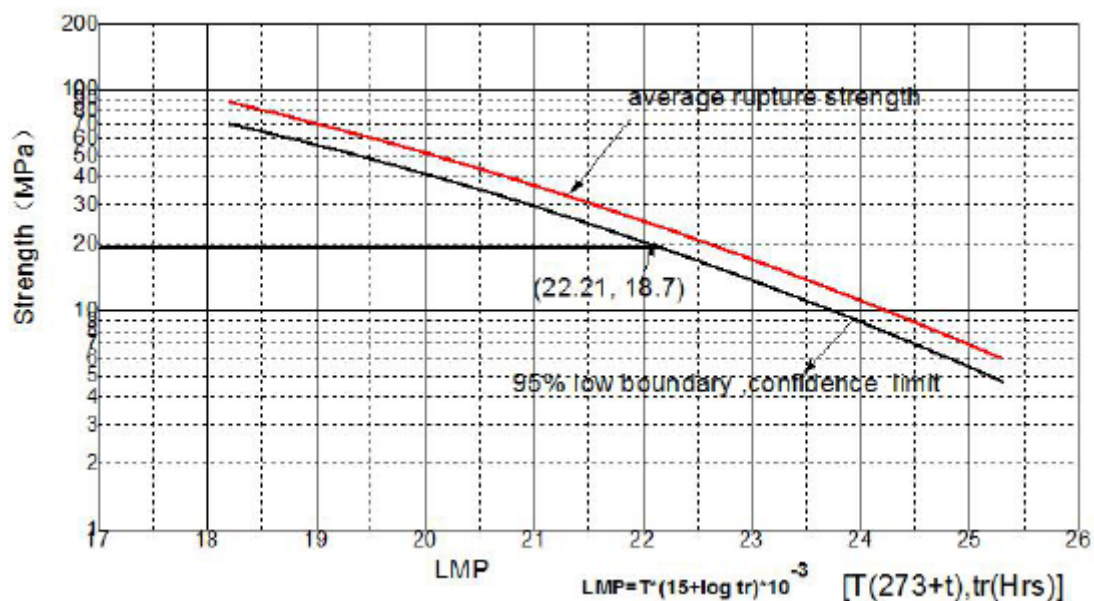
**Figure 5.** The L-M curve of HK40 alloy and evaluated point of remaining life

In this detection, the corrosion of the furnace tube1 is the most serious, so the furnace tube will be used to evaluate the remaining life. With the more serious corrosion, its effective wall thickness will be reduced, which will cause the furnace to bear the stress increased, the corresponding P value decreases, the residual life of the tube will also be reduced, In this paper, the medium diameter formula and L-M curve are used to evaluate the life [4].

The design of the furnace tube diameter 168mm, Wall thickness 14mm, The design pressure is 0.9MPa and the applicable temperature is 820 ~ 860°C. Furnace tube measured temperature between 706 ~ 841 °C. For safety, the temperature used for life prediction is 860°C. Measured maximum corrosion layer thickness of 6.4mm, used time is the 15 month (40,000hrs), the corrosion rate calculated by uniform corrosion is 0.356mm per hour. According to HK40 alloy L-M curve of  $P = T * (15 + \log tr) * 10^{-3}$  formula, P value for 40,000 hours is 22.21, L-M curve corresponding to its lower limit stress is 18.7MPa [5], the 80% of the stress is 15.0MPa as shown in Figure 5. According to the relevant provisions of GB150-2011 and JB4732-1995, the furnace tube in this paper belongs to the internal pressure cylinder equipment, the main stress can be obtained by the following formula

The measured minimum wall thickness is  $14-6.4=7.6\text{mm}$ . The outer surface corrosion layer is  $0.5\text{mm}$  and that of the inner surface is  $1\text{mm}$ . The minimum effective wall thickness for calculation is  $6.1\text{mm}$ . The safest minimum wall thickness for 40,000 hours can be calculated by the formula (1-1) is  $3.88\text{mm}$ . Safe and effective wall thickness of only  $6.1-3.88=2.22\text{mm}$ , according to the corrosion rate of  $0.356\text{mm/month}$ , the tube safe use of time only 6 months.

None of the three tubes was found to have sulfur corrosion ditches. Good mechanical properties, the strength index is good and is higher than the standard, the plastic properties of materials decreased. The eutectic carbides remained in a good condition by microstructure analysis. The secondary carbides are small and divergent and have a large amount of needle-like  $\sigma$  phases precipitated. Needle-like  $\sigma$ -phase precipitation leads to the material brittle and cracks and welding property decreased. The inside of the furnace tube contacts the reaction gas and the outside contacts the combustion air. Usually furnace tube are beard high temperature, internal pressure, weight, other stress, as well as repeated low-cycle fatigue caused by the parking[6]. In order to improve its high temperature corrosion resistance and high temperature strength should be replaced with a higher level of nickel-chromium alloy.
