# Analysis of Failures of High Speed Shaft Bearing System in a Wind Turbine

**Abstract:** During the operation of wind turbines with gearbox of traditional configuration, consisting of one planetary stage and two helical stages high failure rate of high speed shaft bearings is observed. Such a high failures frequency is not reflected in the results of standard calculations of bearing durability. Most probably it can be attributed to atypical failure mechanism. The authors studied problems in 1.5 MW wind turbines of one of Polish wind farms. The analysis showed that the problems of high failure rate are commonly met all over the world and that the statistics for the analysed turbines were very similar. After the study of potential failure mechanism and its potential reasons, modification of the existing bearing system was proposed. Various options, with different bearing types were investigated. Different versions were examined for: expected durability increase, extent of necessary gearbox modifications and possibility to solve existing problems in operation.

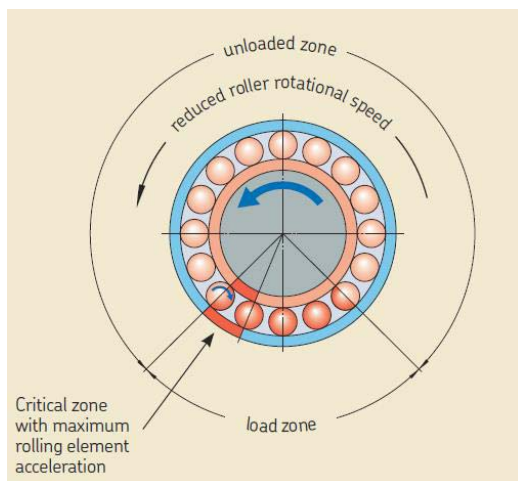
**Figure 7.** Mechanism of bearing failure caused by sliding of rolling elements [9]

Roller element bearings are vulnerable to the conditions of loading and unloading, which causes sliding of the rolling elements [9]. As explained in Figure 7 [9] the rolling elements leaving the loaded zone are disengaged from the inner raceway due to centrifugal forces and their rotational speed is lowered considerably. Then entering the loaded zone again the elements become accelerated, but their inertia opposes such acceleration, so the elements slide with respect to the raceways and excessive heat is generated causing overheating, structural changes and even adhesion in metallic contact areas. This failure mechanism is often referred to as smearing or adhesive wear. Structural changes of bearing material caused by repeated overheating is also one of the failure modes characteristic for wind turbine bearings, known as WEA (white etching areas) [10]. As pointed out by Erichello [10] there are several hypotheses for the root cause of these failures including not only sliding, but also impact loads, hydrogen embrittlement; electrostatic discharge, corrosion fatigue, and adiabatic shear. None of these hypotheses has been proven, and it is a field of current research.

The sliding of the roller elements affects larger bearings and bearing with high rotational speeds, which is the case of HSS bearings in the gearboxes of wind turbines. Avoiding too loose fits and too low loads are the methods of preventing this failure mode. In the bearing design procedures,

specifying minimum bearing load is the only means of preventing sliding of the rolling elements [11]. In the machines with fluctuating loads fulfilling these specifications may be impossible.

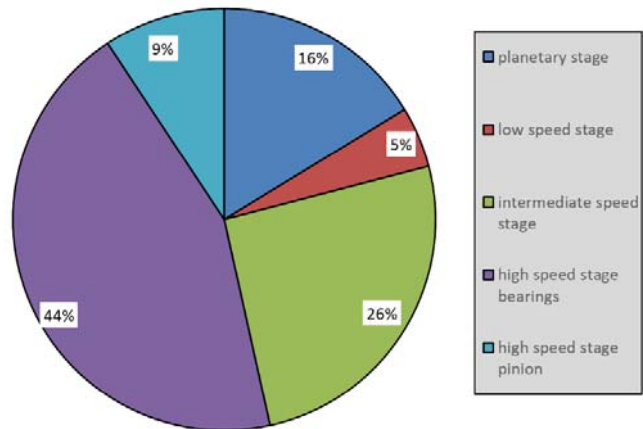
**Figure 8.** Percentage of failure of particular turbine elements in the analysed Polish wind farm [4]

An analysis of the reasons of failures in 1.5 MW wind turbines installed in one of Polish wind farms presented in Figure 8 showed that the percentage of particular reasons was similar to that observed worldwide, with 44% of the failures occurring in the high speed shaft, mostly in the bearings [4].

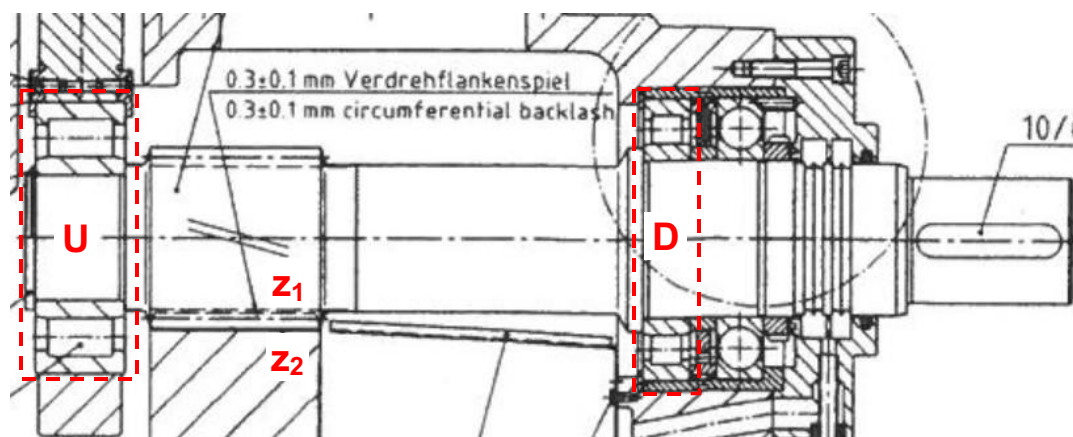
**Figure 9.** Existing bearing system of the high speed shaft in the analysed wind turbine [4]

Figure 9 shows the high speed shaft with its bearing arrangement of the studied wind turbine. The shaft is located on three bearings: first, on the left hand side there is a cylindrical roller bearing (designated as U – Upwind), providing radial support, and on the right hand side there is a system of two bearings: a second cylindrical roller bearing (D- Downwind) and four-point contact bearing, playing a role of locating bearing. In operation it was found that the downwind cylindrical roller bearing has the highest failure rate. Larger number of failures in comparison to upwind bearing is not consistent with higher theoretical rating life  $L_{10}$  shown in Table 1.

Inconsistency may be caused by the failure mechanism not considered by the standard bearing durability calculations, i.e. by smearing (adhesive wear) caused by sliding of the rolling elements. Sliding of the rolling elements is the reason of overheating of the bearing rings and structural changes of the bearing material. Plastic deformation of the material (Figure 10), being possible only at elevated temperature was observed in the microscopic image of the destroyed bearing ring [4]. This may indicate smearing caused by sliding of the rolling elements as a possible failure mechanism in the analysed case.

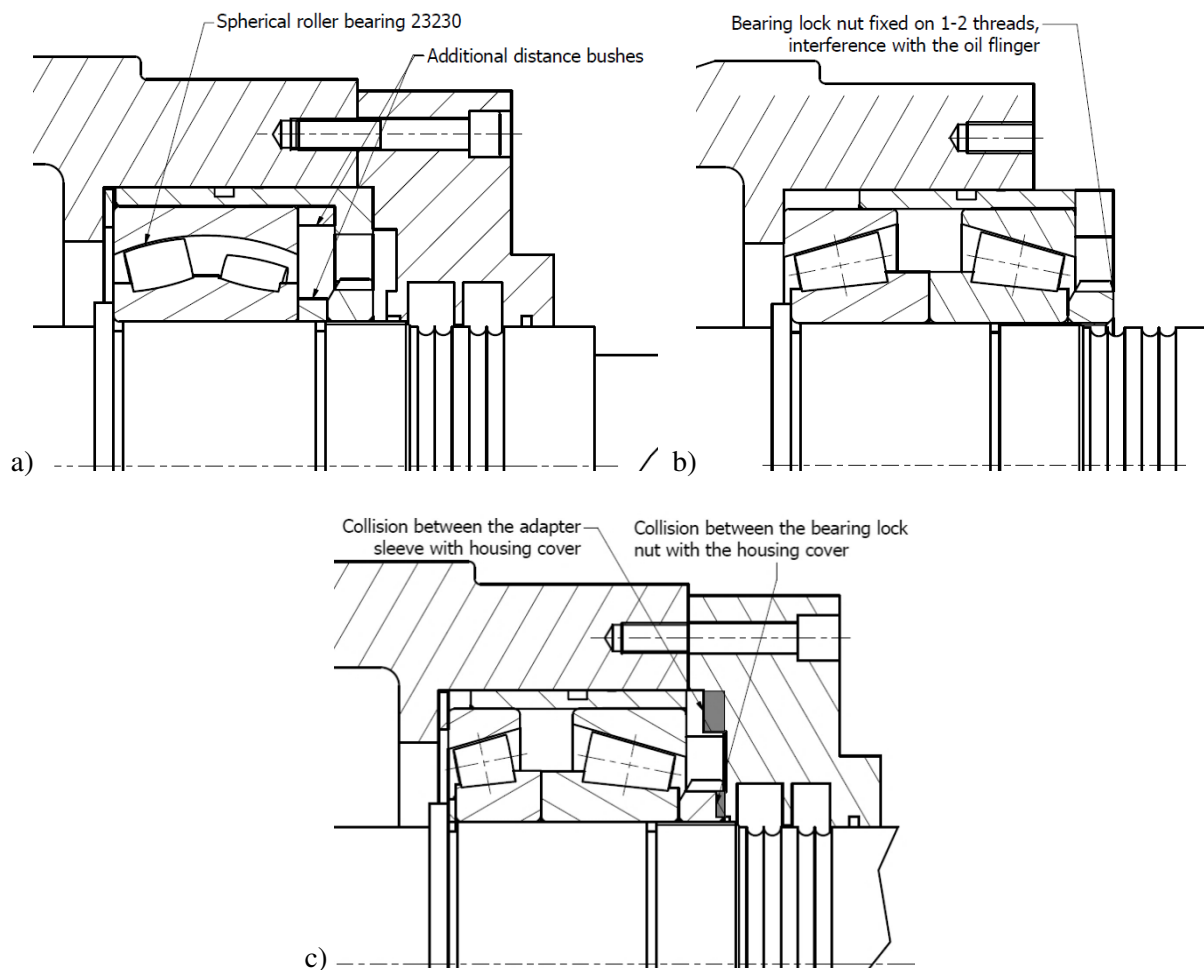
**Figure 11.** Proposed bearing arrangements: a) Spherical roller bearing 23230 – version A, b) Set of two identical taper roller bearings 32230-A in X arrangement – version B, c) Set of two different taper roller bearings 32230-A, 30230-A in X arrangement – version C [13]

As it can be seen in the figure, only one design (Case A) with spherical roller bearing 23230 (Figure 11 a) fits into the housing without any modification concerning the housing and the cover, this design only requires using an additional distance sleeve, but its use does not provide conditions for limited sliding of the rollers, because in two row spherical roller bearing loaded with substantial axial load and small radial load one row of rollers is unloaded, so despite good theoretical rating life this version was discarded.

Version B - a pair of 32230-A bearings shown in Figure 11 b can not be used because of excessive size in axial direction. Bearing lock nut is improperly mounted - most probably it would be fixed only on 1-2 threads and the nut would interfere with the oil flinger. Furthermore, bearing from the side of the lock nut, is partially seated on the threaded area itself, which will not provide proper fit. At the figure, the housing cover is not presented, due to other existing conflicts.

In case C incorporating a set of two tapered roller bearings of different size, shown in Figure 11 c, there is an expected collision between the bearing lock nut and the adapter sleeve with the housing cover. However, modification of the shape of the housing cover can be done, so the mounting will be possible. Other possibility to accomplish such mounting, is to design special bearing lock nut and an adapter sleeve, to avoid interference with the cover. Bearings in X arrangement are shown in the figure. O-type arrangement is not presented, because an increased axial length of such a bearing arrangement would make the use of a lock nut impossible, and would not ensure proper operation of the flinger seal arrangement.

Because of large number of failures and evidence that smearing is a probable reason of failures a redesign of the bearing system of the high speed shaft was considered. Quite an obvious assumption of the planned retrofit was minimizing necessary modifications of the gearbox design. Especially changes in the gearbox housing, shaft with pinion should be limited. Design changes should comprise small bearing mounting elements, such as bearing bushing, gaskets, housing cover. Various possible bearing configurations were considered utilizing bearings of the outer and inner rings diameters unchanged, i. e. shaft diameter of 150 mm and housing diameter of 270 mm. Three of the proposed versions with satisfactory life rating values are shown in Figure 11 [13]
