# Determination on Damage Mechanism of the Planet Gear of Heavy Vehicle Final Drive

**Abstract.** The works focus on the investigation of damage mechanism of fractured in the form of spalling of the planet gears from the final drive assembly of 160-ton heavy vehicles. The objective of this work is to clearly understand the mechanism of damage. The work is the first stage of the on-going research on the remaining life estimation of such gears. The understanding of the damage mechanism is critical in order to provide accurate estimate of the gear's remaining life with observed initial damage. The analysis was performed based on the metallurgy laboratory works, including visual observation, macro-micro fractography by optical stereo and optical microscope and micro-vickers hardness test. From visual observation it was observed pitting that form lining defect at common position, which is at gear flank position. From spalling sample it was observed ratchet mark at the boundary between macro pitting and the edge of fractured parts. Further observation on the cross-section of the samples by optical microscope confirm that initial micro pitting occur without spalling of the case hardened

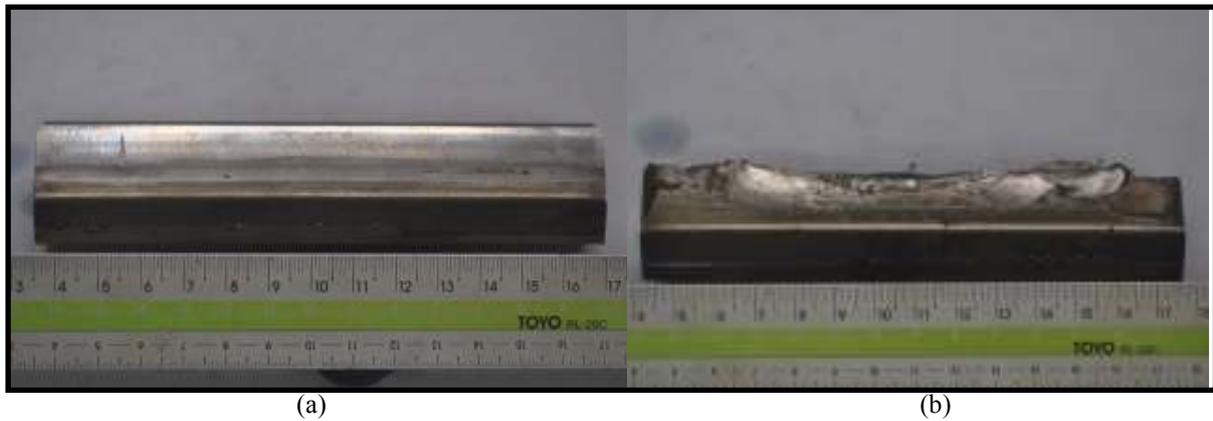
The Figure 1 shows two gear samples with initial pitting and spalling defect respectively. It can be seen from Figure 1(a) that commonly initial pitting exists at certain position on the gears and forming line pattern. It should be noted that pitting terminology here is not representing pitting defect resulted from corrosion process. However it is resulted from mechanical works between two mating parts. From observation of various gears sample with pitting defects, it was observed that typical position of the defect mainly occur at 1/3 distance from the lower section of the tooth (gear flank position). On the other hand Figure 1(b) shows uncommon failure of the gear that experience spalling due to uncommon incident as well.

Figure 1. Two gear samples with initial pitting (a) and fractured failed (b)

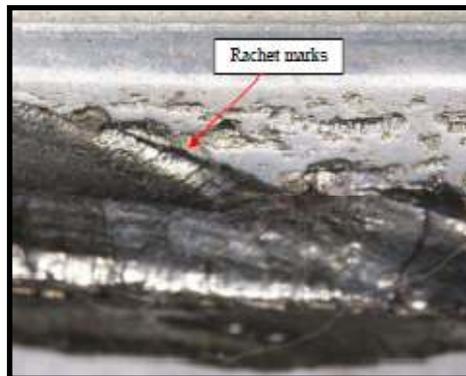
Figure 2 shows one closer view of figure 1(b) which showing the boundary between the spalling parts and the pitting parts. It can be observed that ratchet marks appear at the boundary of the spalling parts. These marks appears near big pitting (resulted from coalescence of several smaller pitting) and indicates that spalling initiate from multiple site close to big pitting. The edge of pitting is having high stress concentration due to sharp edges and it is predicted that there is critical size of pitting that finally induce in the bigger fracture of the parts (spalling case). Other interesting features are fine and coarse ridges on the crack surface. It can be seen from Fig. 3 that rupture crack propagated by forming fine ridges before coarse ridges occurs at the final stage of fracture. On the further observation, the

Figure 2. Ratchet marks on fracture surface

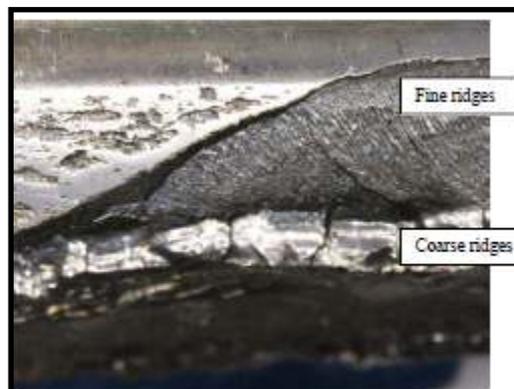
Figure3. Fine and coarse ridges on fracture surface

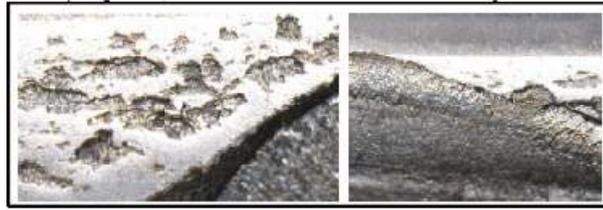
ridges texture is found to be appeared on both macro pitting and rupture surface which is the characteristic of fatigue fracture (Fig.4).

Figure 4. Ridges pattern on macro pitting and rupture crack surface

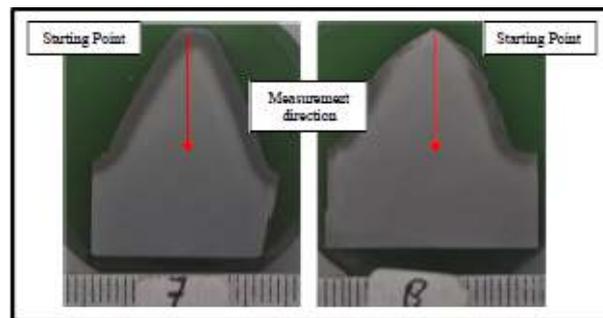
In addition, samples inspection at cross section area were conducted in several processes which are macro case-hardened profile, micro-structure characterization and microhardness test. Case-hardened profile inspection was conducted in order to identify and compare the cross section between gear tooth which has micro pitting and another gear tooth that has been fractured. Figure 5 shows gear teeth that having micro pitting (left figure) and the fractured gear (right figure). From the left figure it can be seen that the gear teeth has homogeneous and compact case-hardened surface that indicate pitting does not preceded with the breaking of case-hardened surface. On the other hand, cross section figure of the fractured gear tooth, shows that the case-hardened surface has been degraded with rupture tend to proceed toward the top of the gear. Refer to the position of the initial pitting which is at the bottom of the gear (flank position), it is predicted that the crack propagation starting from this position up to the top of the gear teeth.

Figure 5. Cross section figure of initial pitting sample (left) and fractured sample (right)

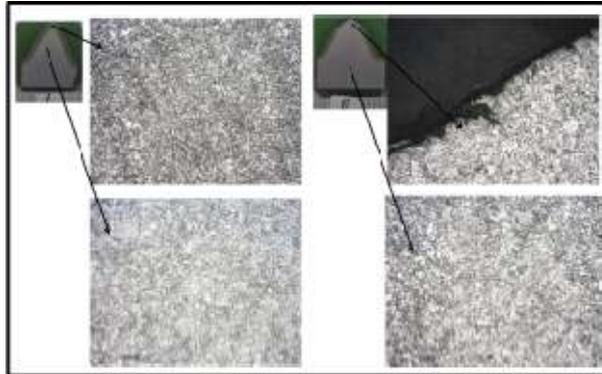
Figure 6 shows cross section microstructure of initial pitting and fractured gear teeth shown in the Figure 5. This characterization was performed in order to observe any microstructure degradation after operation. From these figures it can be seen that both of gear tooth contains the same phase which is Tempered Martensite. However there is a distinct phase morphology between them. The left figure contains surface structure that finer than its core structure, while the right figure for the fractured gear, the case-hardened surface has been diminished and the surface structure become similar with its core.

Figure 6. Cros section microstructure of initial pitting gear teeth and fractured gear teeth

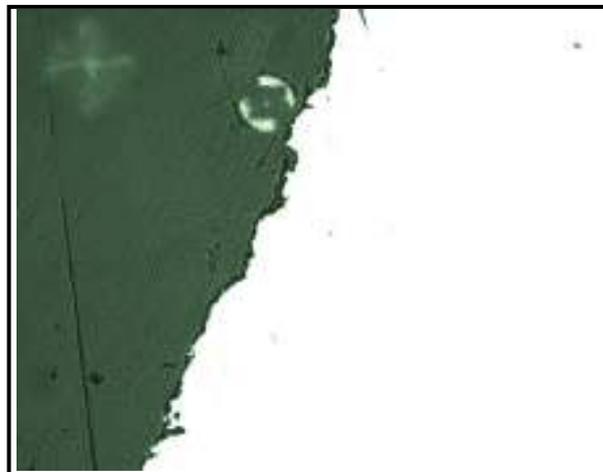
Figure 7 shows cross-section surface texture of initial pitting gears by optical microscope. It can be observed uneven texture with the appearance of sharp high peaks and valley texture. According to Moorthy [11] this peak and valley texture can be a trigger for the initiation of micro-crack and micro-pitting. Therefore up to this point, we have obtained two conditions for the initiation of pitting, occur at the gear flank position and preferably on the coarse surface with sharp peak and valley texture.

Figure 7. Surface Texture of Gear Teeth with initial pitting

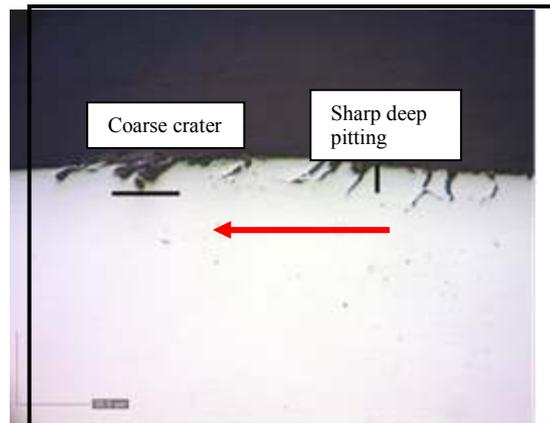
In addition, Figure 8 shows the appearance of deep micro pitting and coarse crater defects. Both of these defects are predicted resulted from the different modes of pitting growth. The deep micro pitting is predicted resulted from single micro pitting that grows into sharp deep pitting. The other one is predicted resulted from the coalescence of more than one pitting and creating coarse crater. Furthermore, micro pitting will grow into its preferential direction which is against sliding direction (Moorthy, 2013) and for this case is toward the top of gear tooth.

Fig. 8 Prediction of pitting growth direction
