Fracture Analysis of Cast Steel Sling

Abstract: The fracture reasons of ZG270-500 cast steel sling are analyzed through such means as macroscopic morphology analysis, chemical composition analysis, and microscopic metallography analysis. Results: coarse Widmanstatten structure and casting defects occurring in casting and subsequent heat treatment process reduce the strength, plasticity and toughness of the steel, which is the main reason of brittle fracture of the sling during work, and corresponding improvement suggestions are proposed herein.

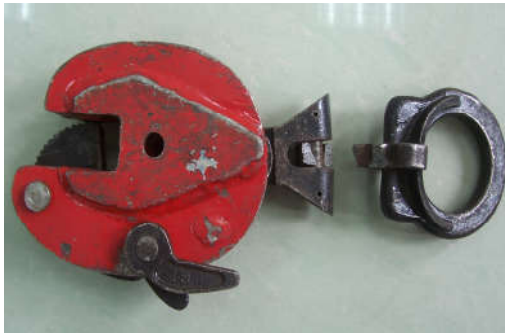
A sudden fracture occurred when the clamping ring made of ZG270-500 cast steel by a mechanical company during use, which caused hoisting workpiece damages, impacted the safety of personnel and equipment, and caused loss of production. Broken rings is shown in Fig. 1. Coarse morphology, chemical composition, and microscopic metallography are analyzed for the fracture site in order to find out the cause of the sling fracture and prevent fracture.

**Fig 1.** Broken rings

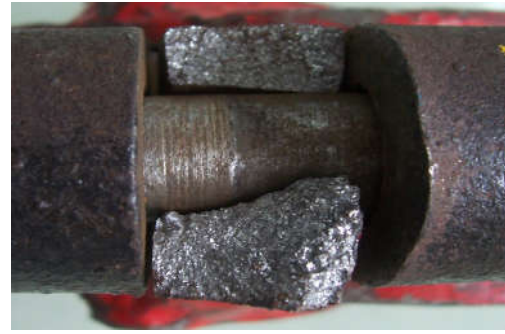
The rings are broken into two parts, some of which remain on the base. The fracture site of clamping sling ring is shown in Fig 2. The component integrally fractures; the fracture surface is relatively large; the macroscopic morphology shows that the fracture is a brittle fracture, the grains of the fracture surface are obviously coarse, and the crack originates from the interior of the material.

**Fig 2.** Macroscopic Morphology of Fracture

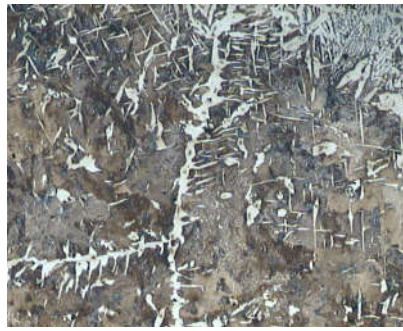
In the hanging ring on the back of the longitudinal section of the specimen, polished after observation under the optical microscope, as shown in Fig. 3. Fig. 3 shows that the structure of the material is the typical Widmannstatten structure, namely free ferrites precipitate along grain boundaries, some ferrites extend to the grain interior from grain boundaries, and some ferrites precipitate independently in the grain interior. The metallography result also shows that obviously coarse grains appear in the material interior but it is hard to find a complete grain under 50x optical microscope. According to GB13299-1991, the level of Widmannstatten structure is Level 3-4.

The Widmannstatten structure has coarse grains and reduces all the strength, plasticity and toughness of the steel, especially toughness. Therefore, Widmanstatten structure is generally not allowed in important products.

Fig 3. Metallurgical Structure of Failure Sample

The main reasons of sling fracture are improper casting and subsequent heat treatment process which caused obvious Widmanstatten structure and coarse grains in the material.

The method for preventing brittle fracture is mainly to prevent the generation of Widmanstatten structure and normal normalizing process can be utilized to eliminate the Widmanstatten structure. As for this product, it can be treated with two normalizing processes; relatively high normalizing temperature is adopted in the first time and relatively low normalizing temperature in the second time, which can not only eliminate the Widmanstatten structure but also can refine grains.

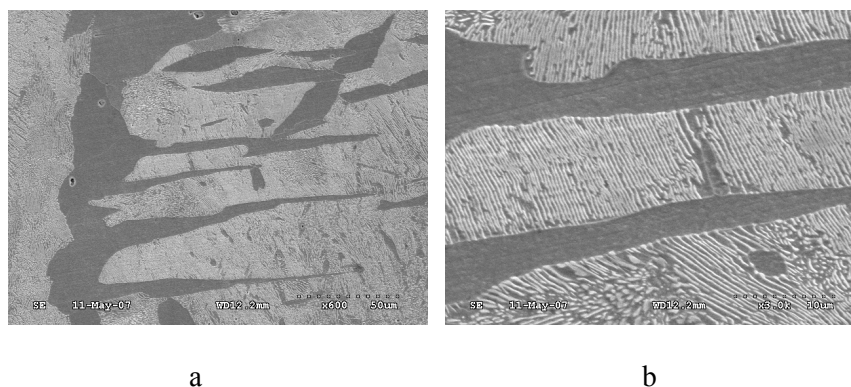
Will ring broken with acetone repeated ultrasonic cleaning, the microstructure of sample fracture is examined with a SEM and the sample microstructure is shown in Fig.4. Fig. 4 shows that massive pearlite exist among ferrite chips in the Widmanstatten structure.

Fig 4. Microstructure of Sample Fracture under SEM

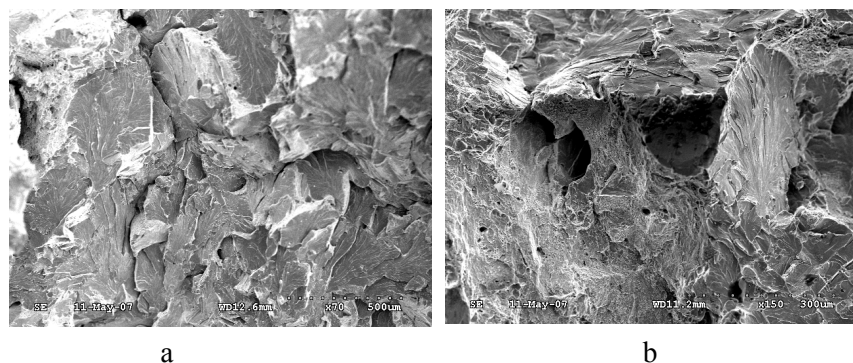
The morphology of the sample fracture is shown in Fig. 5. Fig. 5 shows that the fracture is an obvious brittle transgranular fracture and the characteristics of radial stripes can be observed. There are a lot of secondary cracks on the fracture surface and there are a large number of casting defects (pore) in the fracture surface material.

Fig 5. Fracture of Failure Sample under SEM
