Failure Analysis of Gold Dust defect in 430 grade Stainless Steel

S Mithra^{1*}, P G Venkatakrishnan¹, D Noorullah¹, V Karthik¹

¹Department of Metallurgical Engineering, Government College of Engineering Salem.

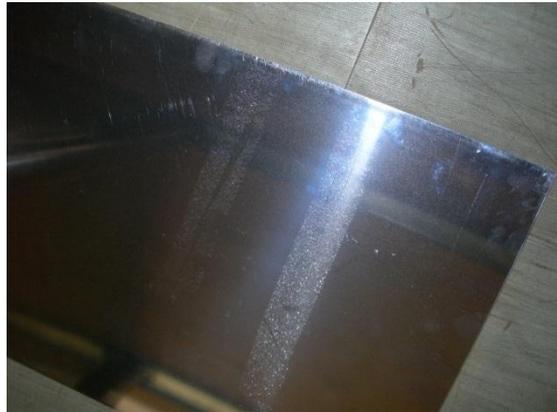
Surface investigation of gold dust in 430 grade stainless steel involves the failure analysis of the cold rolled surface. Gold dusting occurs on the surface after the cold rolling process. The defect appears as the metal powders deposited on the on the rolled plates as shown in figure 1 that are visible to naked eye and they easily stick on the hands when touched. These powders are usually identified by placing a transparent tape. Once the tape is removed most of the powders stick in the tape. Hence they can be easily wiped off and a simple grinding process can remove the powders on the surface. The grinding of the surface layer will not only cost a lot but also result in continuous precipitation on further ageing after treatment.

Figure 1: Gold Dust defect in 430 grade Stainless Steel

Use of a low carbon alloy will completely eradicate the above problem but while considering the compatibility of such steel with respect to the application it is required, there are a number of practical ways to prevent or lower the sensitization which include:

1. Limiting of the annealing temperature to 840°C (which is still sufficient for recrystallization).
2. Lowering of the cooling rate after annealing (by the use of batch annealing, for example), and a limiting of grain growth.
3. Stabilization using Titanium or Niobium-which readily forms carbides than chromium and hence lowering the chances for Chromium Carbide precipitation.

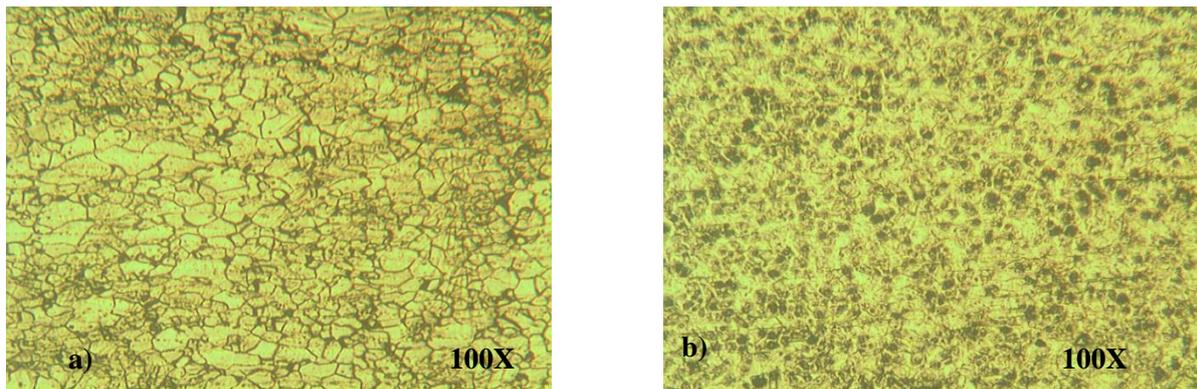
Coil no.136329

Figure 2: a) Fine recrystallized structure with distributed carbides (Micrograph of defect free sample)
b) Partially recrystallized structure with carbide precipitates at grain boundaries (Micrograph of defect sample).

From metallurgical micrograph (Figure 2(a) and Figure 3(a)), there is fine recrystallized grain grains whereas in in Gold dust sample shown in figure 2(b) and 3(b), the areas near the grain boundaries appear black indicating that there is a profuse carbide precipitation at the grain boundaries as a result of sensitization. Further from the figure 4 the grain boundaries are distorted towards the surface due to the precipitation.

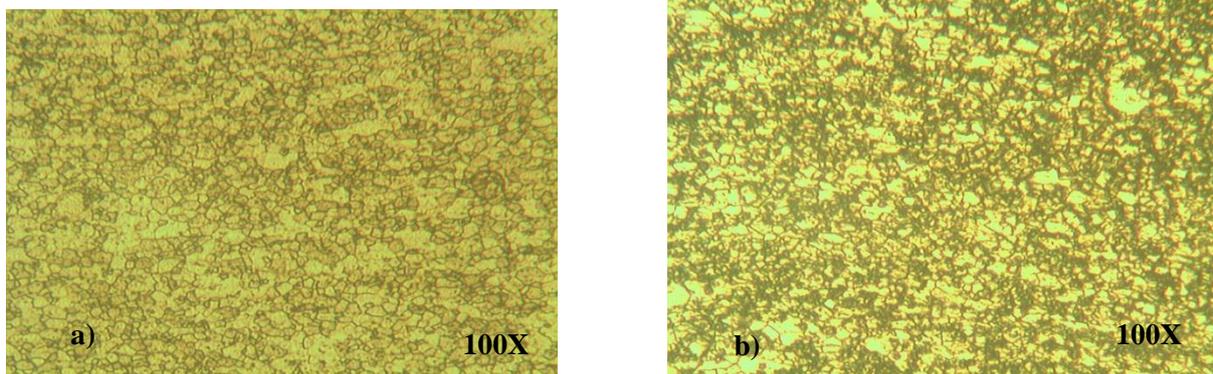
Coil no.139821

Figure 3: a) Fine recrystallized ferritic grains of size 8 throughout the structure (Micrograph of defect free sample). b) Fine recrystallized ferritic grains of size 8 throughout with profuse carbide precipitation. (Micrograph of defect sample).

The sample with the defect shows profuse precipitation when compared with the defect free sample. The comparison of the microstructure from case to core is also made which is shown in the figure 4. The grain boundaries are broken in the case whereas towards the core they are complete.

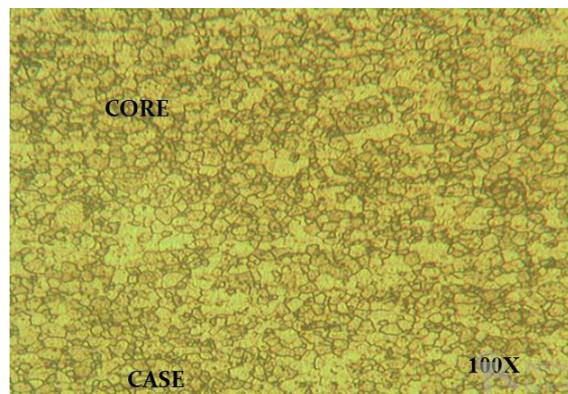
Coil No: 139667

Figure 4 : Comparison of Case and Core.

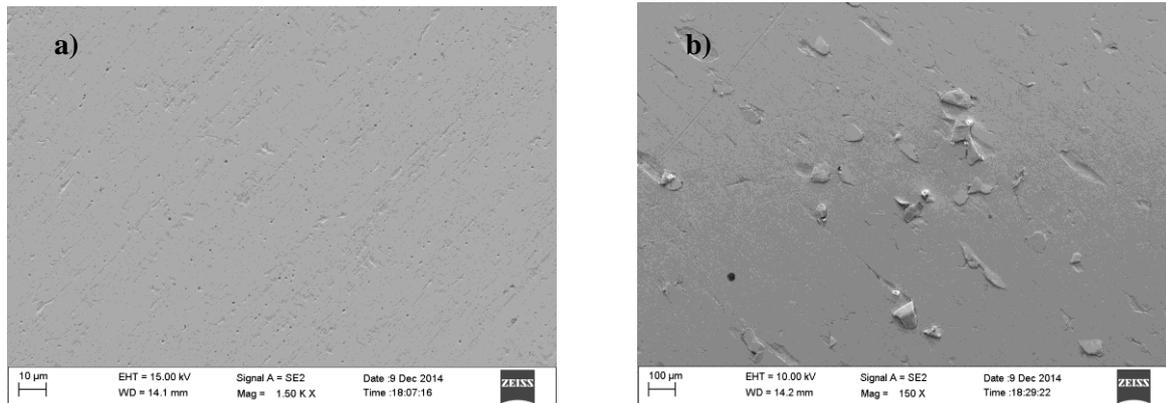
The SEM image of the defect free sample at 1500X magnification is shown in the figure 5(a). The SEM image of gold dust sample at 150X is shown in figure 5 (b). The SEM image of gold dust sample at 1000X is shown in figure 6.

Figure 5: a) Scanning electron photomicrograph of cold rolled surface of 430 grade stainless steel at 1500X Coil no.139821 (without gold dust defect). b) Scanning electron photomicrograph of cold rolled surface of 430 grade stainless steel at 150X Coil no.136329 (with gold dust defect).

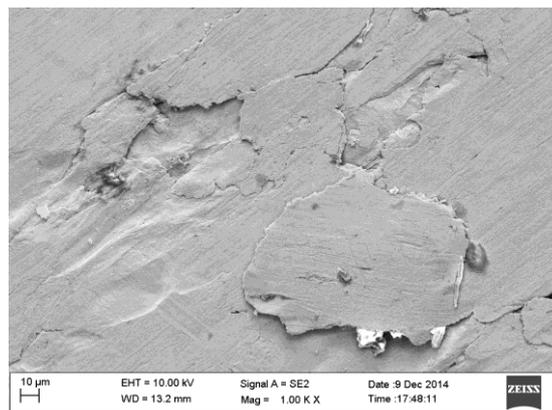
Figure 6: Scanning electron photomicrograph of cold rolled surface of 430 grade stainless steel at 1000X , Coil no.136329 (with gold dust defect).

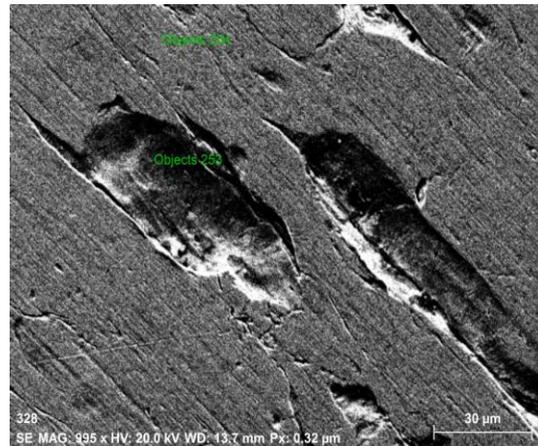
Figure 7: Micrograph from energy dispersive spectroscopy. Analysis is done at two points: one at the defect area and another on the surface near the defect.

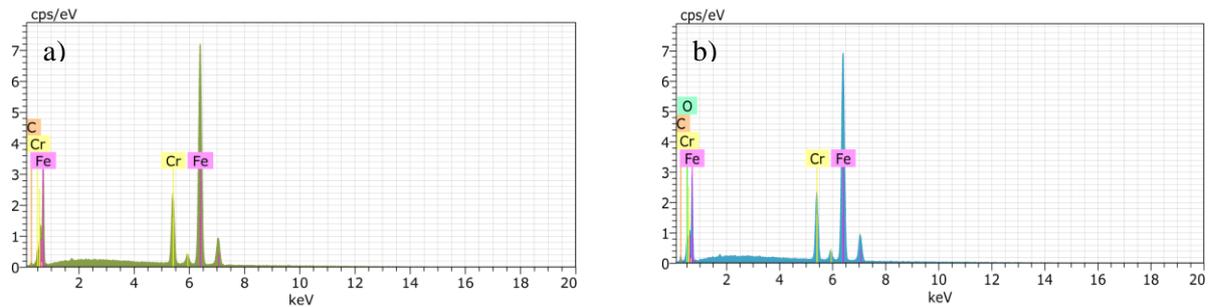
Figure 8: a) Graph obtained at the area of the defect at point 254 in Energy Dispersive Spectrometer micrograph b) Graph obtained at the area near the defect at point 253 in Energy Dispersive Spectrometer micrograph

The chemical composition of the specimen at two points are taken one on the surface of the gold dust and the other on the matrix near the defect. The variation in the chemical composition is shown in the graph and the spectrum at two points such as spectrum 254 and 253 are listed below the graph in figure 8 a) ad b) respectively.

The EDAX results show that there is a significant decrease in the chromium percentage and increase in the carbon percent and oxidation has occurred at or near the region of the defect when compared with the matrix far away from the defect.

In Scanning Electron Microscope and Energy Dispersive Spectroscopy, Gold dust samples show a significant decrease in Cr% and increase in C% clearly indicating that the area affected by defect suffers Chromium depletion and the related Chromium Carbide precipitation. There is also increase in O₂% which is due to the fact that there is no sufficient Cr for passivation and hence an oxide formation has occurred at the surface.
