# Failure Analysis on Tail Rotor Teeter Pivot Bolt on a Helicopter

**Abstract.** Tail rotor teeter pivot bolt of a helicopter fractured when in one flight. Failure analysis on the bolt was finished in laboratory. Macroscopic observation of the tail rotor teeter pivot bolt, macro and microscopic inspection on the fracture surface of the bolt was carried out. Chemical components and metallurgical structure was also carried out. Experiment results showed that fracture mode of the tail rotor teeter pivot bolt is fatigue fracture. Fatigue area is over 80% of the total fracture surface, obvious fatigue band characteristics can be found at the fracture face. According to the results were analyzed from the macroscopic and microcosmic aspects, fracture reasons of the tail rotor teeter pivot bolt were analyzed in detail

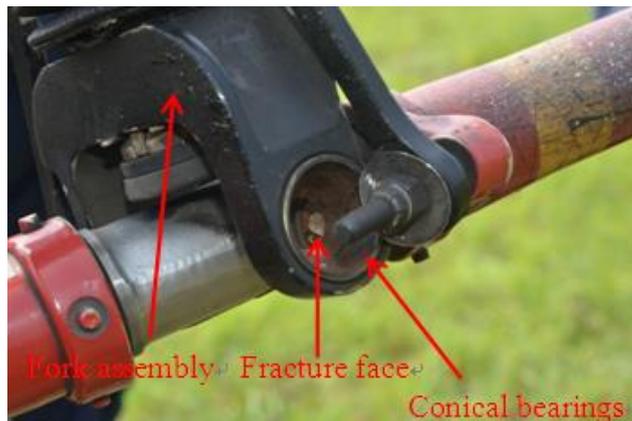
**Figure 1.** Fracture face of the tail rotor teeter pivot bolt

Examination of the fracture face of the teeter pivot bolt showed that it had failed in a plane very close to the exposed face of the threaded insert, allowing the dust shield and washers on one side of the hub to be lost (Figure.1). The thread insert is screwed into the hub forging. The fracture face incorporated a raised angular peak and trough at one edge with a ridge or step extending from the peak across the section separating the two halves of the fracture. Each half occupied a slightly different, though parallel, plane and the two were thus independent fracture surfaces. The paper on the fracture of the teeter pivot bolt were analyzed, the failure mode, analyzes the causes of failure[2].

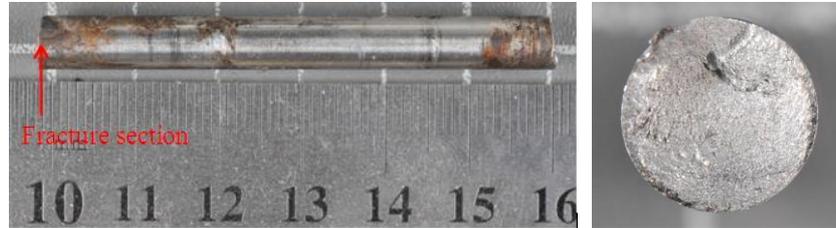
The whole morphology of fractured tail rotor teeter pivot bolt is shown figure 3. No obvious bending

deformation was found in this section of the bolt. But, at ends of the surface visible obvious signs of corrosion, wear characteristic is not obvious. The fracture section is located on the left side of the bolt. The fracture face is located at the edge of the threaded end bearing, the corrosion feature of the fracture surface of bolt is serious.

**Figure 3.** Morphology and fracture section of teeter pivot bolt

According to the fracture profile of the bolt. Fracture section height slightly difference, the underside side is relatively flat, upper side is rough. It can be seen from the above figure 3, left and right sides of the lower radiation ridge feature near the surface of the origin of the position, indicates that its source fracture is located in this location.

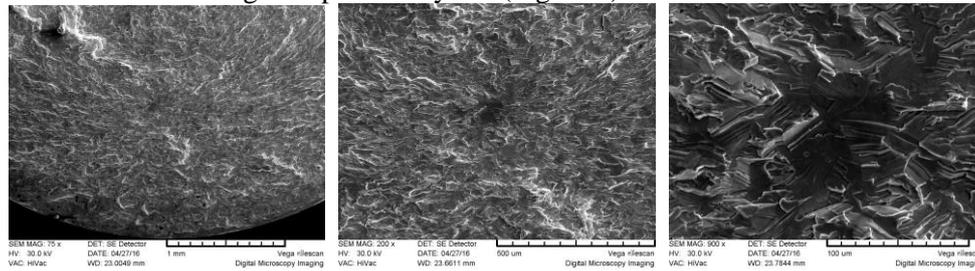
Scanning Electron Microscope (SEM) examination of the bolt found that fatigue cracking had sourced at the below side surface of the fracture section, no obvious defect on the source location. Fatigue growth from the source area to the left and right sides of the fracture surface, fatigue strip fine, fatigue expansion full. Besides, according to the fracture feature, it can be seen that the cyclic stress of fatigue fracture is small and more fatigue expansion cycles (Figure.4).

**Figure 4.** Microscopic feature of fracture source section

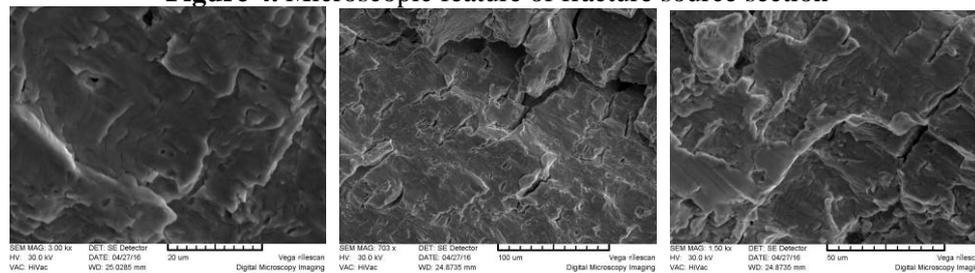
**Figure 5.** Microscopic characteristics on the left fatigue expansion of bolt

The microscopic characteristics of fatigue expansion at the left and right sides, from the front, middle and late stages of the fatigue source of the bolt fracture, the fatigue characteristics of fracture are obvious, fatigue strip fine, fatigue expansion full (Figure.5 and Figure.6). The fatigue had the characteristics of torsional shear stressing applied in two distinct directions. However, the torsional evidence was, not orientated about an axis coincident with that of the bolt. Therefore, it can be concluded that the fracture property of the bolt is fatigue fracture.

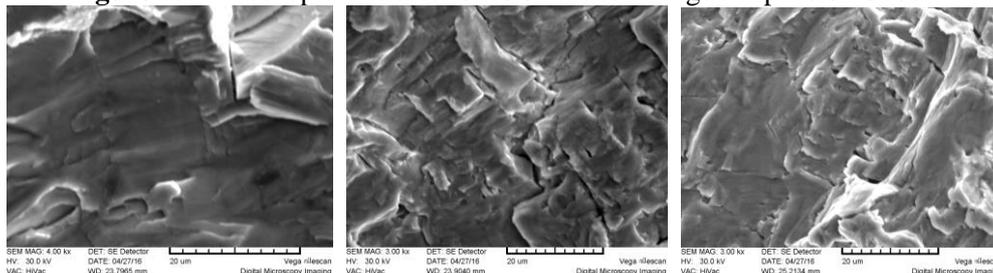
**Figure 6.** Microscopic characteristics on the right fatigue expansion of bolt
