Analysis of electrical audit and energy efficiency in building Hotel BC, North Jakarta

Agung Wahyudi Biantoro

Abstract. The Hotel BC is using power source from PLN with capacity of 4300 kVA which is divided into 3 units of 2000 kVA transformer. Transformers are used to supply the load of Mall tenants, and Utility loads, such as Chiller, pumps and others. Problems found in the field are complaints from the hotel regarding the safety of electrical installations and wasteful, inefficient electrical costs. The purpose of this study is to check the electrical installation in the building and determine the *Energy Use Intensity (EUI)* and the cost of payment according to usage based on historical data of the building then compare it with the *EUI* standard of Ministry of Energy and Mineral Resources of Indonesia. The method used is survey measurement method and quantitative descriptive analysis by comparing in general condition of energy consumption of this building with standard issued by Ministry of Energy and Mineral Resources of Indonesia. The *EUI* is average 645.58 kWh/m²/year, or 53.79 kWh/m²/month, this is inefficient category, because its *EUI* value is > 24 kWh / m² / month.

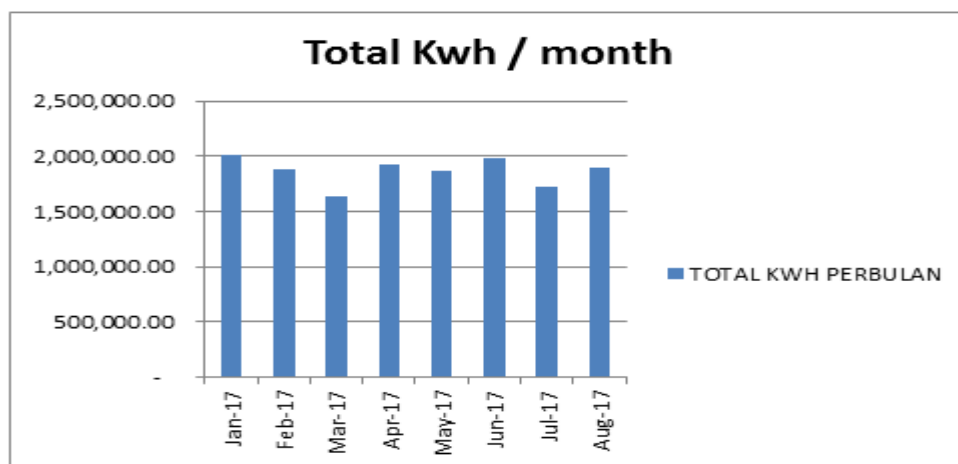
Figure 1. Total Kilowatt per hour / month in Hotel BC, Jakarta.

As we know that the building area of the hotel bc is 34,616 m², and the evarage kwh per month is 1,862,285. So the EUI value is 53.79 kWh/m²/month or 645.58 kWh/m²/year. As we know that the building area of the hotel bc is 34,616 m², and the evarage kwh per month is 1,862,285. So the EUI value is 53.79 kWh/m²/month or 645.58 kWh/m²/year. The electrical load distribution at BC Hotel Building, the highest is air conditioning, then followed by lighting. The full percentage is as follows:

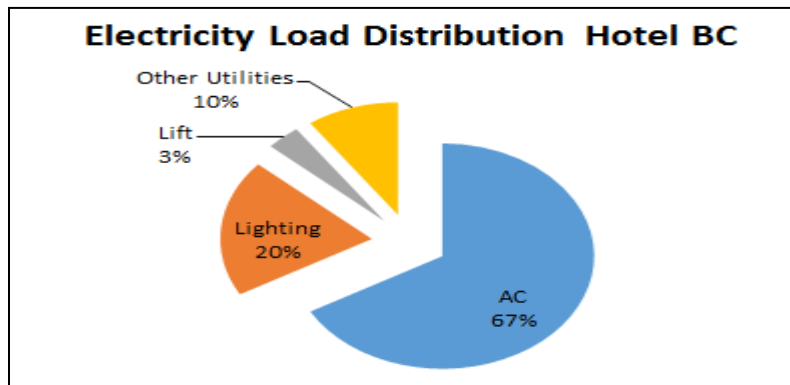
Figure 3. Estimated electrical load distribution at Hotel BC, Jakarta

From Table 1 it can be compared between the actual value of EUI in the field with reference value of ASEAN USAID standard 1987. Based on this table the value of EUI Building Hotel BC = 645.58 kwh/m²/year, included in the category inefficient / wasteful.

The potential for energy savings can be focused on the system of air and lighting in the BC Hotel Building. Use of R-410 or R-32 refrigerant on AC inverter to replace R-22 refrigerant on some Split AC units to be installed. Because the freon type R-410 or R-32 is lighter than the freon type R-22 so that the compressor work is not too heavy and electric energy is also smaller, besides that this type of freon has entered standard green because it does not damage ozone. The Simulation for Energy Saving Potential (PHE) is as follows:

1. Fix the Building Automation System (BAS) system to set the central AC system.
2. If possible, increase the AC temperature setting.
3. Perform AC maintenance (filter cleaning at least 3 months).
4. Turn off the AC and lights if the room is not in use.
5. Replace electrical appliances, air conditioners, and pumps that exceed the technical age limit (more than 20 years).
6. Control-motor control should use Variable Speed Drive(VSD).
7. The transformer capacity can be lowered to 1000 kVA to reduce transformer losses. Currently, the transformer load is only 28.3%.

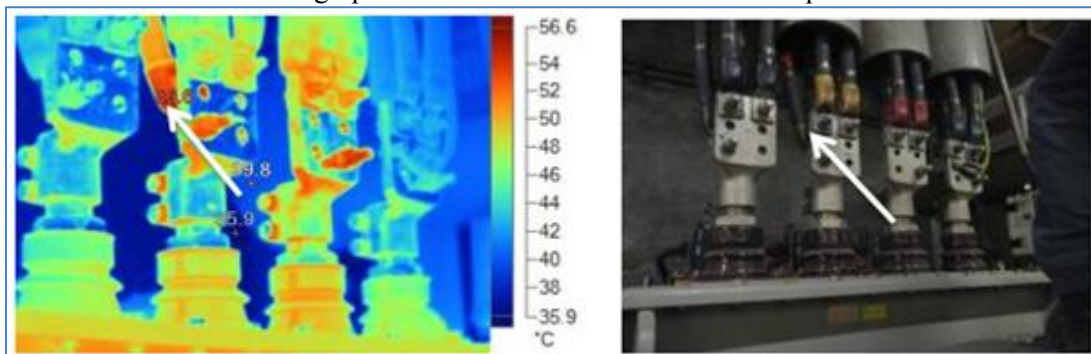
Figure 4. Thermographic test data on 2000 kVA transformer, with load 566 kVA

The result of thermal imaging at 2000 kVA transformer, Out Going Cable Spot, obtained result of the highest temperature 56.6 ° C. The highest temperature is found in phase S cable skeleton, with load at each phase is R = 929.9 A, S = 907,3 A , T = 853.9 A. The temperature in this panel is still in the normal category, no need for improvement.

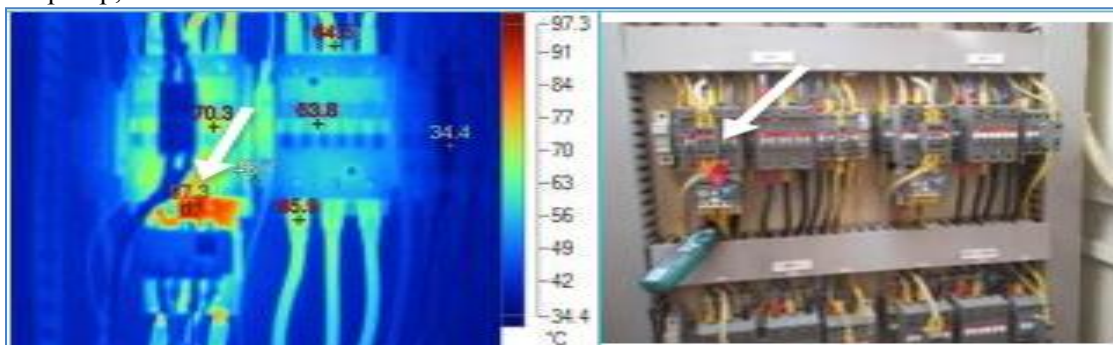
Figure 5. Thermo graphic test data at panel out going of chiller pump, 200 A

At Figure 4 there is Thermo graphic test data at Panel Out Going of chiller pump, 200 A. That Panel Out Going for chiller pumps on 200 200 C Contractor Slot, the highest temperature is 97.3 C, at 200 A phase S termination, while the load has reached 93.1 A and the temperature of the contactor body is 70.3 C, with cable using NYAF type 16mm. With the highest Temperature of 97.3 C, this is included in the major category. The panel on the cable uses NYAF type 16 mm, does not match the load. We recommend wiring NYAF 16 mm replaced with NYAF 35 mm cable. Further recapitulation of all electrical panel at Building Hotel BC is as follows:

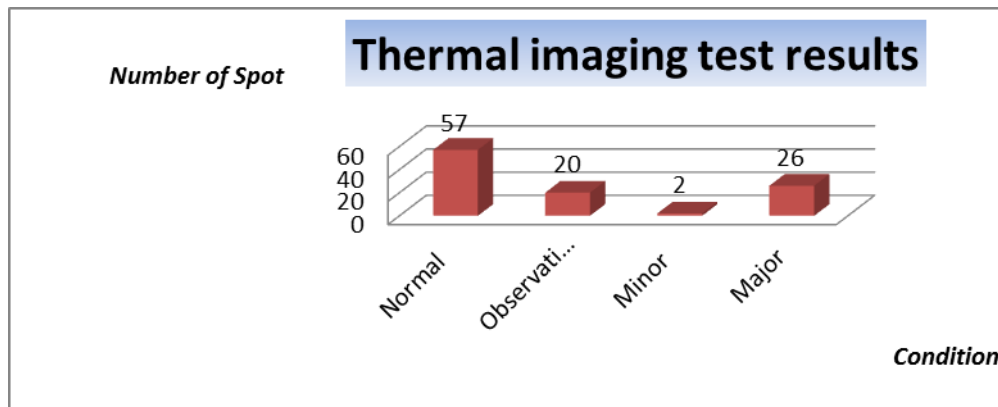
Figure 6. The thermal imaging test result

From the table above shows that total of the major categories are 26 spots, while minor are 2 spots. The number of hot spots on the capacitor bank panel there are 10 major points, and chiller panel has 10 major and 1 minor point. In addition, there are panel AHU panel, tenant panel, panel floor 7 and STP panel which also has 1 major point each, while the pump panel there are 2 major panels. The number of major points is quite dangerous because it can cause excessive heat can eventually occur short-circuit or fire hazard on the panel. It is imperative to take precautionary measures, for example by cleaning the panel, replacing the cables or tighten the termination of the contactor.
