Identification of deep-rooted transverse cracks using Ground Penetrating Radar

Jacek Sudyka¹, Lech Krysiński¹, Adam Zofka¹, Tomasz Mechowski¹, Przemysław Harasim¹

¹ Road and Bridge Research Institute, Warsaw

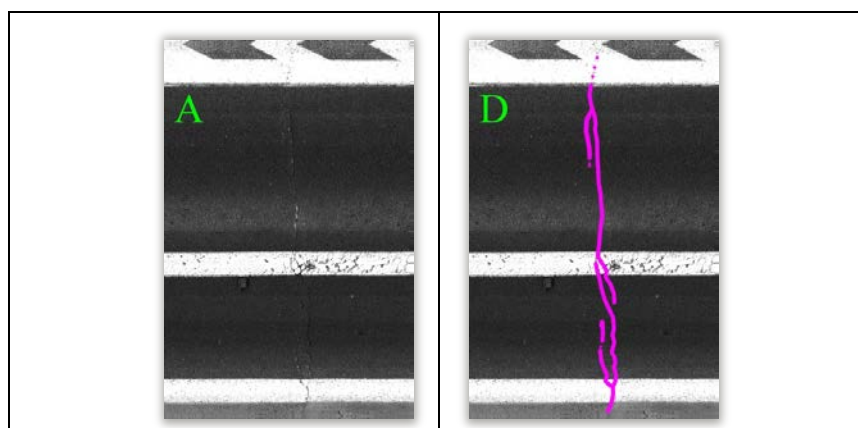
Figure 2. Identification of transverse cracking based on the photo. A) Original form of the photo, D) course of the cracking line marked on the original photo.

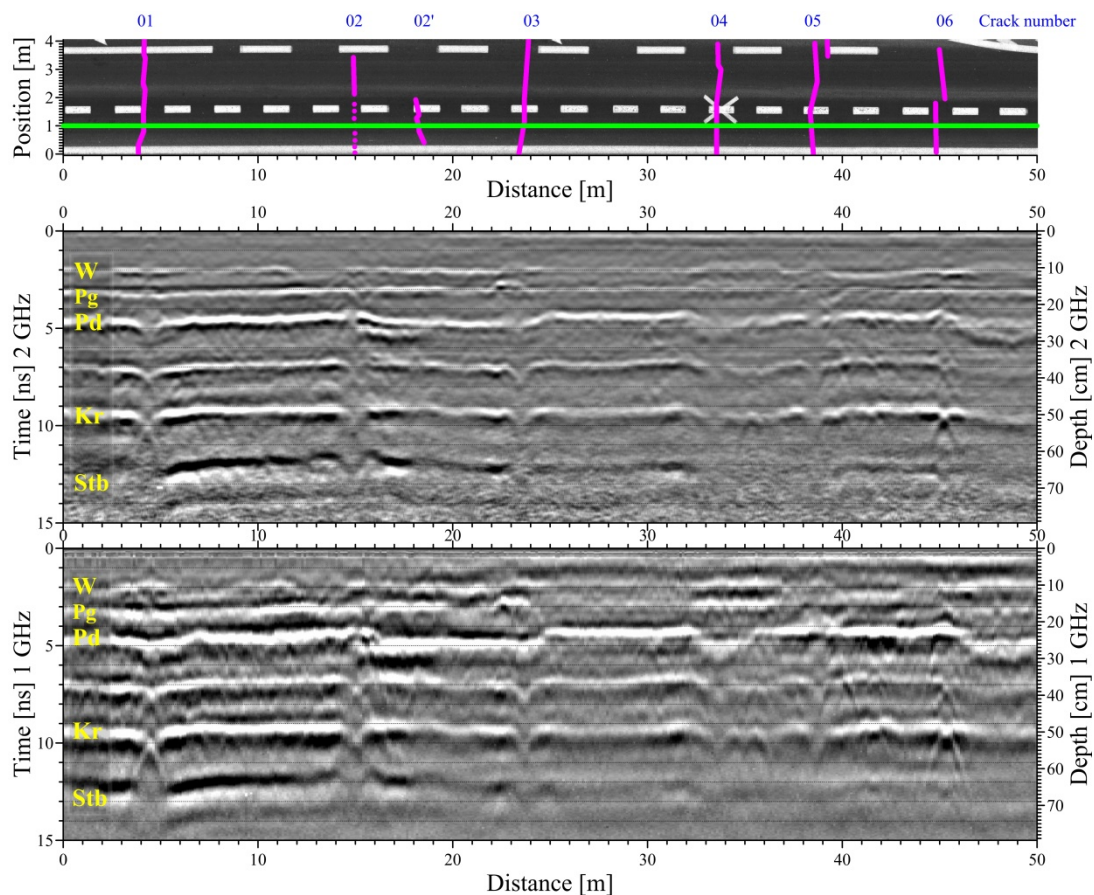
The cracks identified in the photos were marked with a violet line and were afterwards compared with a fragment of the echogram corresponding to that section, on which spectacular and well-located manifestations of cracks inside the pavement structure are visible (Fig. 3). They have very well developed forms that are variants of the Christmas tree layout [4]. This combination shows that the GPR manifestations of the cracking structure, and more precisely their axial planes, occur synchronously with their surface manifestations, with accuracy to one decimetre. It is worth mentioning the crack marked with number 02, that line is observed on the surface during the measurement and which does not intersect the line of the measuring profile yet, but very intense internal manifestations of the crack appeared below the profile at the point where it intersects with the extension of the axial plane of the crack. This is characteristic of very developed cracks recently covered with a new layer of asphalt, when this restoration process is not yet very advanced. The cracks visible in that figure have a very developed structure. Their presence in the structure is obvious based only on echograms, without confirmation with visual observations. The intensity of manifestations and their width (stretch along the profile) increase together with the depth, so that their presence in the sub-base and deeper courses is beyond doubt. The width of the zone with structural and material changes in these deeper levels reaches values greater than one metre. The forms of scattering caused by the structure of the cracks at the levels of inter-layer borders differ considerably from the pattern of the hyperbola, and take the shape of a Chi pattern, which proves wide zones of structural change.

Figure 3. An example of an excellent correlation of the position of cracks visible on the surface with their very distinct and well located manifestations on a GPR image. The above figure presents the photographic map of the pavement with the cracking lines visible on the surface marked with a violet line and the route of the measuring profile marked in green. Synchronously compared echograms obtained using antennas with the central frequencies of 2 GHz and 1 GHz are presented below. The reflection levels corresponding to the lower surfaces of the structural layers are designated as W (binder course), Pg (asphalt roadbase), Pd (asphalt sub-base), Kr (sub-base), Stb (mechanically stabilised layer).

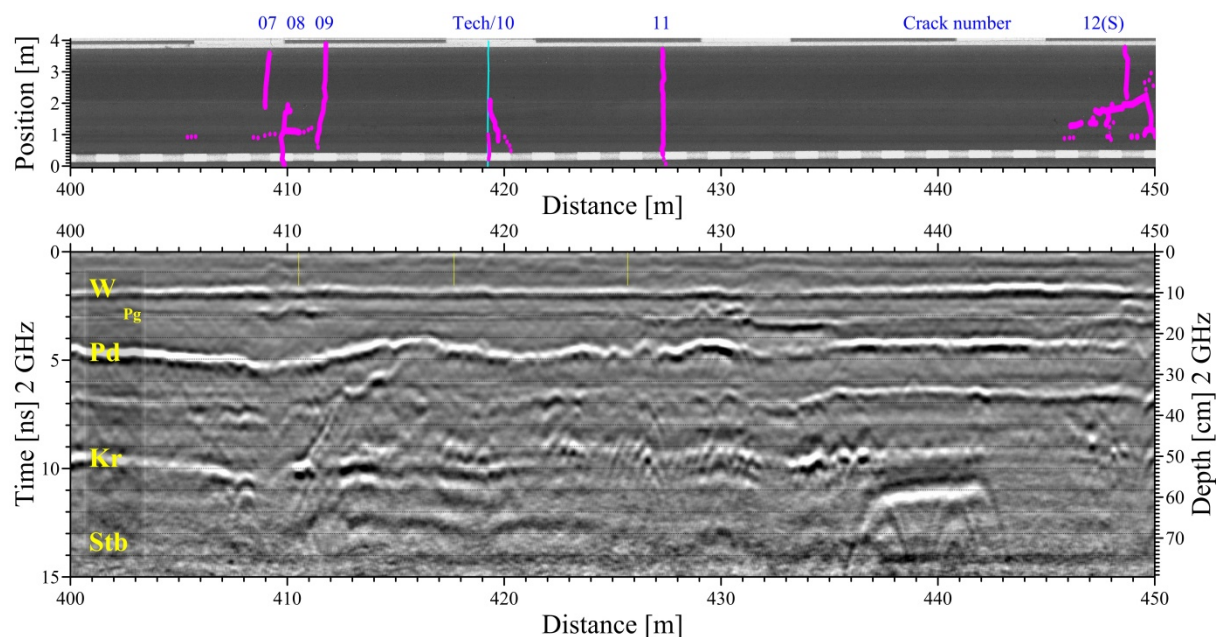
Another part of the tested pavement section (Fig. 4) may be indicated as a comparative example presenting less obvious cases requiring a more complicated discussion. The image of the layered structure should be in this case defined as heavily distorted. The base course structure is especially distorted. Here one can see numerous elementary characteristics of potential presence of cracks, but they are not arranged in vertical groups clearly suggesting the specific locations of cracks. What is more, the defects and disorders of the layered structure of the packet are not numerous (three short ranges) and do not present conclusive evidence of piercing of the packet by cracking. Three cracks found on the surface of this section are accompanied by certain GPR traits of the potential presence of cracks, providing a chance to determine the probable position, but which alone are not the basis for suggesting its probable presence. In the case of crack 11, with precise synchronization with photography it is possible to recognize which elementary traits are the manifestation of the crack and what's more they form a typical Christmas tree pattern; however, it is masked by a multitude of elementary figures in its surrounding. Crack 12(S) and the group 07, 08 and 09 constitute two examples of branched cracking systems, which suggest the early stage of development of alligator cracks. Those areas in the asphalt packet present defective interlayer connections, whose range of occurrence strictly corresponds to the area subject to cracking. In this regard particularly significant

are defects in asphalt base. These defects have a form characteristic for debonding, but a chaotic scattering pattern is visible in those areas in the packet, which even leads to weakening and partial masking of structures located below, which is visible in the echogram in a form of a vertical zone called the *masking umbrella*. This irregular scattering suggests that the lower layers of the packet may be significantly mechanically degraded. An accurate view of the image of layers underneath the asphalt packet allows for determining that Chi patterns forming a Christmas tree arrangement are visible there and the axial plane of that arrangement corresponds to one of the transverse cracks (449.5 m in the case of network 12(S), while the cases of group 07, 08, 09 correspond to crack 08 of 410 m). The initial crack 10 which appeared in the vicinity of the construction joint (Tech, 419.2 m) may be regarded as not having the clear manifestations of deep-rooted cracking apart from the generally disturbed structure of the base course.

Figure 4. An example of a section with a disturbed structure suggesting occurrence of cracks, the precise location of which in the echogram is however difficult. The above figure presents the photographic map of the pavement with the cracking lines visible on the surface marked with a violet line, and the construction joint marked with a blue line. An echogram obtained using an antenna with the central frequency of 2 GHz and synchronously compared with the map is presented below. The reflection levels corresponding to the lower surfaces of the structural layers are designated as W (binder course), Pg (asphalt roadbase), Pd (asphalt sub-base), Kr (sub-base), Stb (mechanically stabilised layer).
