Influence of Excessive Moisture in the Subgrade on the Durability and Load-Bearing Capacity of Road Pavements

Mieczkowski P., Budziński B.

West Pomeranian University of Technology Szczecin

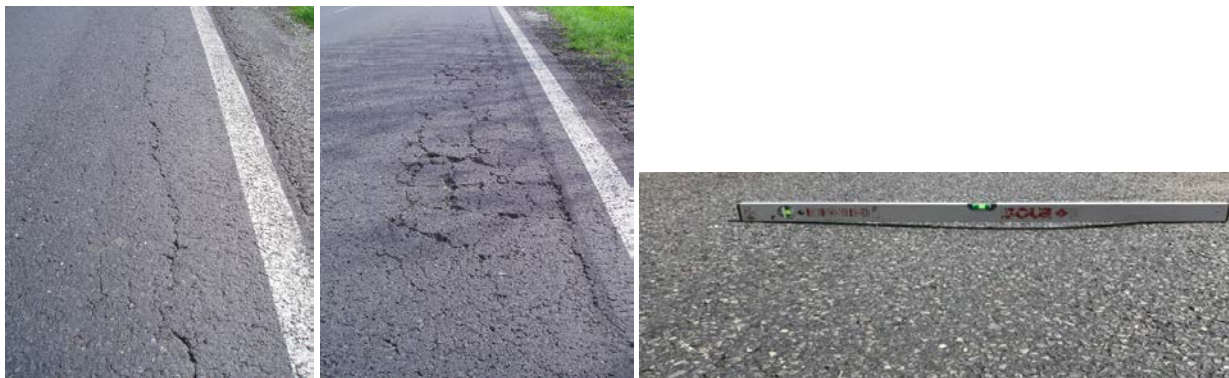
Fatigue cracks started to appear locally after 3-4 years of trafficking along with structural deformations (Fig. 2). The distress was most severe at low spots of the road (e.g., within concave vertical curves).

Figure 2. Fatigue cracking and rutting after 3-4 years of open road into service.

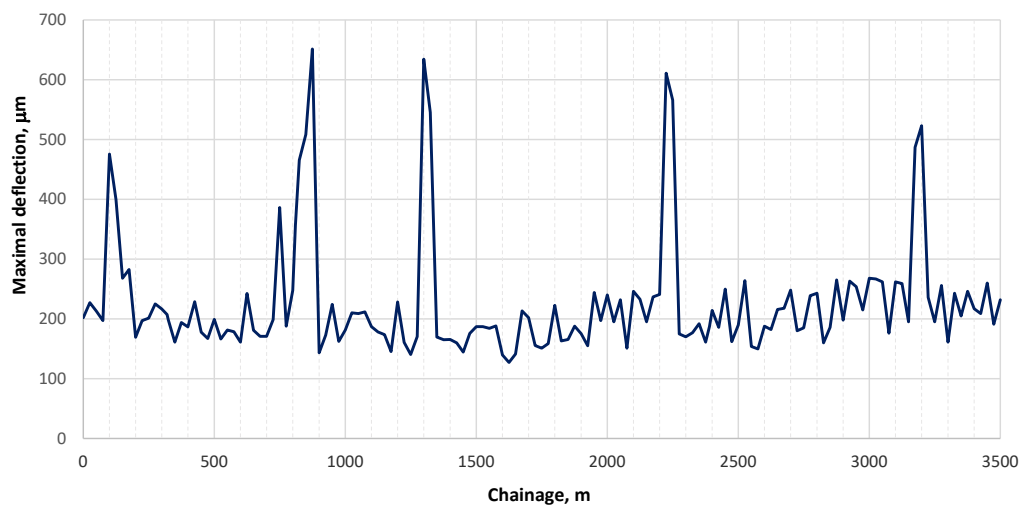
Figure 3. Maximal deflection from FWD test (nearest wheel, nearest line).

The maximum deflections at the plate centre can be classified in two groups. The first group includes results falling in the range from 125 to 270 μm making up over 90% of all the results. The second group includes results obtained at twelve test points. There the deflections exceeded 350 μm . This grouping of results was also relevant for the deflection bowl shapes. This concerns primarily much greater increase of deflection with the decreasing distance to plate centre recorded at these twelve test points where high values of maximum deflections were recorded. Fig. 4 presents the character of deformation obtained through deflection measurements on the respective geophones for the above-mentioned two groups of results.

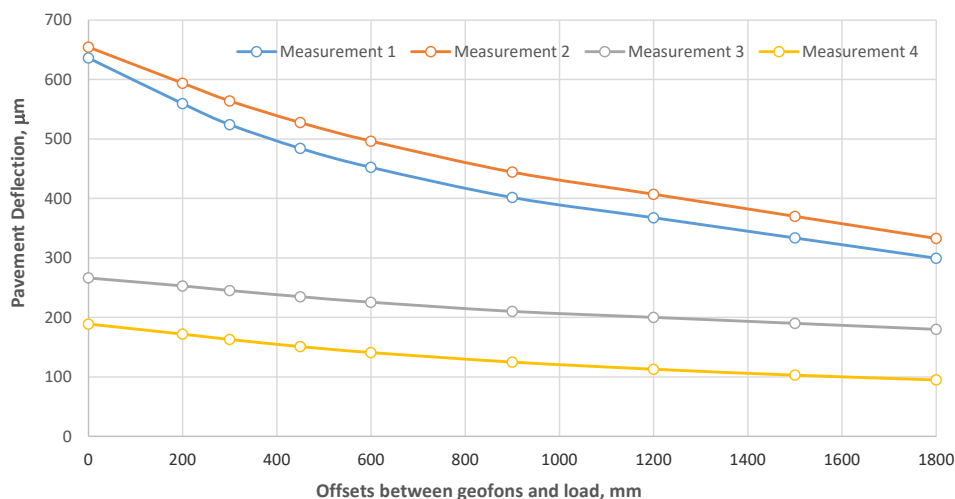
Figure 4. Pavement deflection in every geophone from FWD test (test 1 and 2 – places where are large maximal deflection, place 3 and 4 – places where are small maximal deflection).

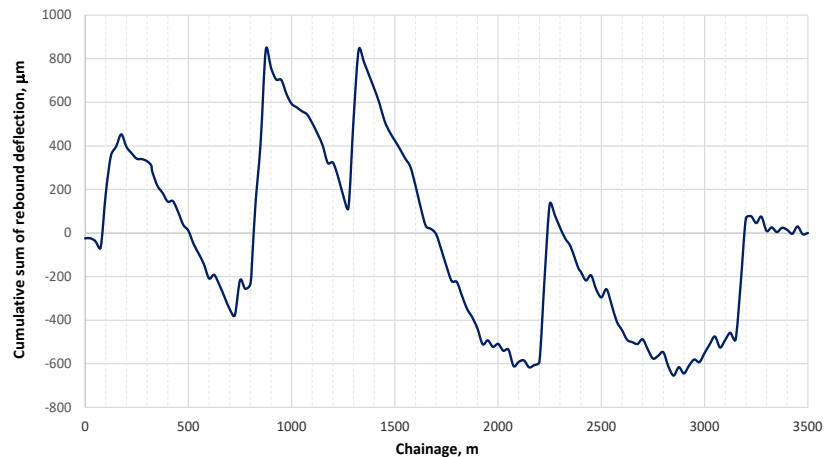
Figure 6. Cumulative sum of rebound deflection on voivodeship road.

It clearly transpires from Fig. 6 that higher values were obtained in isolated spaces influencing the shape of the curve and the number of uniform sections. In order to obtain a better illustration of the effect of places with deflections exceeding the maximum allowed value basic static calculations were conducted for the whole analysed section (before adjustment) and for the section without areas with higher deflections (after adjustment) for both lanes (Table 3).

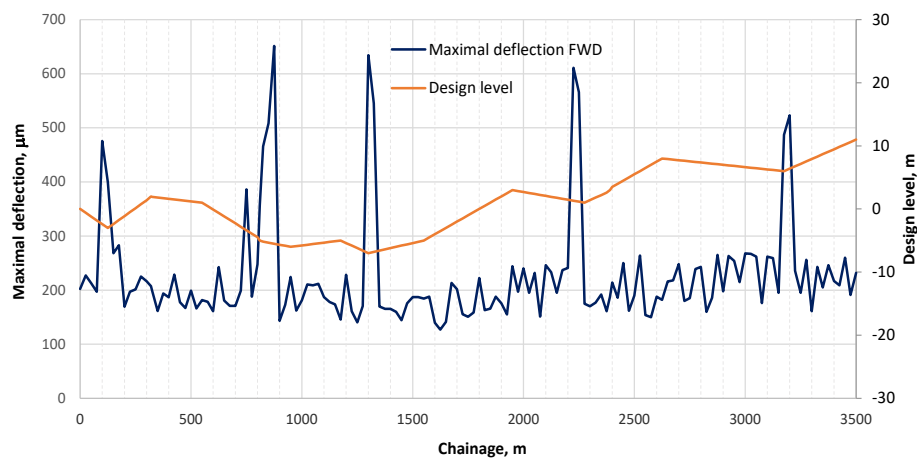
Figure 7. Road vertical alignment with maximal deflection.

From the analysis of results presented in Fig. 7 it can be seen that the greatest deflections coincide with concave vertical curves. Storm water could pond there and penetrate under the structure through the edge of dirt shoulder. This affected the bearing capacity of subgrade and, subsequently, also of the pavement courses, in particular the layers of increased stiffness, i.e. cement-treated and bituminous.

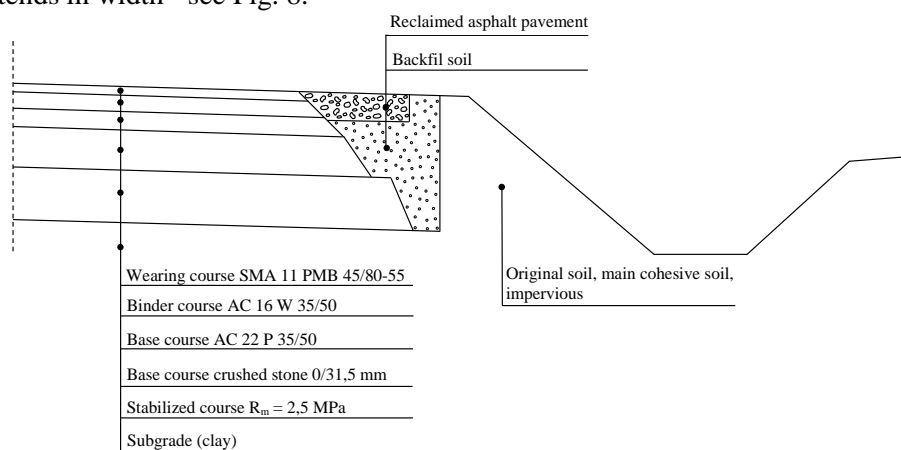
At the dips of the road profile storm water penetrates under the pavement structure when it cannot drain into open ditches. This suggests that efficient drainage of water outside the roadway prism was not ensured during the works. In order to verify this, test pits were dug at pre-determined locations at the road edge. It was found out that the cross section and the layer locations vary and conform to the design only in places (Fig. 1), deviating from it on a major part of the section, in particular where shoulder extends in width - see Fig. 8.

Figure 8. Cross section of road with marginal strip.

It clearly transpires from Fig. 8 that accumulation of storm water under the pavement and plastic yielding of subgrade soil was caused by reduced width of the cement-treated soil layer and replacement of the native soil in the shoulder with loose material (permeable and non-swelling). The native soil which was left undisturbed in the shoulder area has varying composition in which cohesive, swelling and impervious materials prevailed. An additional factor hindering the flow of storm water were higher places in shoulder area (beyond the RAP strip) created by growth of vegetation.

The recommended treatments include immediate repair of the affected areas, replacement of the shoulder material and widening of the cement-treated soil layer to the whole width of the road prism.
