Construction strengthening in historical wooden cupolas restoration

Yury Yuzhakov and Alexander Belkin

Moscow State University of Civil Engineering, Yaroslavskoye Shosse, 26, Moscow, 129337, Russia

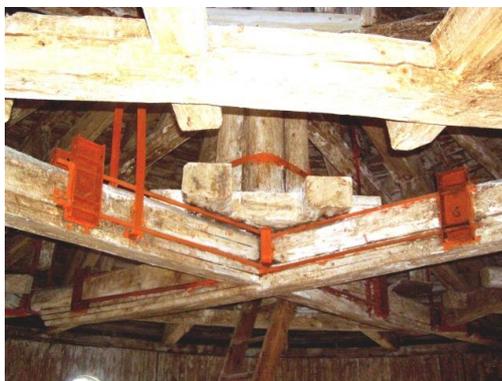
It was revealed, that some uprights of belvedere walls and some boards of the floor have surface rotting and damage caused by wood fretters and need prosthetic appliance. The testing of dome construction to bear permanent load and temporary load has shown that there is an overstress of 41,5 % in one of the elements in the upper multiangle construction. There is an overstress of 18 % in the lower inclined element of the intermediate rafter, weakened with junctions. The stresses in the other elements are below rated, in the floor beams deflection is below limit.

Figure 2. The main house of Ostankino estate. Reinforcement of tightenings of the main arches and elements of the framework by means of steel tension bars with stop channel bars and splice pieces of wood boards

- reinforcement of tightening of the main arches and elements of the framework by means of steel tension bars with stop channel bars and splice pieces of wood boards [Fig. 2];

- reinforcement of the intermediate rafter, overstressed in the middle, with wood boards on both sides;
- taking the bark of some elements.

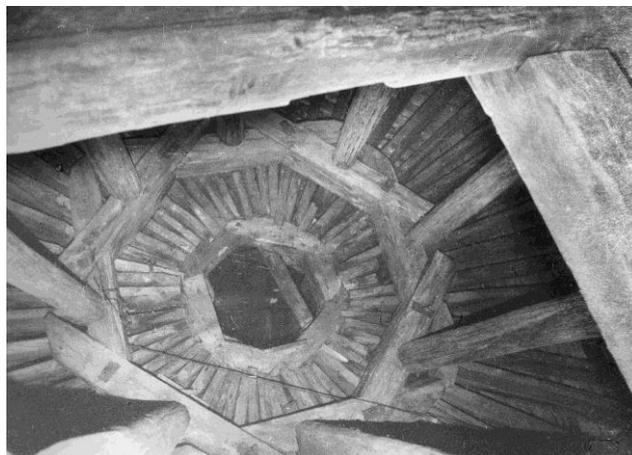
Complex analysis of constructions revealed biological and entomological decay of some elements (greyish-brown rot and white mould), caused the deterioration of physical-mechanical characteristics of wooden cupolas constructions. Separate elements, including the central support - flagstaff base, have rotting and damage from wood fretters [Fig. 4].

Figure 4. Petrovsky Putevoy Dvorets in Moscow. Separate elements, including the central support - flagstaff base, have rotting and damage from wood fretters

Physical wear of the external cupola below 20%, of the decorative cupola below 30%. General condition of wooden constructions is restrictedly durable. Some pieces are unsafe. The unsafe is caused with:

- absence of the ventilation of supporting ends of constructions;
- Condensation between the external and decorative cupolas, leads to biological decay;
- the roof leaks, the absence of hydro and steam isolation in framing constructions.

Testing calculations of external cupola constructions to bear permanent and temporary load has shown that there is over allowed deflection of triangular trusses of external cupola.

- reinforcement of rafter trusses with installation of two three-hinge frames made of laminated wood with the section 100x500 mm, in parallel to historical trusses;
- replacement of some upper and lower knee braces and installation of bracings along the top and bottom chords of the trusses to include new trusses in the work of the whole structure.

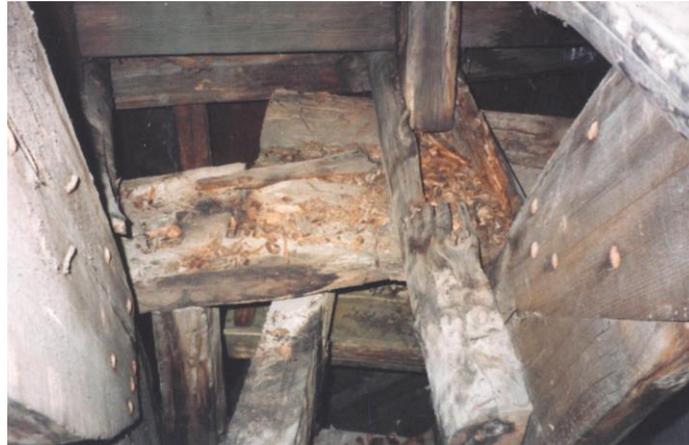
Dissemblance of the internal cupola changed the static scheme of a truss, broke the work of elements and junction, and caused numerous defects and damages. Nevertheless, main damages are the result of a long exploitation (more than 180 years [Fig. 6]).

Figure 6. The Building of the Board of Guardians, destruction of the wood

Owing to destruction of wood and under the influence of the thrust, an opening is created of conjunctions of segments of curb plates and there is bending and shearing of wrought nails in the nodes.

The testing of the external cupola framework to bear permanent load and super-load has shown that the existing section of the elements is not enough to resist loads and these elements should be strengthened. The calculation of the nodes of the curb plates revealed that the insufficient number of the driven in nails resulted in bending and, here and there, shearing of nails.

The decision to partial changing and prosthetic appliance of some elements was adopted, based on the results of engineer-constructive and chemical-technological research. In the course of the cupola restoration the following was performed:

- full reconstruction of the original (authentic) framework of the internal cupola using whole timber, $\delta=60$ mm; junction of the elements with stub tenon [Fig. 8];
- addition of spatial bracings made of whole timber between the arches of the external and internal cupolas with the formation of crescent-shaped semi arches;
- replacement of wrought nails in nodes by bolted connection.

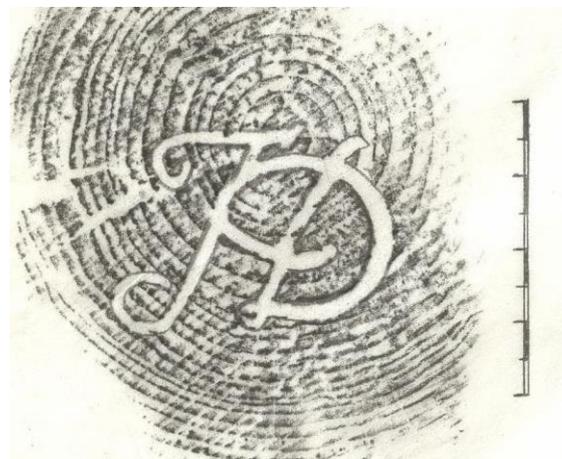
The engineer A.N. Gustova on the timber samples fulfilled the research of building and finishing materials in laboratory conditions choose after taking of a plaster. It was revealed, that some upright timber and some boards of the floor have surface rotting and damage caused by wood fretters and need prosthetic appliance. The sawn wood ends have trademarks stamped by a hammer [Fig. 7].

Figure 7. The Building of the Board of Guardians. The sawn wood ends have trademarks stamped by a hammer

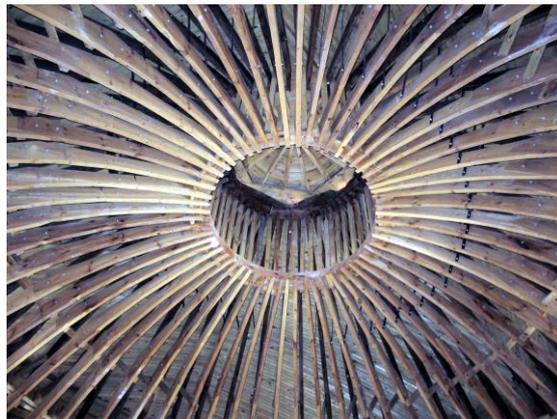
Figure 8. The Building of the Board of Guardians. Full reconstruction of the original (authentic) framework of the internal cupola using whole timber

- cupolas consist of 61 curve pieces (each) of board, $\delta=60$ mm, with 4 elements in every curve piece, step of curve pieces 480-660 mm;
- external cupola has a curve upper plane, and internal cupola has a curve down plane, $R = 6,81$ m;
- curve pieces of external and internal cupolas are based on wooden uprights, 60x350 mm in section, 5.9 m and 2.0 m in length external and internal cupolas adequately. Lower ends of uprights are connected with saddle beam by stub tenons;
- drum inner row uprights and the cupolas bases have pole strut of beams $\varnothing 150$ mm in width, 3.3 m in length, organized radially from a wooden platform of the bay window.

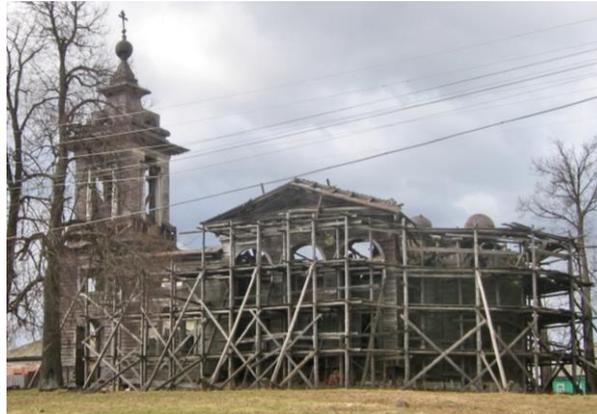
- at the time of observation (2007) the wooden structures of the cupola and the structures of the building partially had been brought down [Fig. 10];

Figure 10. The Cathedral of the Transfiguration of Christ in vil. Snoved. At the time of observation the wooden structures of the cupola had been brought down

- diameter of the cupola – 10.46 m, rising height – 5.18 m.
- the bearing structure of the cupola is created by two segmental truss made of timber. The lower truss belt has 350x370 mm in section, three uprights have a step 1850 mm and section of 270x330 mm; the section of two upper belts is 180x220 mm;
- truss height is approximately 4960 mm, span is approximately 7400 mm;
- curve pieces of the cupola were made of 120x450 mm timbers connected by trenails 40 mm over, and were covered by roof steel over boards.
- «zenith» ring with diameter 1000 mm is made of two steel strips 90 x 20 mm, connecting up and down curve pieces ends;
- junctions of the elements are made with stub tenons and suspensions of steel strip 90 x 20 mm;
- cathedral structure state was estimated as ruined.

Laboratory research revealed that timber was damaged by dry rot (*Poria vaporaria* and *Coniophora cerebella*). Humidity of beams and board facing is very high (30-50%). The walls of the Cathedral had extensive places of rotting and damage from wood fretters that caused the structures of the cupola to be brought down. The engineer N.A. Syomina on the samples of timber held the research of materials.

Laboratory endurance test and research of physical-mechanical characteristics made on the 45 samples, sawed from timber-blocking, upper and lower rings and curve pieces of cupola, revealed, that endurance of timber is not adequate to the demands of the State Standard. Basing on the results of engineer-constructive and chemical-technological research, the decision was adopted to change totally timber-blocking on the existing stone basement [Fig. 11].

- restoration of the cupola shape by means of computer modeling with the use of archival drawings from 1849 and full-scale measurements;
- full reconstruction of main structures of cupola made of bentwood semi trusses with the section 120x400 mm, saving the historical forged elements.
