Façade biological colonisation assessment

I Kukletová¹ and P Buchta¹

¹ Výzkumný ústav stavebních hmot, a.s. Hněvkovského 65, 617 00 Brno

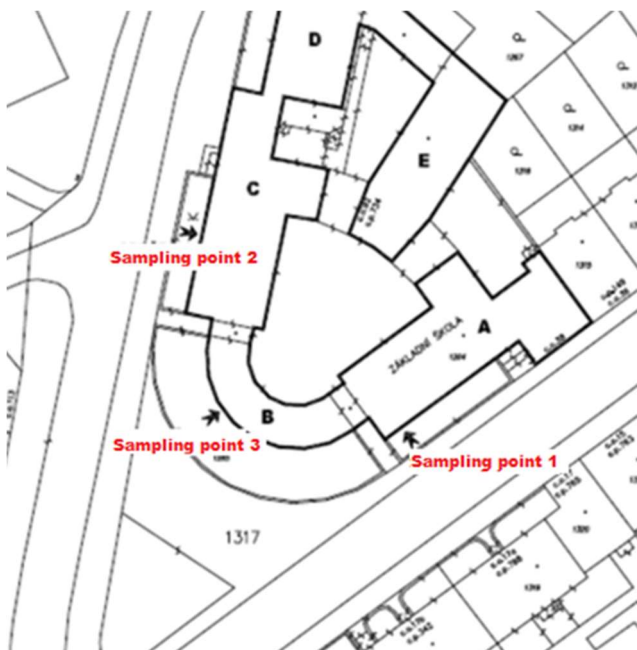
Figure 1. The building floor plan.

To determine the biological colonization of the facade, 3 sampling points were selected, see Figure 1. Samples were taken from these sites by the "swab-bulk-swab" Method [5].

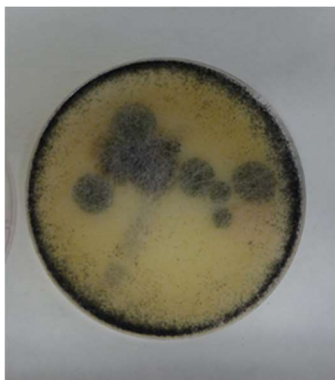
Figure 3. Sampling spot 1.

For both the first and the second sampling points, the difference between the two swabs cultivation is evident. The contamination of the second sampling point after abrasion was minimal, indicating a fast

growing species. The difference between findings at individual sampling points confirms high contamination only on the surface of the façade, under the surface the infestation is lower.

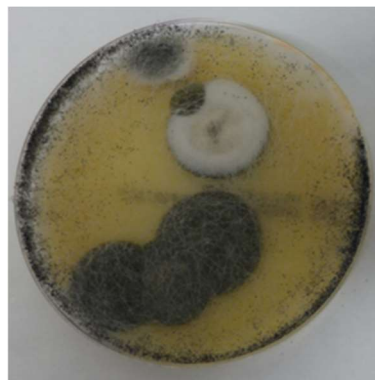
Figure 4. Sampling spot 2.

The results show that the façade was least infested at sampling point 2, where the contamination under the plaster was minimal and the green algae contamination unproved. However according to literature, a healthy plaster contains up to 1×10^2 CFU/g [8] only, so the sampling spot must be considered infested by mould growth. On the other hand, at the sampling point 3, the façade was massively colonized, which corresponds with its location. Sampling point 3 is found in the northwest arc of the object, adjacent to the park, where vegetation of bushes closely surrounds the building.

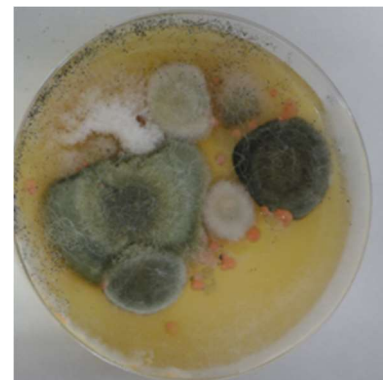
Figure 5. Sampling spot 3.

At the third sampling point, a relatively strong colonization through the entire layer of plaster occurs, biofilm was evident even during sampling. Identification of microbiological genera is presented in Table 1.

The analyses prove infestation of the façade through the plaster at all sampling points, i.e. on the surface, in the plaster bulk and also under the top layer. Among the sampling spots, spot 2 was the least colonized, while spot 3 was massively infested and therefore created a new source of further air contamination. These findings correspond with the location of the sampling spots, as spot 3 is located on the north-west side of the building and surrounded with adjacent park vegetation. Based on the analyses, replacement of the contact insulation system layer was recommended together with elimination of trees and bushes from the closest vicinity of the building.
